RECONSTRUCTING RIVER RESERVOIR NO. 3 – FROM EMERGENCY ACTION TO BREACH TO SAFE OPERATION IN 21 MONTHS

ABSTRACT

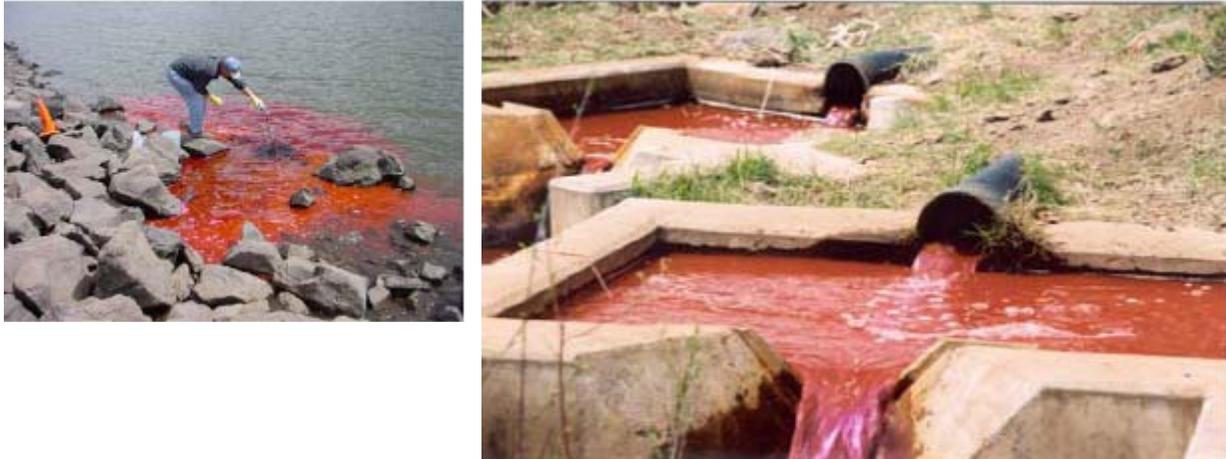
In order to determine the time it took for the water to flow from the upstream face to the downstream toe of the dam, tracer dyes were introduced into the reservoir and the travel time for the dye to emerge at the weirs was recorded. The tracer dye study was performed by Ozark Underground Laboratory on April 29th and April 30th when the level of the reservoir was at Elevation 8,210 feet and again on May 20th when the level of the reservoir was at Elevation 8,192 feet.

Figure 2 – Dye Test Results: Inserted dye into reservoir and dye discharging from toe drain weirs.

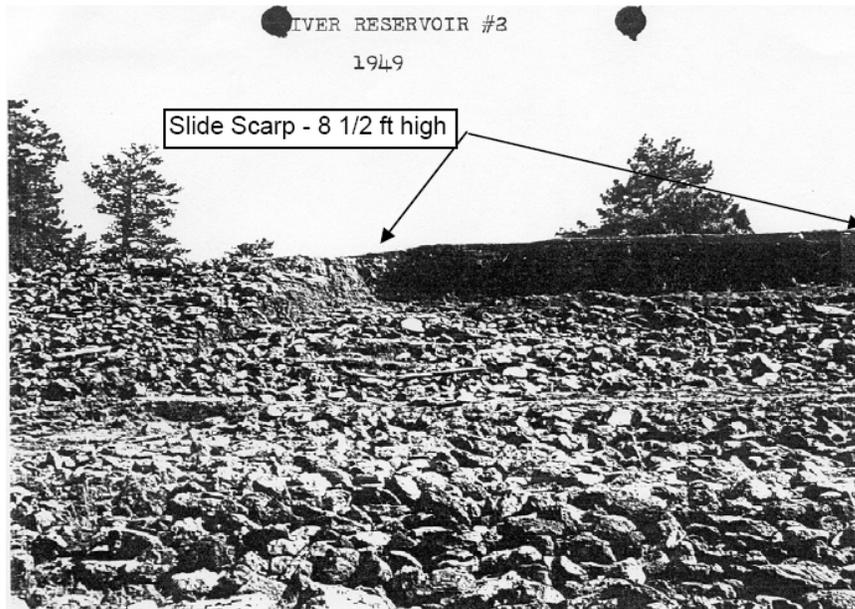
indicate that numerous slide failures have occurred at the maximum section nearly continuously on an annual basis between the years of 1920 and 1949. The reports indicate that additional soils as well as brush and tree branches were placed in the slide areas throughout the years to stabilize the slope to an acceptable condition. A major repair of the dam was completed in 1949 by the U.S. Soil Conservation Service when a major slide due to drawdown occurred earlier in the year. The slide left an 8 ½ foot deep scarp in the crest and was approximately 200 feet wide.

Figure 3 – Historical Upstream Slide (1949)

The repair work completed in 1949 included removing some of the brush and regrading the upstream slope to a 4H to 1V. Apparently none of the slide mass was removed. The drill holes and test pit completed during this investigation confirm this condition. The drill holes (EM-4, 5, and 6) that penetrated the slide mass soils appeared variable with some softer zones interfaced with firmer sections. Small pieces of wood were observed in some of the samples collected from the drill holes. Erratic soil patterns were also observed in the test pit and pieces of wood up to 3 inches in diameter and 18 inches long were uncovered in the excavation.

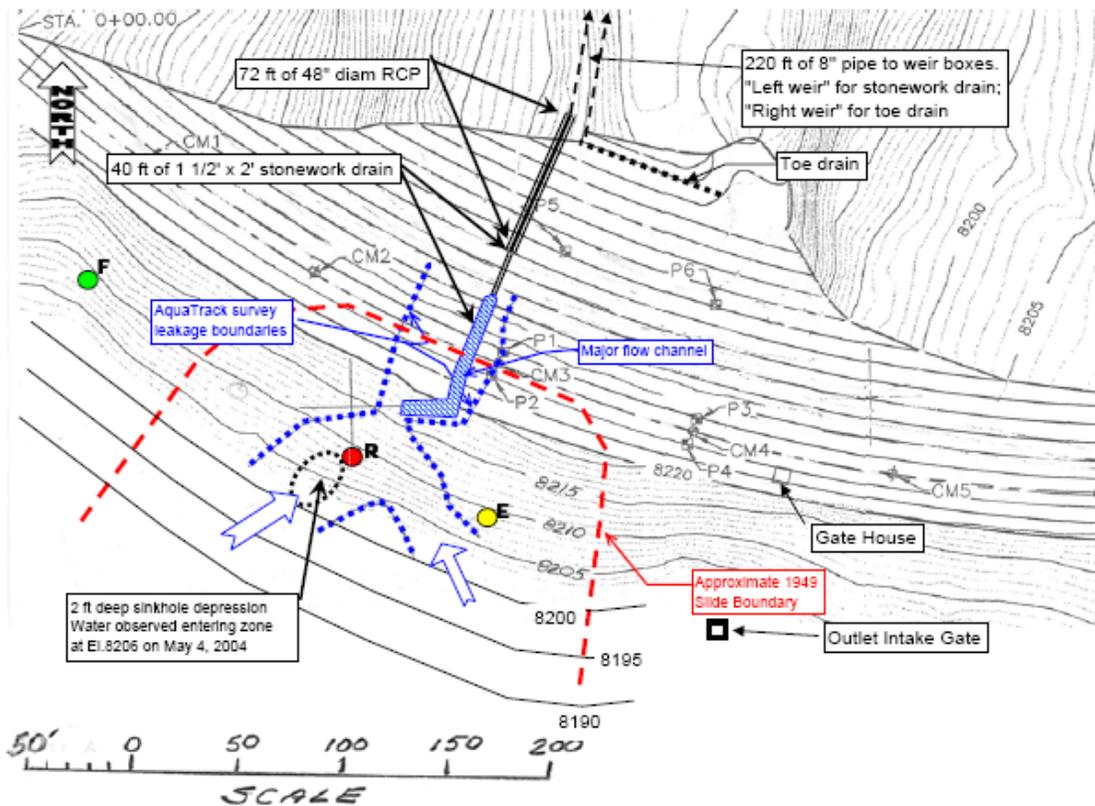
The AquaTrack geophysical surveys indicated that there were two broad flow channels where most of the water entered the upstream face (see Figure 4). These flow channels are located within the boundaries of the 1949 slide. The tracer dye studies also confirmed that there were various flow routes where water entered the embankment within the old slide mass.

Notes: Dyes introduced into reservoir at 9:45 am on April 30, 2004 when reservoir was at 8210. Introduction points shown by dye symbols. Wind and water currents moving in easterly direction, spreading dyes to the east during first 2 hours of tracer survey.

Figure 4 – Results of Investigations and Pre-Repair Features

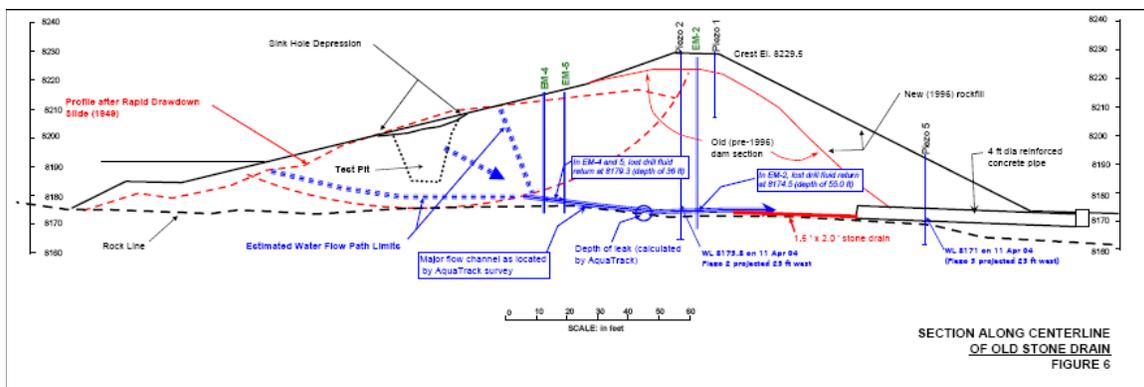
A total of six exploration bore holes were drilled (3 into the crest and 3 into the upstream face of the dam at the locations shown on Figure 5) during the period between June 28th and July 9th. Each drill hole was logged and representative soil samples and rock cores were collected for future laboratory testing.

The drilling program confirmed the AquaTrack surveys. Drill holes EM-2, 4, and 5 were positioned to intercept the concentrated flow path and drill holes EM-1, 3, and 6 were located to penetrate to the outside limits of the flow path. During the rock coring operations, drill holes EM-2, 4, and 5 lost all circulation at the contact between the embankment and the foundation. This is at the approximate level identified by AquaTrack as being the elevation of the concentrated flow channel. The drilling fluid lost in these holes emerged in the weirs several minutes later. The drill holes EM-1, 3, and 6 did not lose any water circulation at this elevation.

Figure 5 – Results of Investigations (Section View)

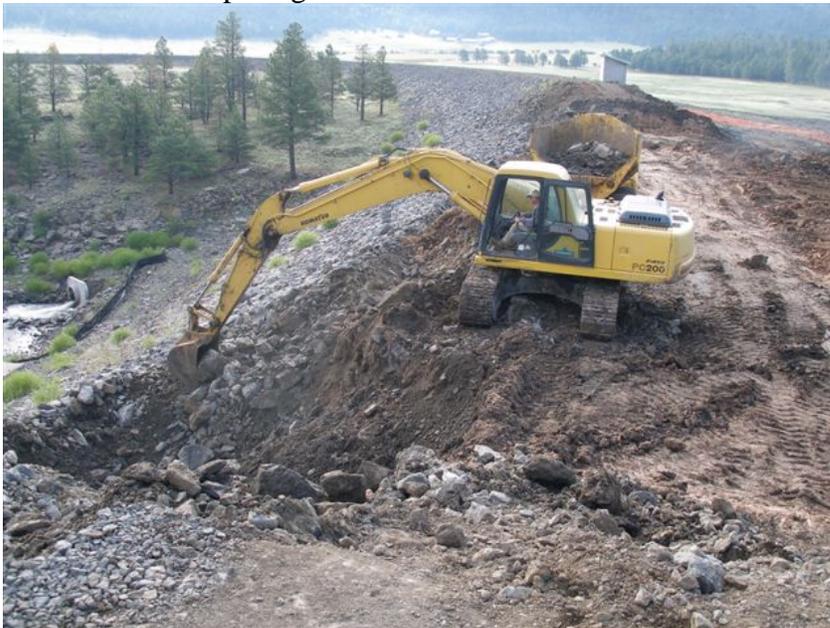
Figure 6 – Excavation of V-Notch

The repair of the dam consisted of excavating a V notch cut and stockpiling the removed clay, rock fill, and riprap in separate areas. After foundation cleanup, slush grouting and dental concrete the V notch was refilled with the previously excavated clay, rock fill and riprap. All of the stockpiled material was located upstream of the dam in the reservoir.

The Contractor removed 72 lineal feet of 48-inch reinforced concrete pipe, one concrete vault approximately 6 feet 4-inches square and about 125 lineal feet of masonry tunnel and head wall. Numerous logs, tree branches, stumps and rock clusters were removed from the upstream part of the dam. The contractor prepared the foundation bedrock by washing with a high pressure water jet and by hand removal of clay pockets and loose rock. A number of high points were jack hammered off to remove overhangs, steep surfaces and sharp irregularities.
