Maintenance Activities and Discussion

The SR89 Chino Valley Pilot Project Dry-well Site has various maintenance activities that take place to care for the physical infrastructure, to ensure groundwater quality is being protected, and to maintain the electronic data collection system. All of these systems must be working, maintained, and calibrated where necessary to produce a fact based data-set and defined set of site conditions on which to base the reports. This report covers the period from February 28, 2023 thru August 31, 2023.

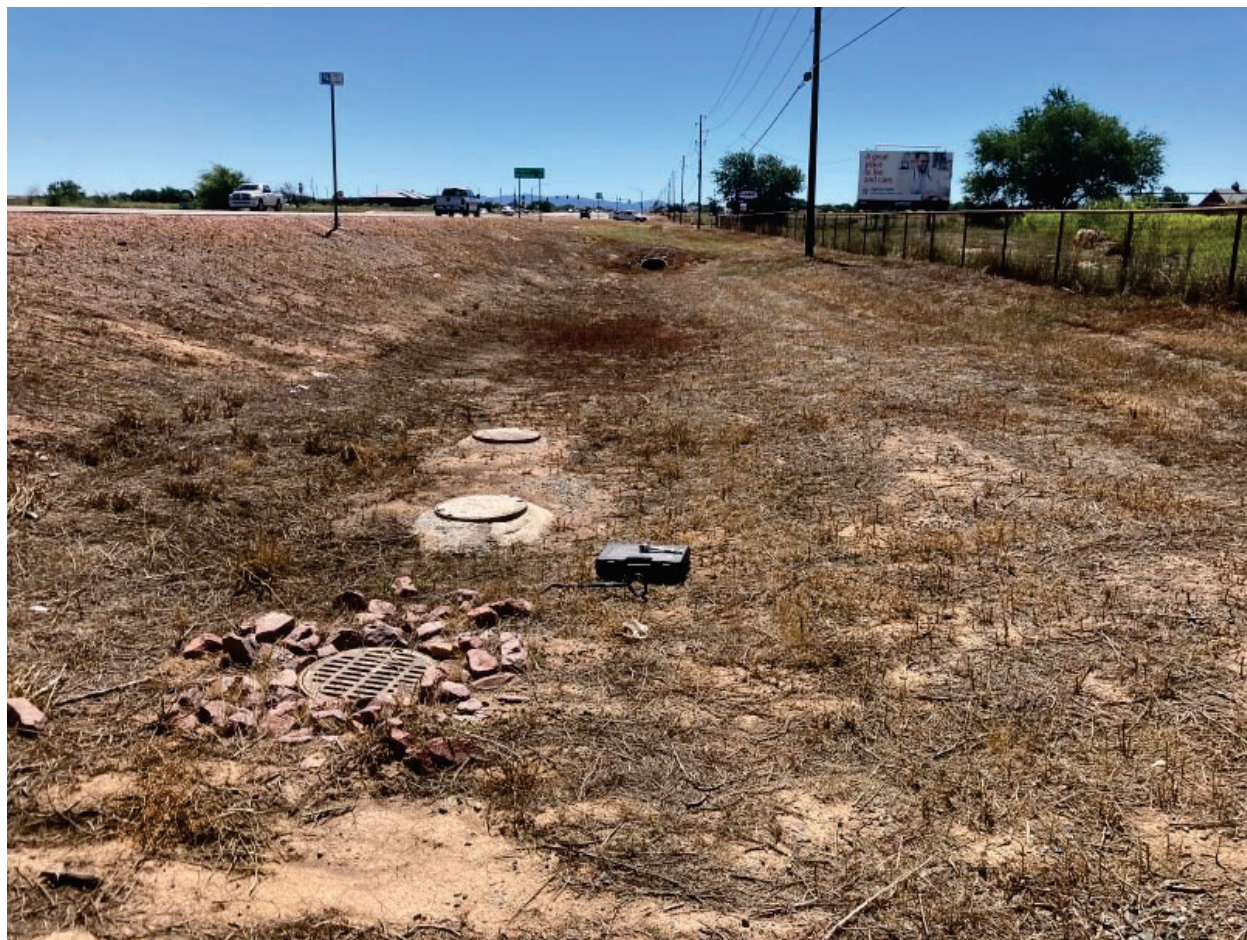
Basin Looking south post mowing and herbicide treatment

Mowing was conducted in the collection basin area one time during the reporting period based on the vegetation growth present, and in accordance with ADOT's Roadside Vegetation Management Guidelines (<https://azdot.gov/business/environmental-planning/biology/roadside-vegetation-management-guidelines>) in order to minimize impact on wildlife and unwanted seed disbursement. The weed growth was significant after the summer growing season with some weeds reaching 48 inches tall after the monsoon rains. The weed growth acts as basin erosion control and additional settling control for suspended sediment that enters the basin with runoff. In addition, weed growth can also uptake certain pollutants if present in runoff as an unintended benefit of their presence.
