Subject: **Tucson Water & ADWR Task 4 Report**

TUCSON WATER – ADWR TASK 4 REPORT
June – December 2023
October 19, 2023

This Report consists of the findings and recommendations resulting from continuing leak detection project with Tucson Water (TW) and Contractors. Tucson Waters goal is to reduce our non-revenue water loss to 4%. The Condition Assessment Program (formerly Infrastructure Reliability & Infrastructure Systems - IRIS) is utilizing technology as a tool to locate leaks within our water distribution mains, water service meters, and other water assets. The report is divided into three sections which include the Executive Summary, Detailed Leak Detection Technology reporting, and Tucson Water Asset Management follow up system.

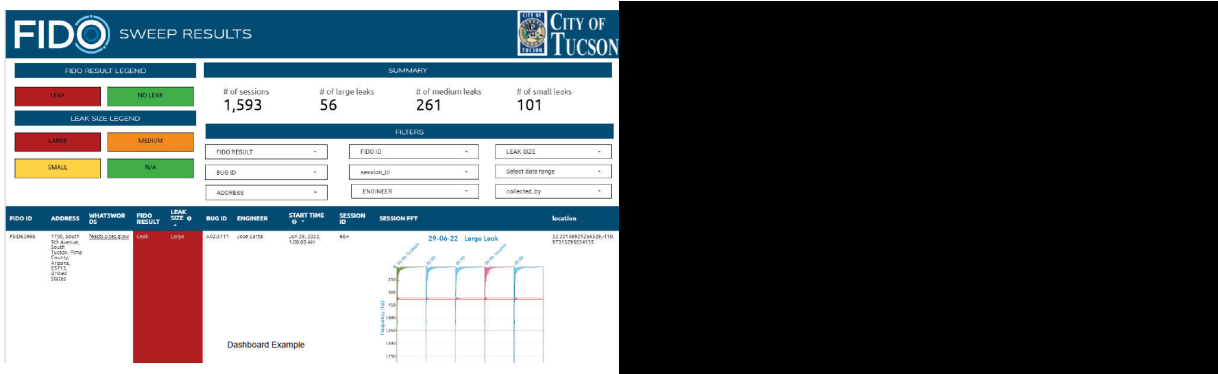
In summary, numerous FIDO sensors were deployed and monitored for more than a month. Multiple sensors identified leaks at residential meters. The Tucson Water and contractor team performed multiple excavations to locate the leaks with no success. In addition, the Tucson Water team performed a simulated leak in areas to try and fully utilize the FIDO sensors, and again had no success. After one and a half month, the pilot project was halted, and all sensors were returned to FIDO.

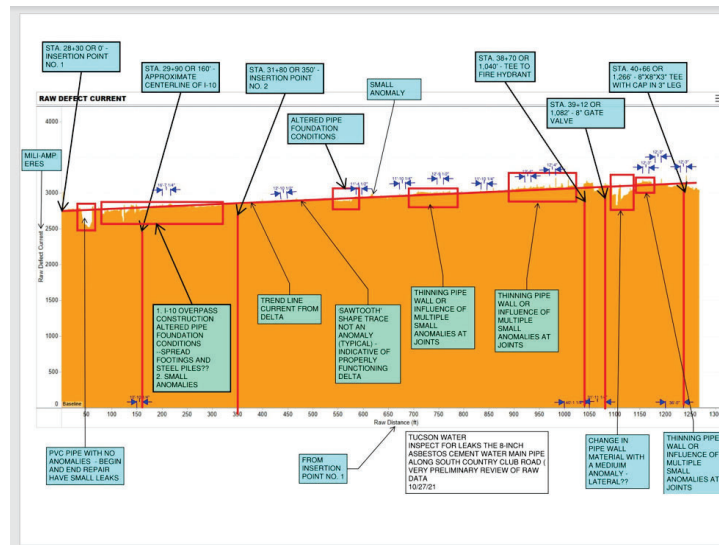
In summary, ElectroScan's technology is very promising and the capabilities can grow substantially if equipment upgrades were made and improve the relationship between the client and company staff. The testing results did not reveal any leaks. However, the technology was able to provide unknown changes in pipe material from AC to PVC. This is indicative of a previous repair. Additionally, the technology was able to detect AC pipe joints where a rubber gasket exists and provide a CCTV snapshot.

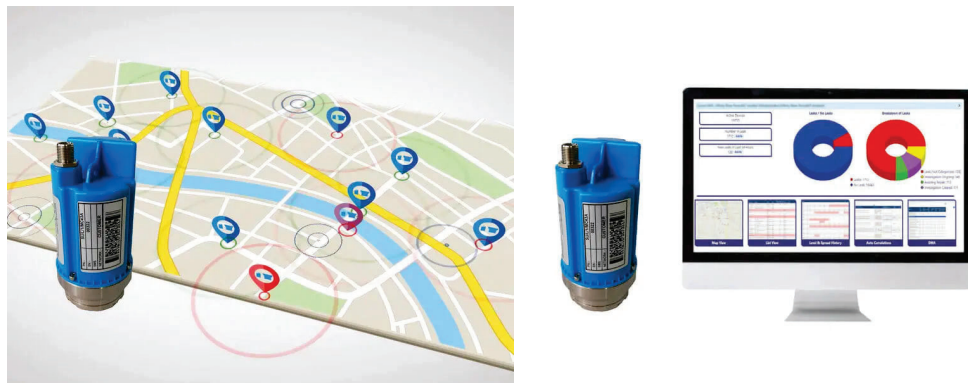
Additional equipment called the PermaNET Su single unit correlating telemetry noise loggers were also provided to pilot. The task is to set (install) at a known water feature for a period of one week allowing for data collection and then recovered (picked up).

In summary, numerous FCS PermaNET SU loggers were deployed and monitored for a few months. Multiple loggers never identified leaks at any installation site. Tucson Water staff performed simulated leaks in areas of easy access to validate the equipment's capabilities and arrived again with no success. After months of testing, the pilot project was halted with the SU loggers and were returned to FCS. However, the leak correlating technology proved to be successful on areas of leak detection.
