Subject: **Tucson Water & Arizona Department of Water Resources (ADWR)
Leak Detection Program – 2023 Annual Monitoring Report Deliverable**

2023
Annual Report

WATER MANAGEMENT
ASSISTANCE PROGRAM

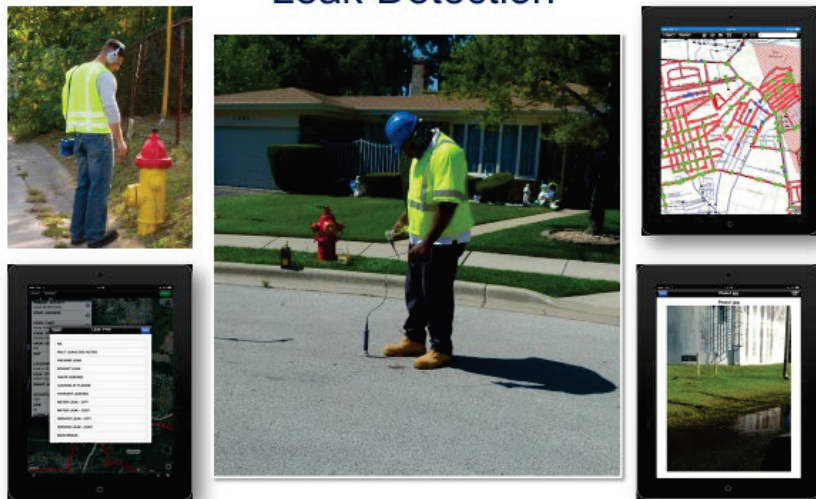
Leak Detection

Tucson Water CAP team continues to validate POI’s simultaneously with other water infrastructure. The CAP team recently added a Full Time Employee (FTE) to aide in the control of Non-revenue water loss. The CAP team accomplished approximately 100+ miles of testing on the distribution system documenting them within the asset management program Hexagon.

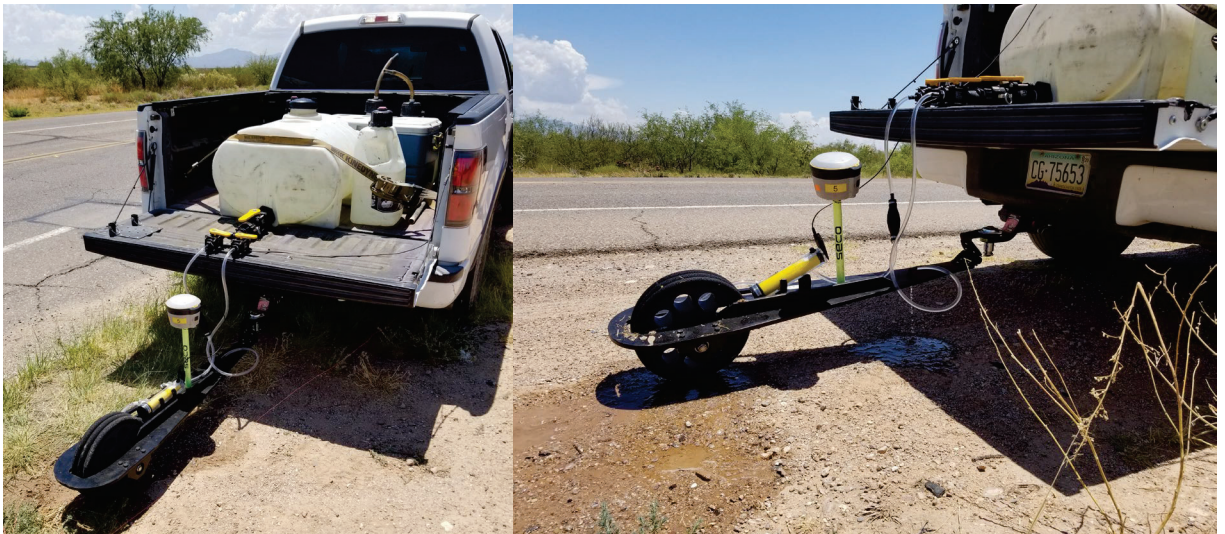
View of the Roto-cell performing a close-interval-potential-survey test.

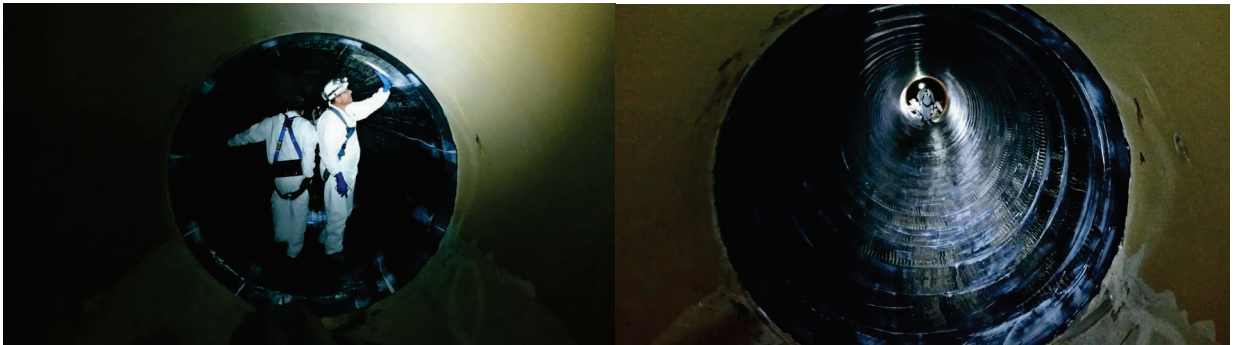
Pipe internal view of a CFRP installation.

Using technology as a tool for complete pipe renewal for structural integrity and a guarantee of no water loss, Tucson Water contracted with Simpson Gumpertz & Heger Inc. to provide engineering services to design the carbon fiber reinforced polymer (CFRP) liner for the 4.5-mile-long 54” Prestressed Concrete Cylinder Pipe (PCCP). This critical 54 in. diameter PCCP transmission main was installed in the 1980’s and has active deterioration of the prestressing wires. An alternative analysis was determined for CFRP to be the most suitable renewal method.

By applying a wet layup of saturated fiber impregnated with an epoxy resin at the designed layers and after the curing process, the structural integrity will be renewed 100% with a minimum 50-year life.

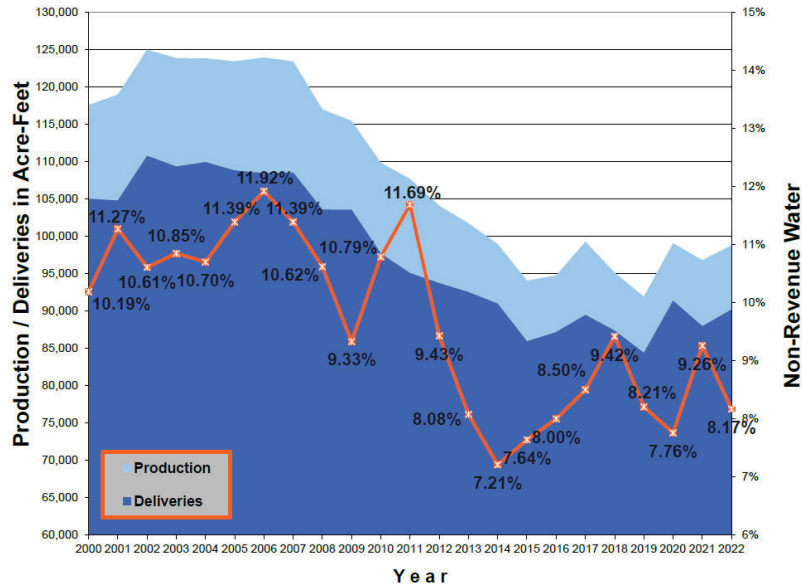
Attached below is a copy of the 2022 Annual Water loss report chart identifying the annual progress. As you are aware, the Tucson Water annual report was submitted previously to ADWR by traditional methods from our Water Quality Division. Tucson Water is hoping to have an updated 2023 water loss chart for the final report submittal. The information for this char is currently being compiled.
