Subject: **Tucson Water & Arizona Department of Water Resources (ADWR)
Leak Detection Program – 2023 Final Monitoring Report Deliverable**

2023
Final Report

WATER MANAGEMENT
ASSISTANCE PROGRAM

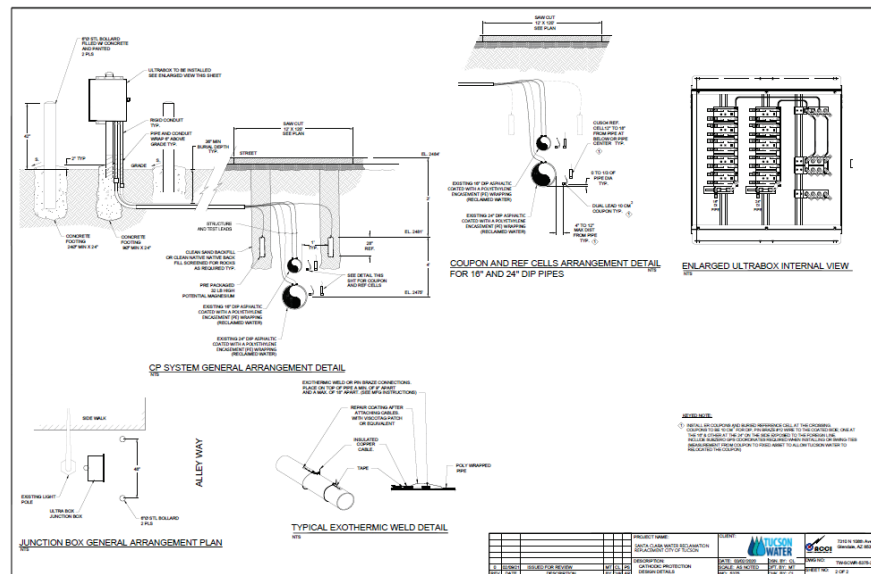
Our program identified two locations experiencing stray current interference. Site one – two ductile iron pipelines (16” & 24”) parallel to each other on our city southwest location. Site two – one 30” welded steel pipeline suction side to a booster pump on the city far east side location. This location had active corrosion cells with through wall pitting and experiencing a leak. **Site one** – remedial measure: a new sacrificial cathodic protection (cp) system was designed and both parallel pipelines were excavated, electrically wired for the cp system, new 32lb. high potential magnesium anodes were installed and wired into an above ground junction box with new corrosion test stations, and a new loose bonded polyethylene encasement installed.
