Maintenance Activities and Discussion;

RE-REVISED (9/9/24) REPORT ADWR DCP ADOT Contract 2020-3129

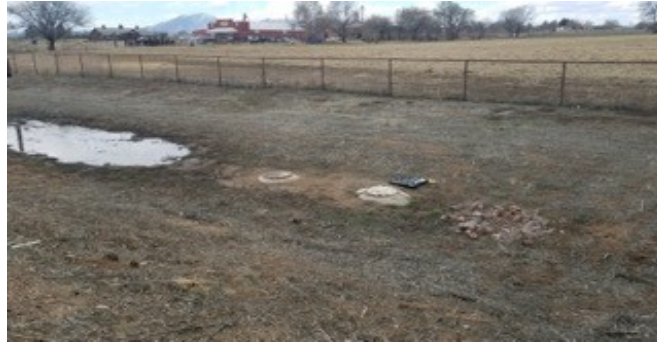
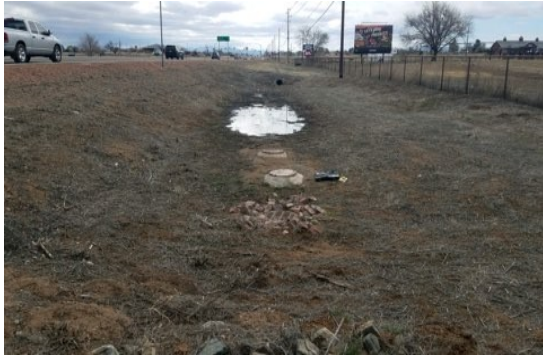
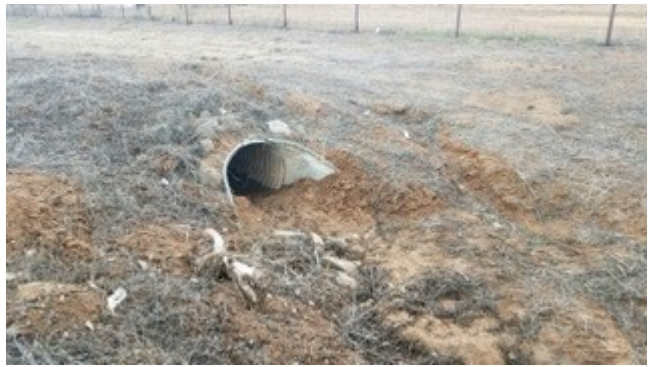
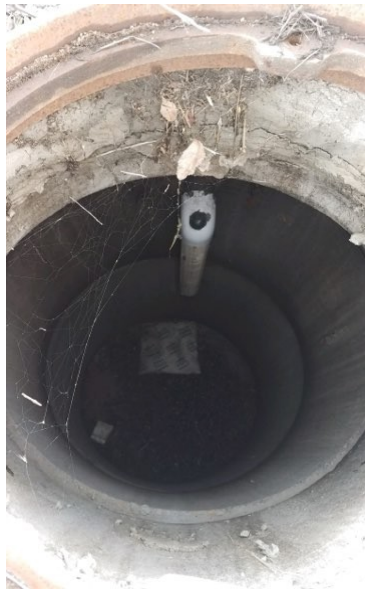
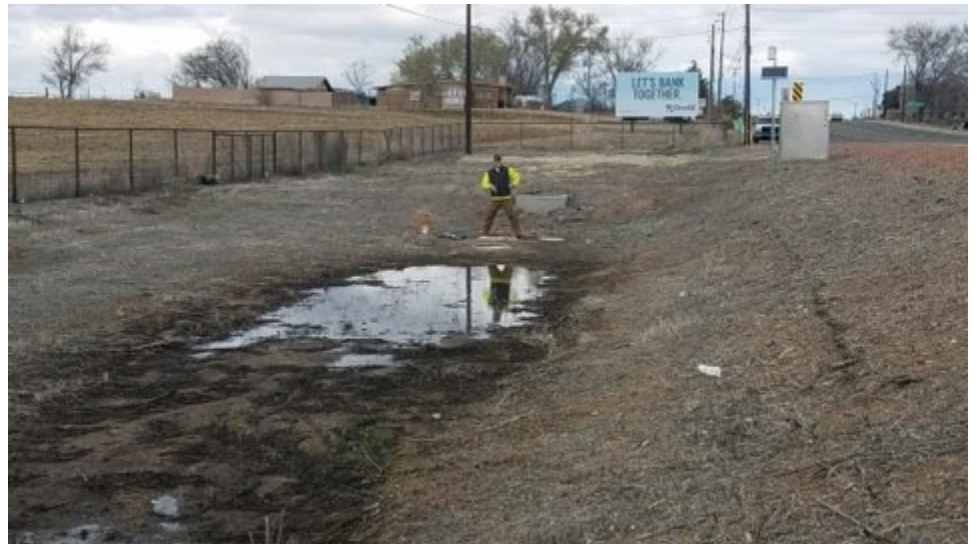
Basin Photos 03/2024

Drainage clearing was necessary on the south end of the collection basin two times during the reporting period. One time due to an influx of mud that created a partial blockage after sliding down from the area above the south inlet's 12" drainage pipe that conveys runoff into the basin, and one time due to wind blown tumbleweeds that had collected and clogged the same entrance point. The mud issue should be eliminated now due to that area above now being fully vegetated and stabilized. It is unknown at this time if the tumbleweeds will be a continuing seasonal maintenance problem and is being monitored.
