DEPARTMENT OF THE INTERIOR  
U. S. INDIAN IRRIGATION SERVICE

MONTHLY  
REPORT

DECEMBER

1914

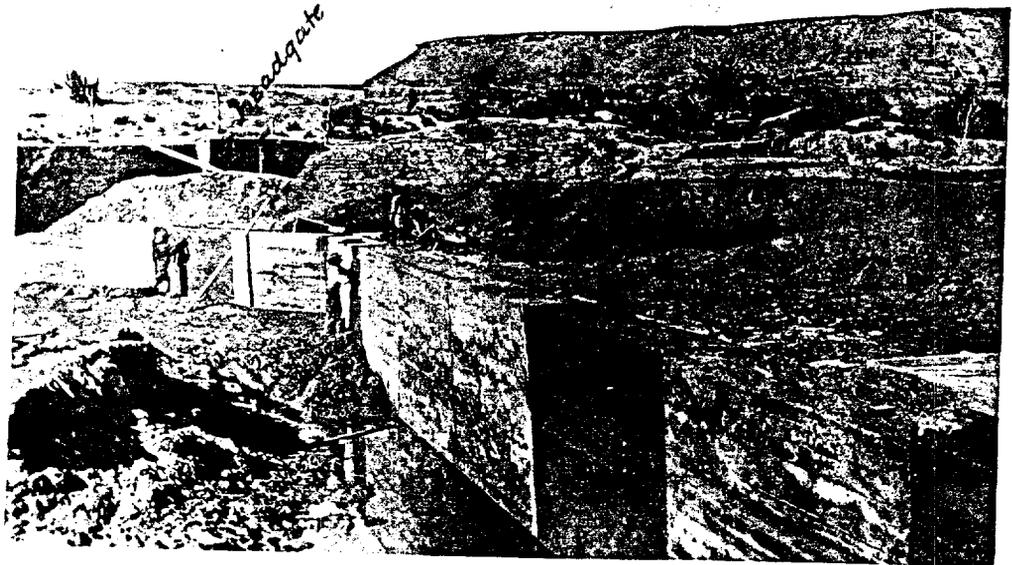
*Face of dam - unfinished.*

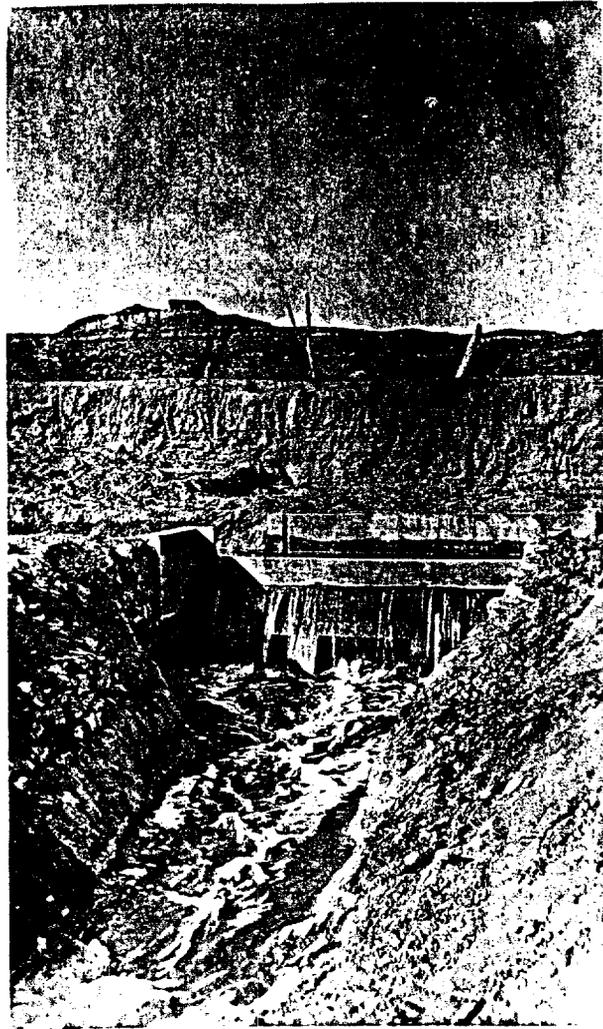
Spillway  
in Ditch.
