Hydrologic and Water Use Data For Cochise Strategic Planning Area

03/05/2016

Arizona Department of Water Resources
Hydrology Division

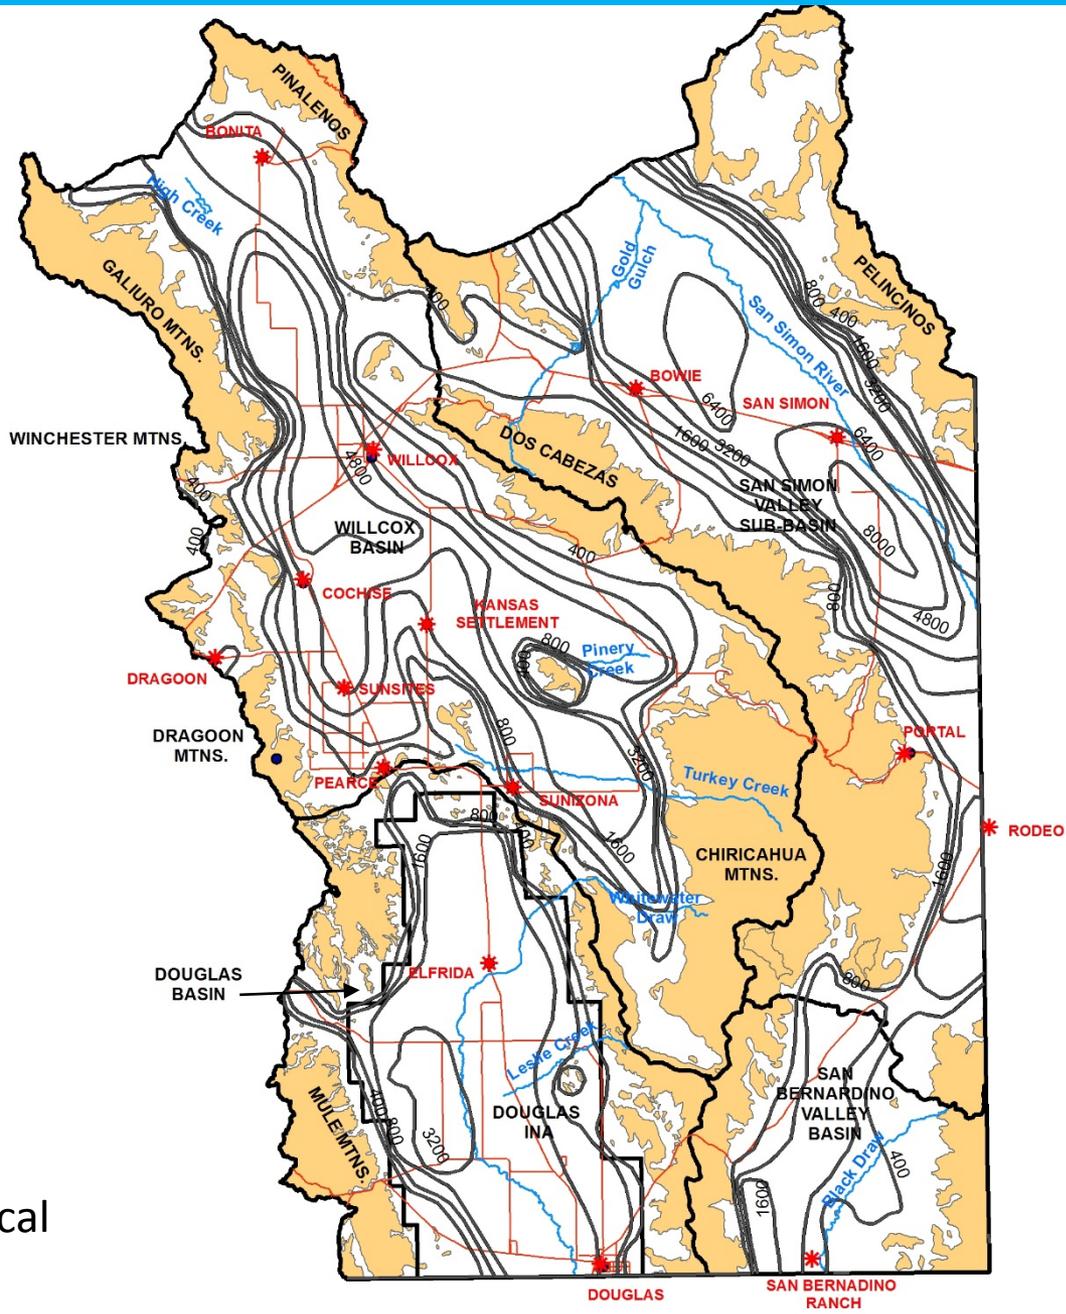
Depth-to-Bedrock In Cochise Strategic Planning Area

Source:
AZ Geological
Survey

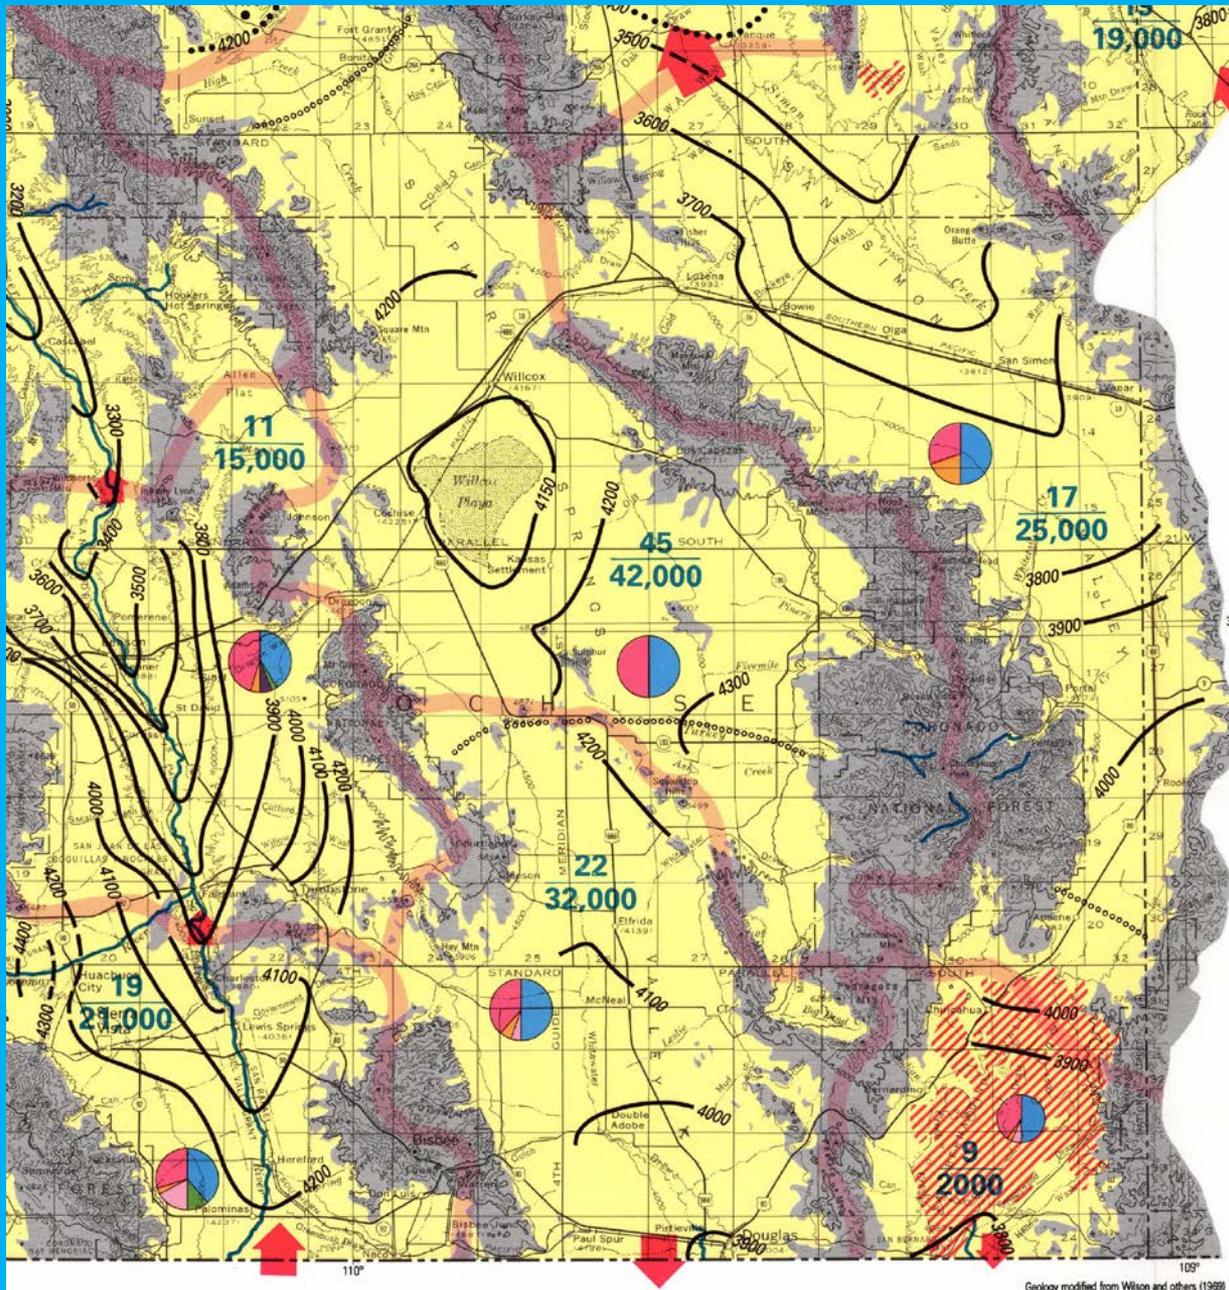
Predevelopment Groundwater Flow Patterns In the Cochise Strategic Planning Area

GROUND-WATER BUDGET

Ratio of Basin Inflow (AF/Yr) To Total Groundwater Storage (To 1,200 FT BLS)

Source: USGS Hydrologic Investigations Atlas HA-664 (1986)

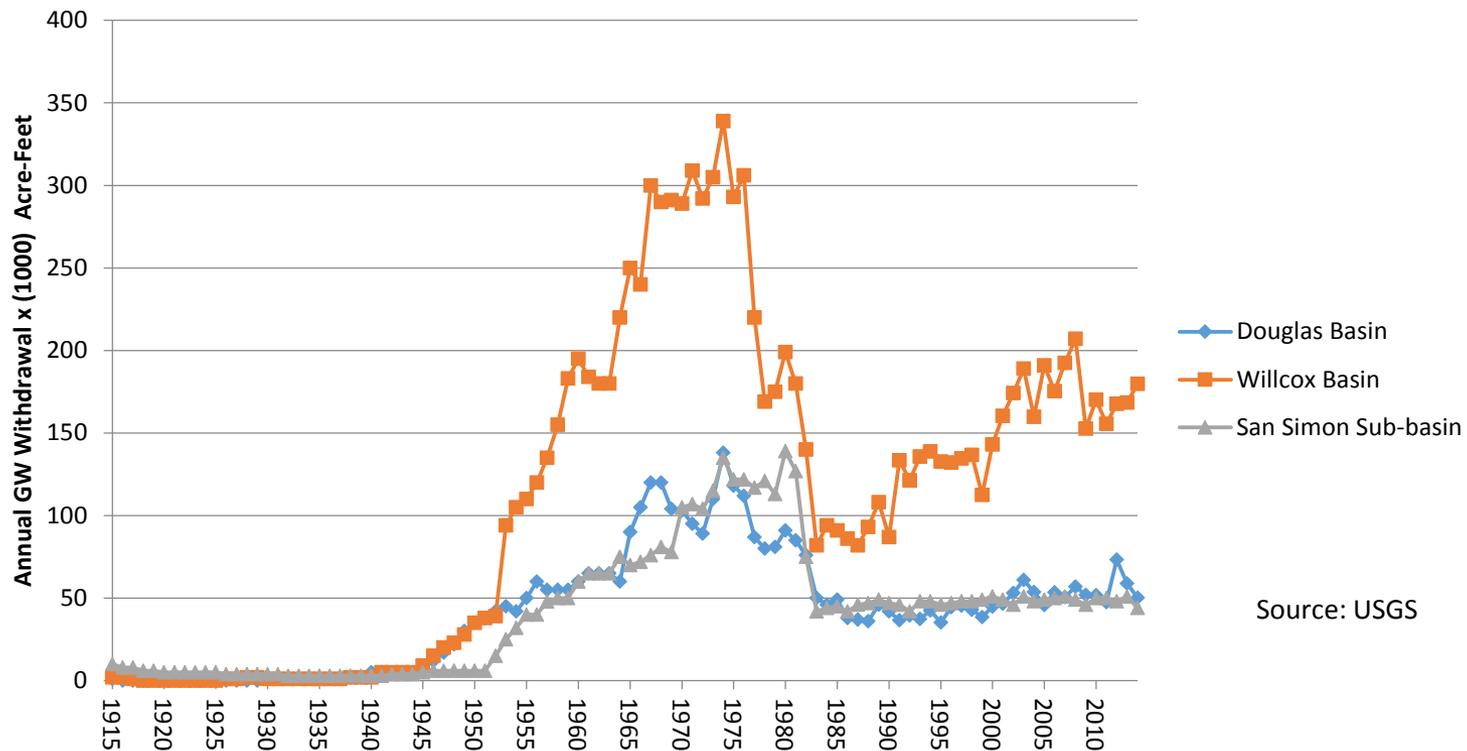
Total Estimated Groundwater Withdrawals In The Douglas and Willcox Basins and the San Simon Sub-Basin 1915 to 2014

Source: USGS

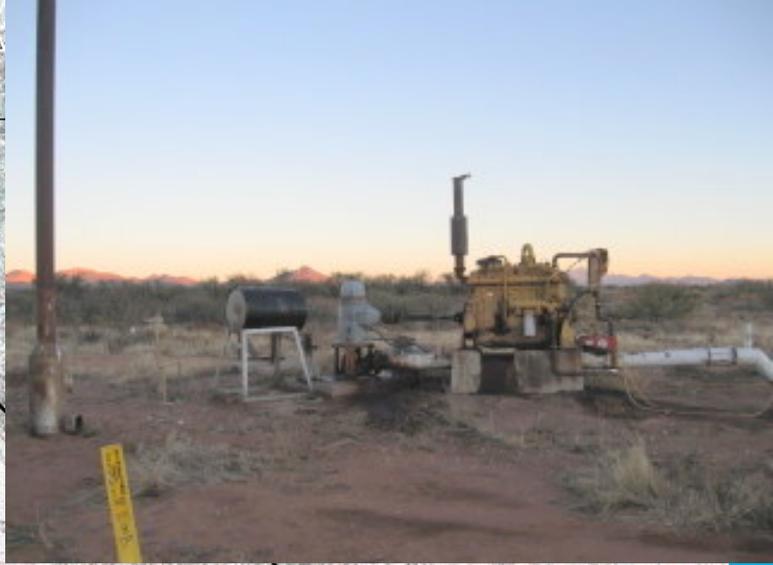
Arizona GroundWater Monitoring Site Hydrograph

| Local ID | Site ID | Registry ID | Latitude NAD27 | Longitude NAD27 | Alt. (ft amsl) | Water Use | Well Depth (ft) | Case Dia. (in) | Drill Date | Latest WL Date | DTW (ft) | WL Ev. (ft) |
| D-11-24 17DAA | 322840109543901 | 622902 | 32° 28' 41.0" | 109° 54' 38.3" | 4472 | IRRIGATION | 700 | | | 11/7/2012 | 428.8 | 4043.2 |

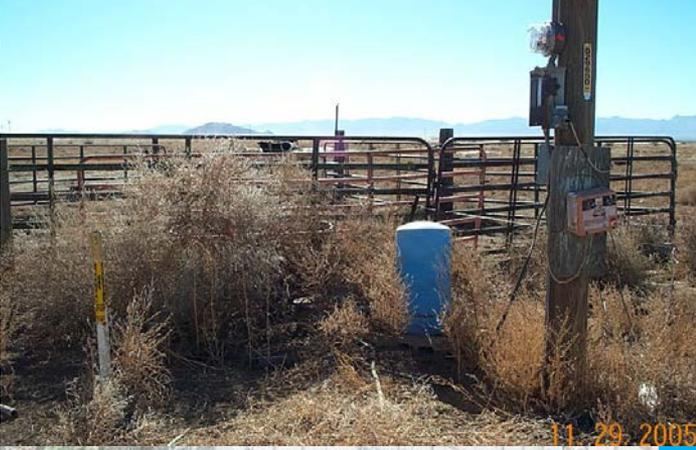
Arizona GroundWater Monitoring Site Hydrograph

| Local ID | Site ID | Registry ID | Latitude NAD27 | Longitude NAD27 | Alt. (ft amsl) | Water Use | Well Depth (ft) | Case Dia. (in) | Drill Date | Latest WL Date | DTW (ft) | WL Elev. (ft) |
| D-16-26 06DDA | 320403109434701 | 612109 | 32° 4' 6.7" | 109° 43' 44.9" | 4257.8 | STOCK | 662 | 16 | 3/22/1958 | 12/10/2014 | 375.1 | 3882.7 |

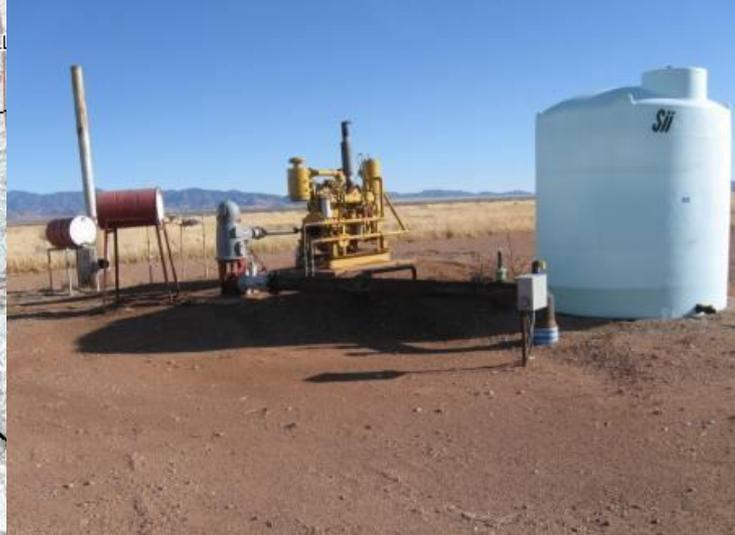
Arizona GroundWater Monitoring Site Hydrograph

| Local ID | Site ID | Registry ID | Latitude NAD27 | Longitude NAD27 | Alt. (ft amsl) | Water Use | Well Depth (ft) | Case Dia (in) | Drill Date | Latest WL Date | DTW (ft) | WL Elev. (ft) |
| D-17-27 28BAA | 315602109360701 | 627815 | 31° 56' 2.7" | 109° 36' 4.8" | 4427 | IRRIGATION | 701 | 14 | 10/22/1965 | 11/5/2013 | 285.8 | 4141.2 |

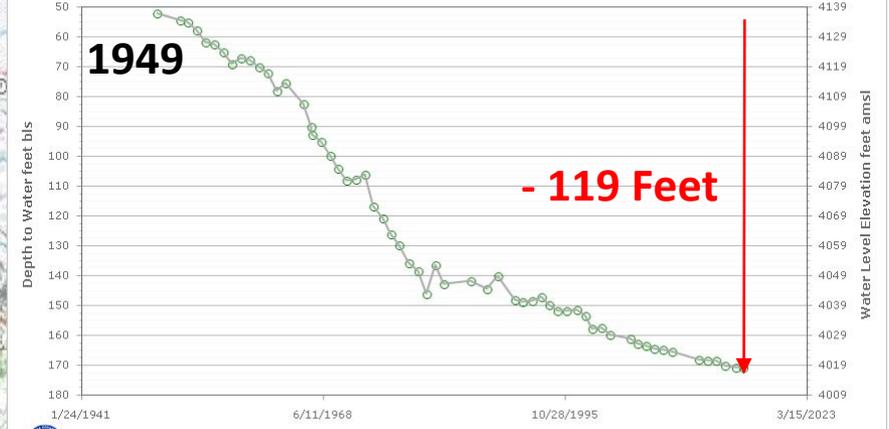
Arizona GroundWater Monitoring Site Hydrograph

| Local ID | Site ID | Registry ID | Latitude NAD27 | Longitude NAD27 | Alt. (ft amsl) | Water Use | Well Depth (ft) | Case Dia (in) | Drill Date | Latest WL Date | DTW (ft) | WL Elev. (ft) |
|---|---|---|---|---|---|---|---|---|---|---|---|---|
| D-19-26 33CDA | 314358109414801 | | 31° 43' 55.0" | 109° 41' 43.0" | 4188.9 | DOMESTIC | 252 | 12 | 9/1/1947 | 12/1/2015 | 170.6 | 4018.3 |

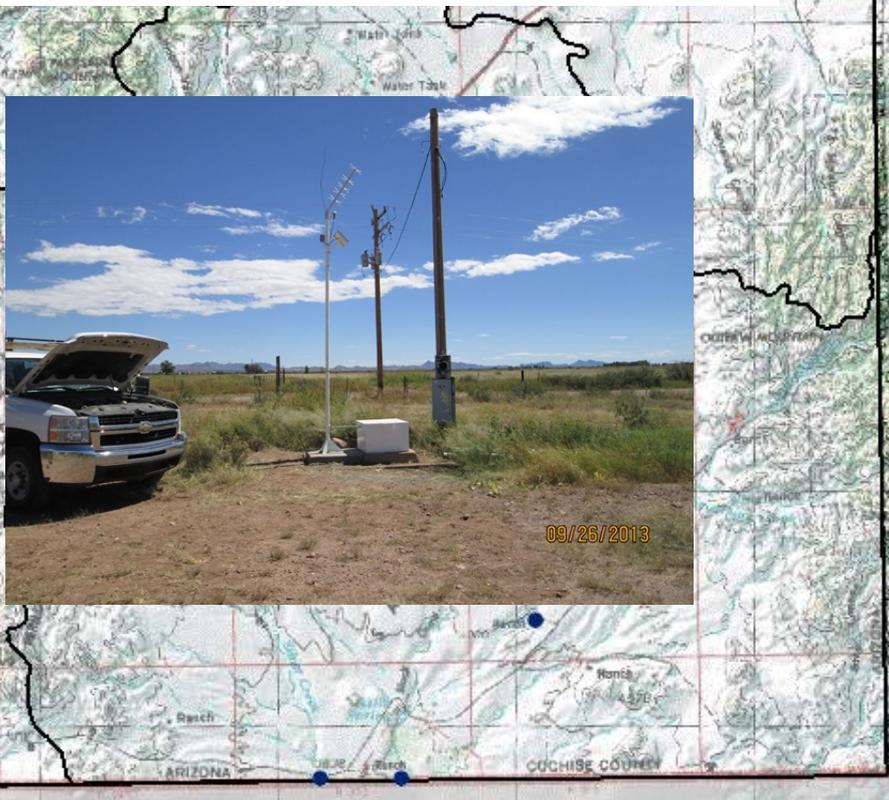
Arizona Groundwater Monitoring Site Hydrograph

| Local ID | Site ID | Registry ID | Latitude NAD27 | Longitude NAD27 | Alt. (ft amsl) | Water Use | Well Depth (ft) | Case Dia (in) | Drill Date | Latest WL Date | DTW (ft) | WL Elev. (ft) |
| D-23-28 31CCC | 312248109323801 | | 31° 22' 45.3" | 109° 32' 37.3" | 4042 | UNUSED | | 14 | 5/1/1970 | 12/4/2015 | 335.9 | 3706.1 |

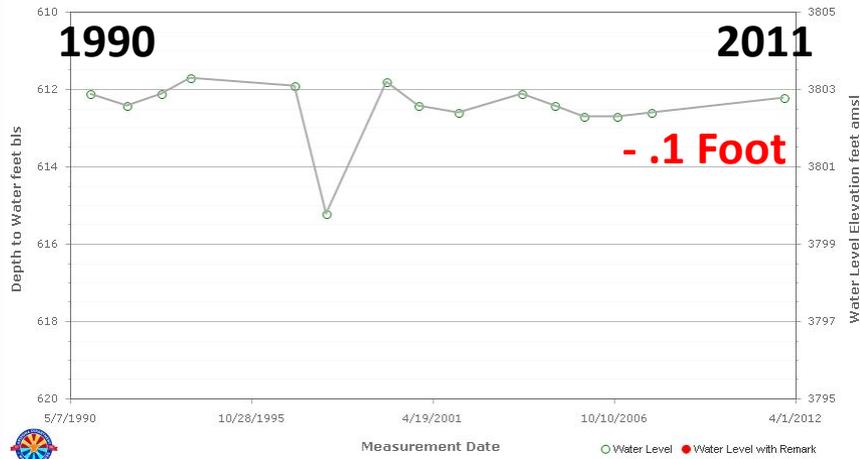
Arizona GroundWater Monitoring Site Hydrograph

| Local ID | Site ID | Registry ID | Latitude NAD27 | Longitude NAD27 | Alt. (ft amsl) | Water Use | Well Depth (ft) | Case Dia. (in) | Drill Date | Latest WL Date | DTW (ft) | WL Elev. (ft) |
|---|---|---|---|---|---|---|---|---|---|---|---|---|
| D-22-30 13CBD | 313057109145901 | 631771 | 31° 30' 55.3" | 109° 14' 56.5" | 4415 | STOCK | 809 | 10 | 11/1/1947 | 11/17/2011 | 612.2 | 3802.8 |

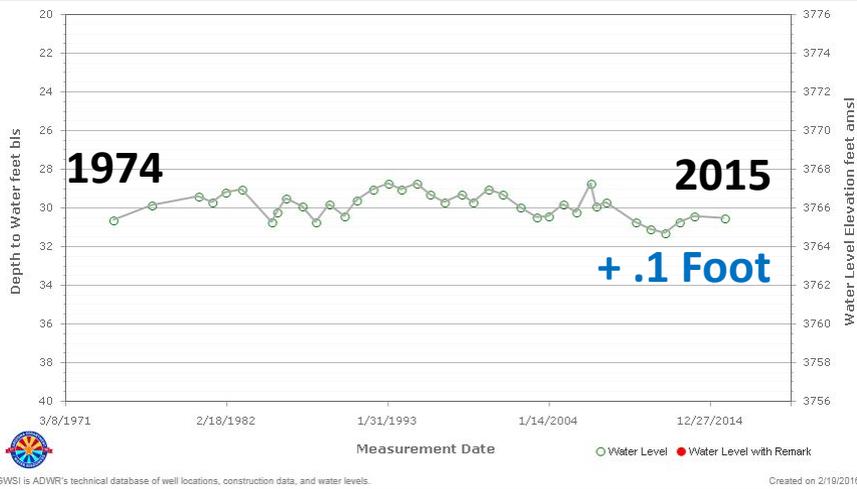
Arizona GroundWater Monitoring Site Hydrograph

| Local ID | Site ID | Registry ID | Latitude NAD27 | Longitude NAD27 | Alt. (ft amsl) | Water Use | Well Depth (ft) | Case Dia. (in) | Drill Date | Latest WL Date | DTW (ft) | WL Elev. (ft) |
|---|---|---|---|---|---|---|---|---|---|---|---|---|
| D-24-30 16CCC | 312006109180601 | 616444 | 31° 20' 4.9" | 109° 17' 59.5" | 3796 | STOCK | 100 | 12 | 7/10/1971 | 12/3/2015 | 30.5 | 3765.5 |

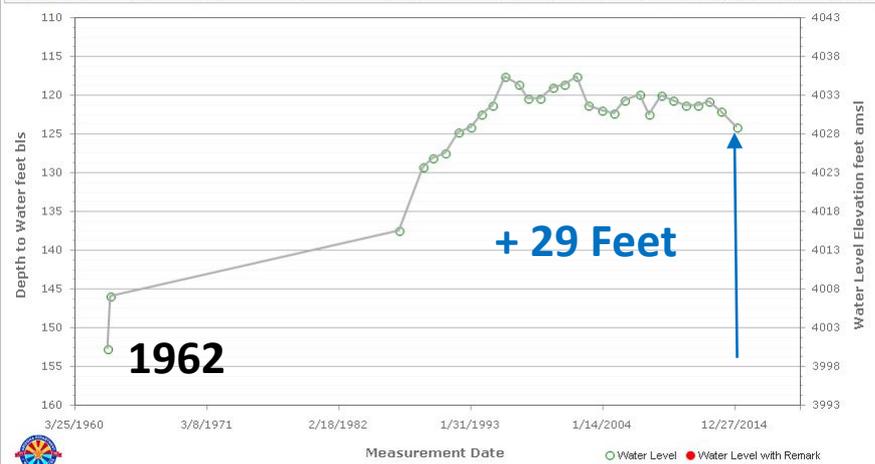
Arizona GroundWater Monitoring Site Hydrograph

| Local ID | Site ID | Registry ID | Latitude NAD27 | Longitude NAD27 | Alt. (ft amsl) | Water Use | Well Depth (ft) | Case Dia. (in) | Drill Date | Latest WL Date | DTW (ft) | WL Elev. (ft) |
|---|---|---|---|---|---|---|---|---|---|---|---|---|
| D-18-32 35CBA | 314854109025601 | | 31° 48' 51.8" | 109° 3' 0" | 4153 | IRRIGATION | 296 | 16 | 7/1/1963 | 3/3/2015 | 124.1 | 4028.9 |

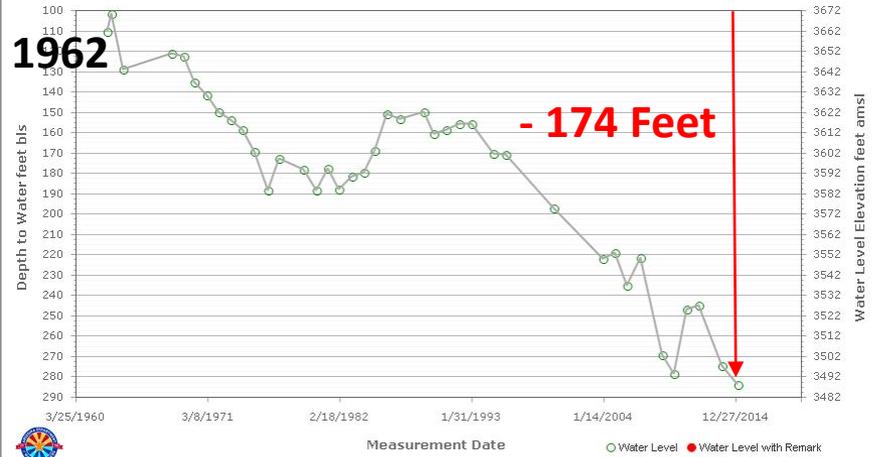
Arizona GroundWater Monitoring Site Hydrograph

| Local ID | Site ID | Registry ID | Latitude NAD27 | Longitude NAD27 | Alt. (ft amsl) | Water Use | Well Depth (ft) | Case Dia. (in) | Drill Date | Latest WL Date | DTW (ft) | WL Elev. (ft) |
|---|---|---|---|---|---|---|---|---|---|---|---|---|
| D-14-31 35BCC | 321016108094501 | | 32° 10' 12.6" | 109° 9' 27.5" | 3772 | IRRIGATION | 800 | 16 | 12/24/1959 | 3/3/2015 | 263.9 | 3488.1 |

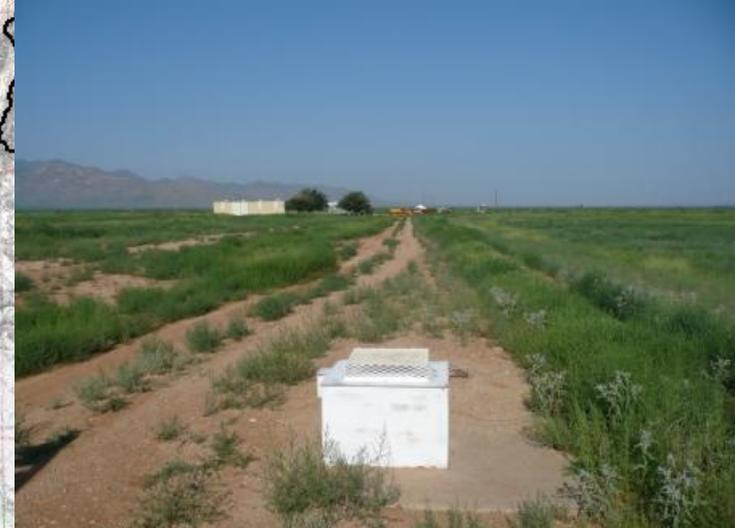
Arizona GroundWater Monitoring Site Hydrograph

| Local ID | Site ID | Registry ID | Latitude NAD27 | Longitude NAD27 | Alt. (ft amsl) | Water Use | Well Depth (ft) | Case Dia. (in) | Drill Date | Latest WL Date | DTW (ft) | WL Elev. (ft) |
| D-13-28 13BCD | 321812109264401 | 610888 | 32° 18' 12.1" | 109° 26' 46.8" | 3732.1' | UNUSED | 177 | 12 | 4/6/1979 | 12/28/2015 | 112.71 | 3619.45 |

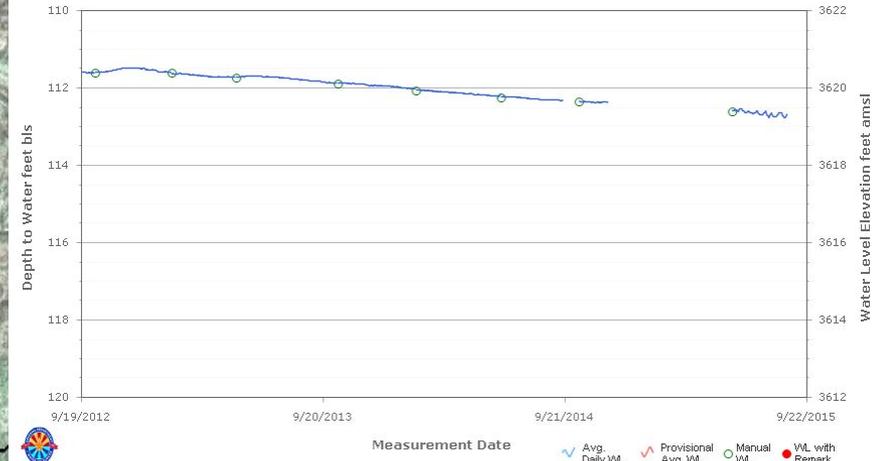
Arizona Automated GroundWater Monitoring Site Hydrograph

| Local ID | Site ID | Registry ID | Latitude NAD27 | Longitude NAD27 | Alt. (ft amsl) | Water Use | Well Depth (ft) | Case Dia. (in) | Drill Date | Latest WL Date | DTW (ft) | WL Elev. (ft) |
|---|---|---|---|---|---|---|---|---|---|---|---|---|
| D-13-28 13BCD | 321812109264401 | 610888 | 32° 18' 12.1" | 109° 26' 46.8" | 3732.1' | UNUSED | 177 | 12 | 4/6/1979 | 12/28/2015 | 112.71 | 3619.45 |

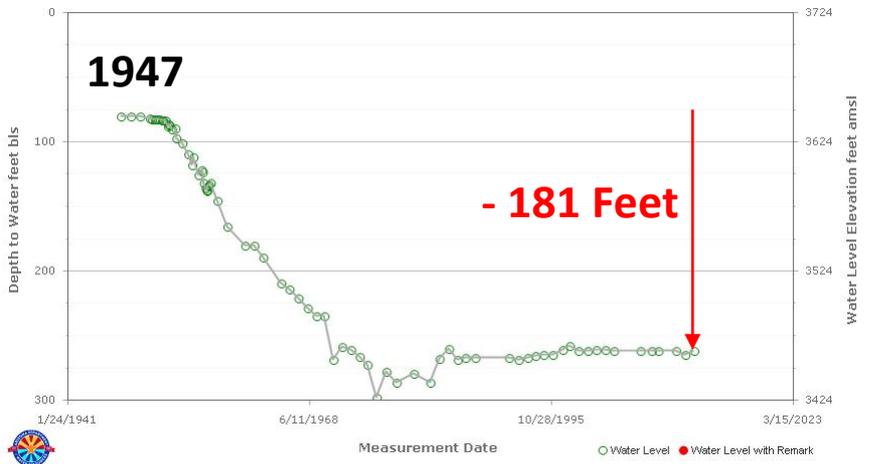
Arizona GroundWater Monitoring Site Hydrograph

| Local ID | Site ID | Registry ID | Latitude NAD27 | Longitude NAD27 | Alt. (ft amsl) | Water Use | Well Depth (ft) | Case Dia. (in) | Drill Date | Latest WL Date | DTW (ft) | WL Elev. (ft) |
|---|---|---|---|---|---|---|---|---|---|---|---|---|
| 0-12-28 17DDD | 322301109300901 | 609816 | 32° 23' 7.0" | 109° 30' 4.9" | 3724 | UNUSED | 567 | 6 | | 11/29/2011 | 261.6 | 3462.4 |

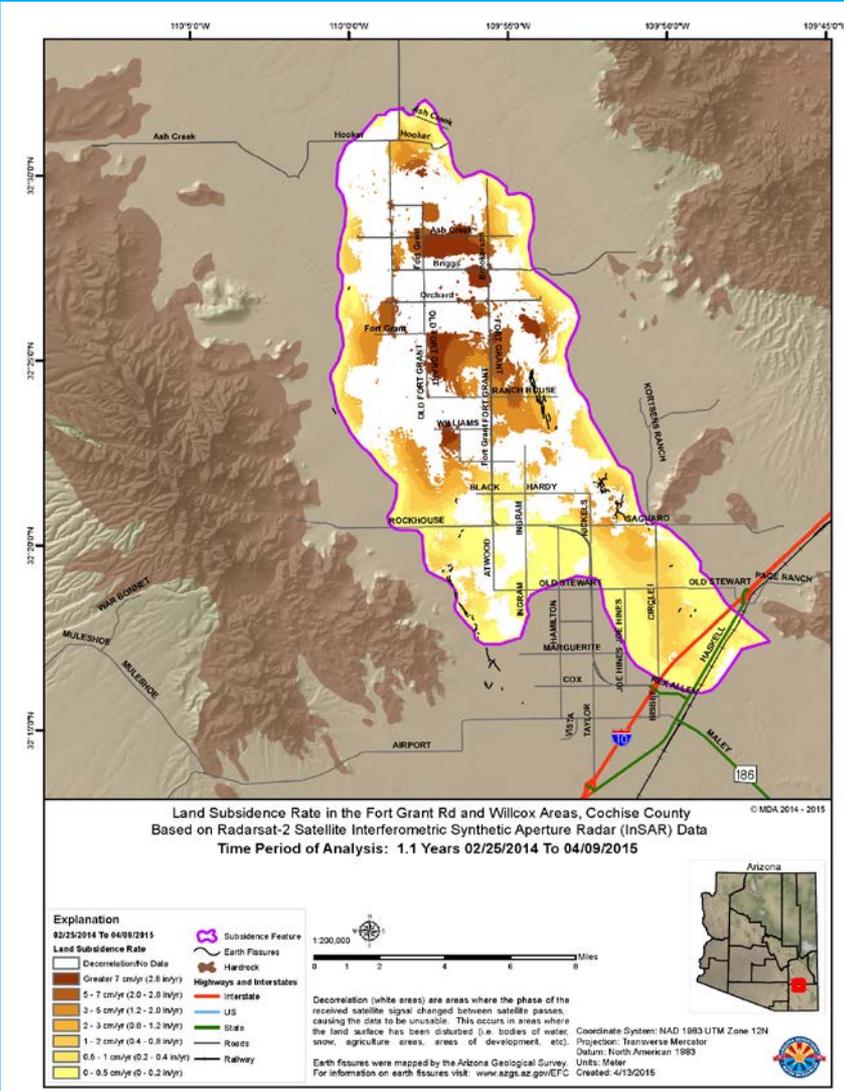
**Ft. Grant Rd. Area
 Northern Willcox Basin**

Land Subsidence in the Willcox Basin 2/14 to 4/15

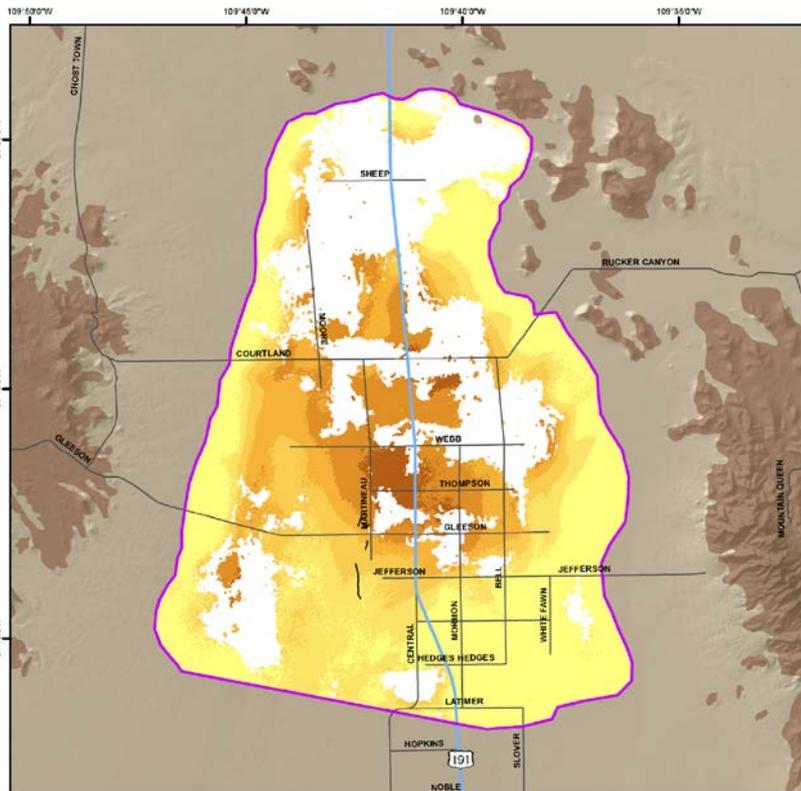
**Elfrida Area
Northern Douglas Basin**

Land Subsidence Rate in the Elfrida Area, Cochise County
Based on Radarsat-2 Satellite Interferometric Synthetic Aperture Radar (InSAR) Data
Time Period of Analysis: 1.1 Years 02/25/2014 To 04/09/2015

Decomelation (white areas) are areas where the phase of the received satellite signal changed between satellite passes causing the data to be unusable. This occurs in areas where the land surface has been disturbed (i.e. bodies of water, snow, agriculture areas, areas of development, etc).
Earth fissures were mapped by the Arizona Geological Survey. For information on earth fissures visit: www.azgs.gov/EFC Created: 4/14/2015

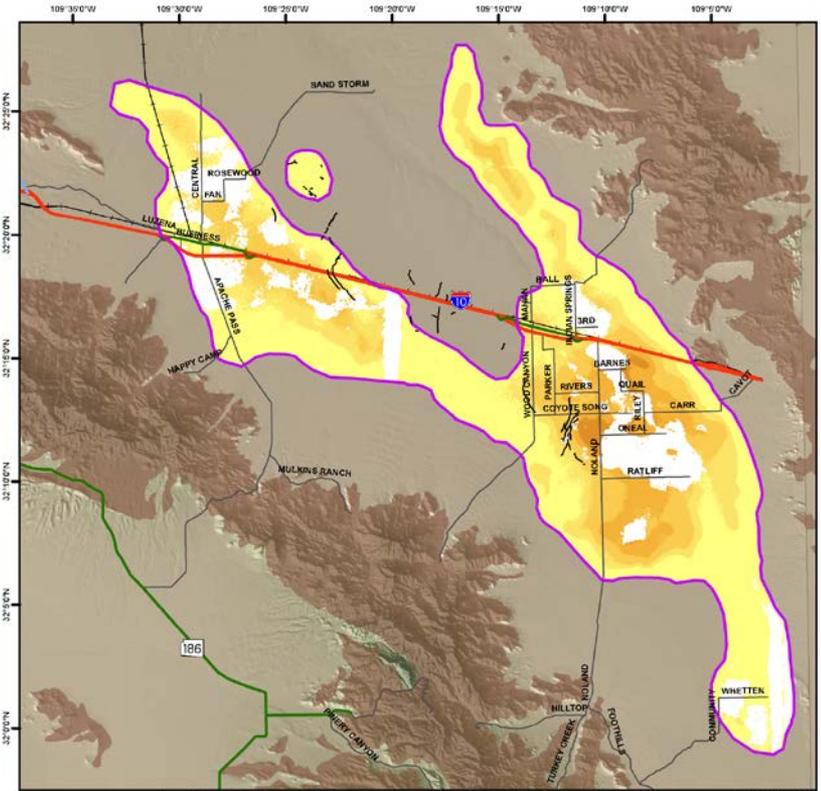
**Bowie - San Simon Area
San Simon Valley Sub-basin**

Land Subsidence Rate in the Bowie and San Simon Areas, Cochise County
Based on Radarsat-2 Satellite Interferometric Synthetic Aperture Radar (InSAR) Data
Time Period of Analysis: 1.1 Years 02/25/2014 To 04/09/2015

Decomelation (white areas) are areas where the phase of the received satellite signal changed between satellite passes, causing the data to be unusable. This occurs in areas where the land surface has been disturbed (i.e. bodies of water, snow, agriculture areas, areas of development, etc).
Earth fissures were mapped by the Arizona Geological Survey. For information on earth fissures visit: www.azgs.gov/EFC Created: 4/14/2015

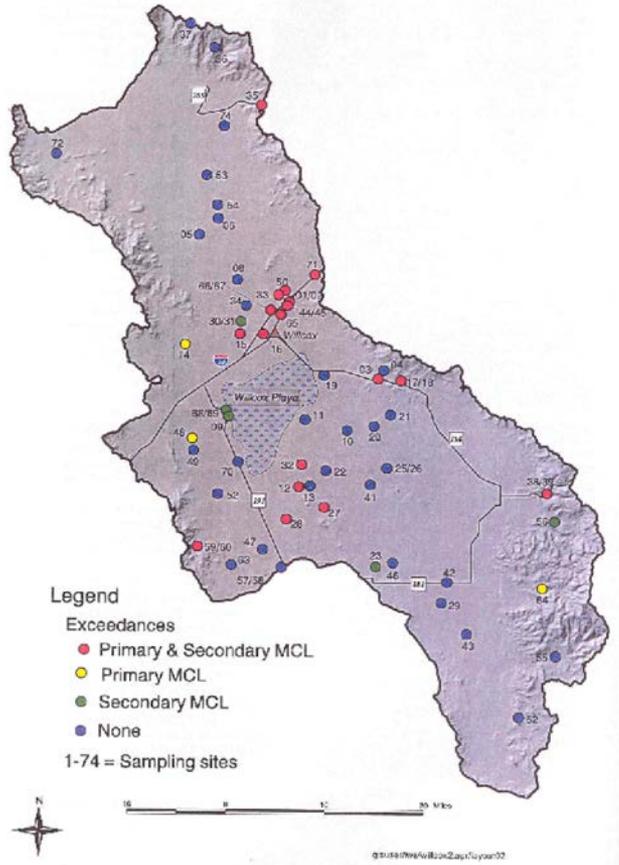
Figure 7 - Water Quality Exceedances and Sampling Sites

ADEQ Water Quality Exceedances For Willcox and Douglas Basins

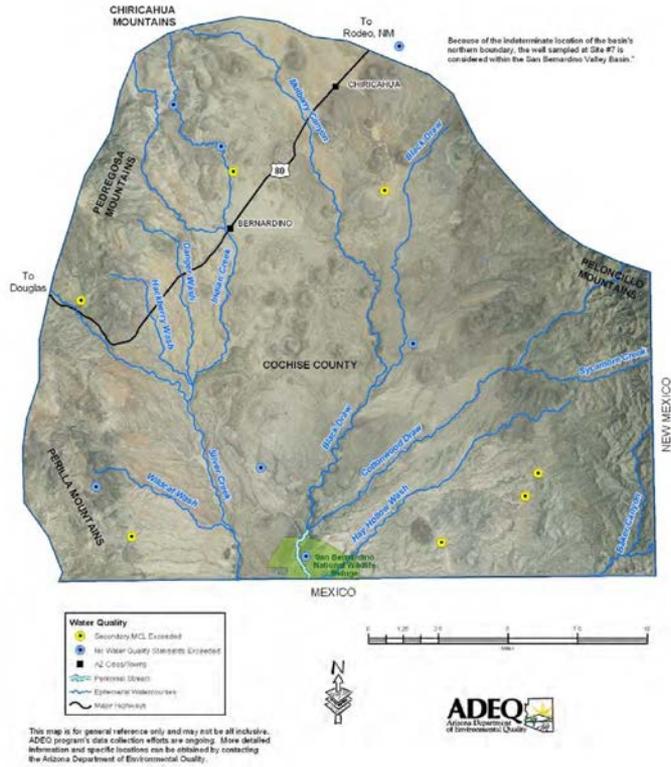
Map 3 - Water Quality Standards

ADEQ Water Quality Exceedances For San Bernardino Basin and the San Simon Valley Sub-basin
