Land Subsidence Monitoring Report

Number 1

July 2013

By Brian D. Conway

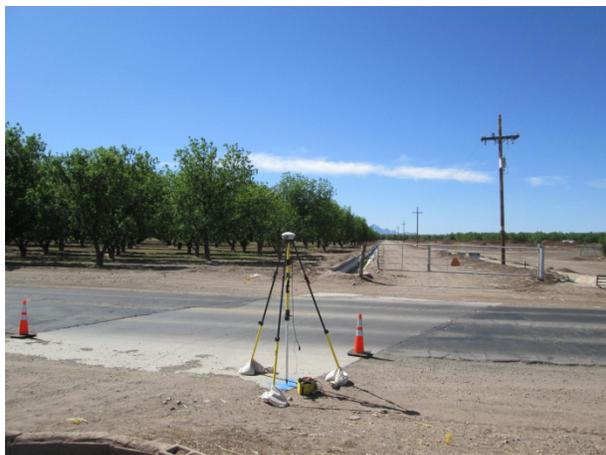
Picture 1 - GPS Surveying along Sahuarita Rd in Green Valley

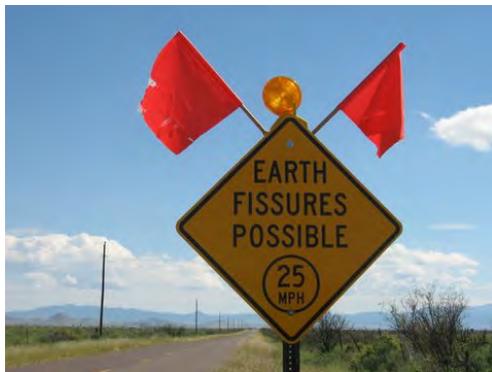
Picture 3 - Earth Fissure warning sign along Dragoon Rd in Cochise County

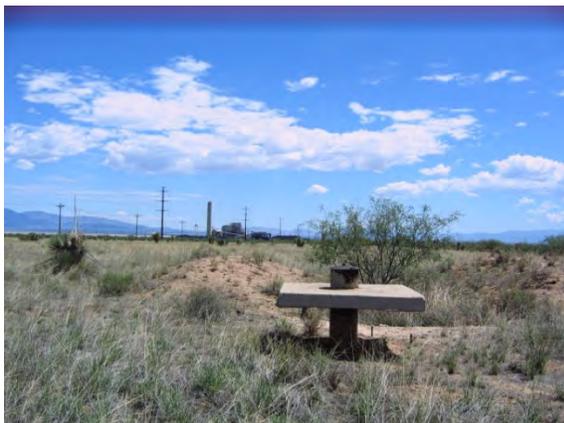
There is also an exposed well casing (Picture 4) about a mile northwest of the V 261 survey monument, and numerous earth fissures located in the Willcox Basin (Picture 5). These features further document the amount of historical land subsidence that has occurred in the immediate area as well as the need for ADWR to continue to surveying V 261 for land subsidence in this area.

Picture 4 - Exposed well casing in Cochise County

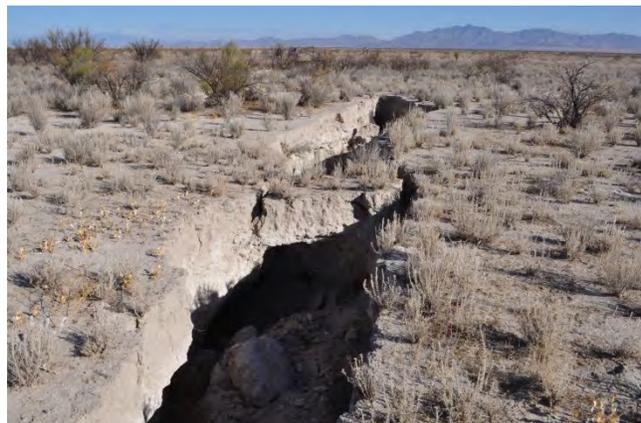
Picture 5 - Sulfur Hills earth fissure in Cochise County

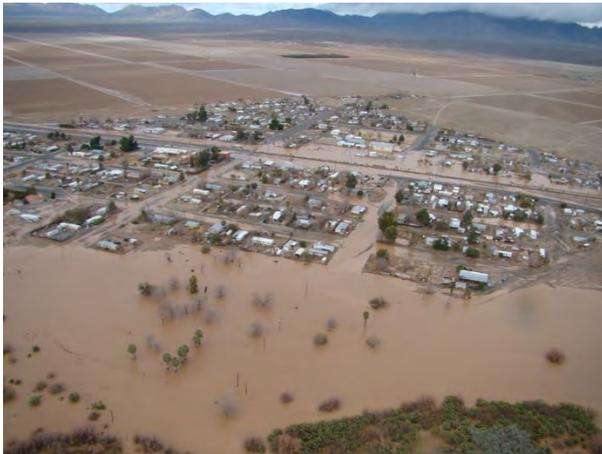
ADWR first detected land subsidence in the McMullen Valley in 2008 with InSAR data. In 2010, the Town of Wenden, located in the McMullen Valley, was flooded for a second time in ten years (2000) by Centennial Wash. The Town of Wenden is located within a land subsidence bowl which has contributed

Picture 6 - Centennial Wash flooding the Town of Wenden in 2010 (Photo credit La Paz County)

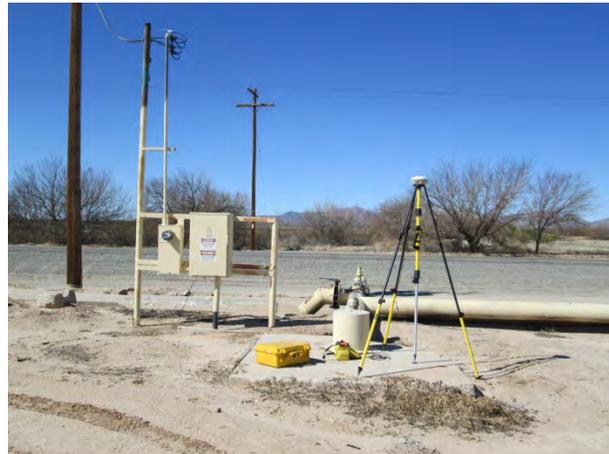
to the recent flooding. ADWR recently recovered three historical NGS monuments (A 480, Y 479, X 479) in the Wenden Area (Picture 7) that will be used for on-going ground-truthing of the InSAR data and for land subsidence monitoring in the McMullen Valley.

Picture 7 - GPS Surveying in the McMullen Valley

Comparing recent ADWR GPS data with the historical 1991 data for the three survey monuments, a total of 0.28 meters (0.92 feet), 0.43 meters (1.4 feet), and 0.81 meters (2.7 feet) of land subsidence has occurred at these three locations since 1991. ADWR will continue to survey (Figure 3) all three survey monuments for monitoring land subsidence in the McMullen Valley.

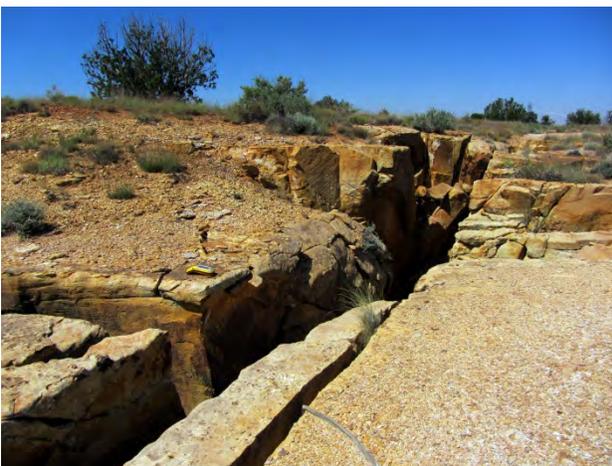
While the two southern-most land subsidence features seem to be directly related to the more than 400 existing sinks located throughout the basin, these two sinks are much larger in size but not as deep. Staff from the AZGS and ADWR visited the Chimney Canyon sink (Picture 9) and collected baseline GPS survey data in October 2012 (Picture 9). Repeat survey data will be collected in the near future to monitor

Picture 8 - One of the many expansion cracks located in the Chimney Canyon Area of the Holbrook Basin

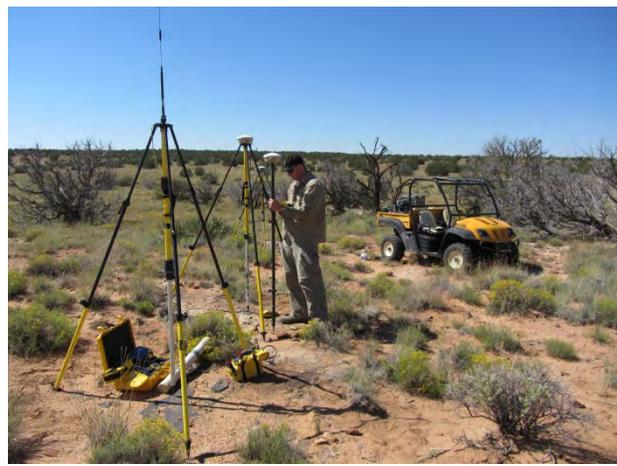
Picture 9 - GPS Surveying in the Chimney Canyon Area of the Holbrook Basin

any changes in these features, as part of the ongoing cooperative land subsidence monitoring efforts between the AZGS and ADWR.

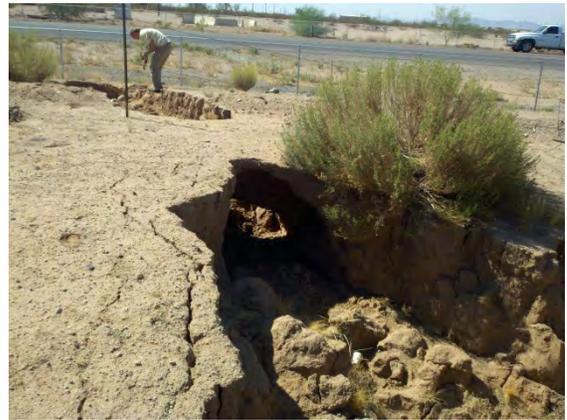
ADWR has conducted several GPS surveys in the Hawk Rock Area since 1997. The monument, SGC 17, was first measured in 1973. Comparing the SGC 17 elevation from 1973 and a re-surveyed elevation from 2013, SGC 17 has subsided just over 1.55 meters (5.1 feet) in 40 years. Recently ADWR recovered three historical monuments, Y 477, SS-C, and SS-D (Figure 4). The SS-C and SS-D monuments were first established in 1978 during the first land subsidence studies in preparation and design of the CAP canal and the Y 477 monument was established later in 1991. Recent ADWR survey results (2013) showed that Y 477 has subsided 0.46 meters (1.52 feet) since 1991, and SS-C has subsided 0.37 meters (1.21 feet) and SS-D has subsidence 0.35 meters (1.13 feet) since 1978. The SS-C and SS-D monuments are located 50 feet across from each other, situated on different sides of an active earth fissure (Picture 10), further documenting the vertical offset on either side of the earth fissure.

Picture 10 - Earth Fissure located at Baseline Rd and Meridian Rd in the Hawk Rock feature

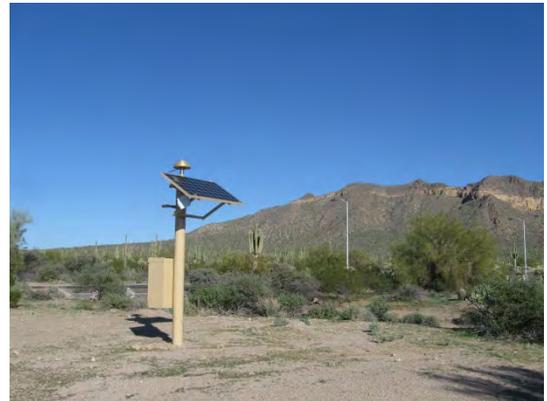
Over the past three years, ADWR has played an important role in site-selection and installation of several GPS Continuous Operating Reference Station (CORS) sites in Arizona. Many of the CORS sites are operated by the State Cartographer's Office (SCO) with the Arizona State Land Department and all the data is managed by the National Geodetic Survey. There are more than twenty CORS sites located throughout Arizona that provide precise GPS data that are then used for both real-time and post-processed surveying projects. For those projects that require accurate and precise elevations, it is crucial that the survey control is stable and not subsiding. As a result, ADWR has provided guidance for where stable sites may be located away from land subsidence areas to not only the SCO, but to other entities.

Picture 11 - Usery Mountain Bedrock CORS

ADWR has worked with the SCO, Central Arizona Project, Maricopa County Department of Transportation, and Maricopa County Parks to install two new stable CORS sites that are located on bedrock in Eastern Maricopa County at Usery Mountain and San Tan Mountain Parks (Figure 17). These sites will provide stable vertical control around the Hawk Rock land subsidence feature to the surveying community.
