Arizona Department of Water Resources

Land Subsidence Monitoring Report No. 3

January 2017

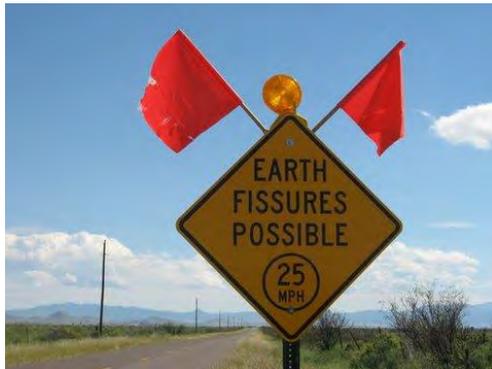
Photo 3 - Earth Fissure warning sign along Dragoon Rd in Cochise County

Earth fissures (<http://www.azgs.az.gov/efmaps.shtml>) have been an ongoing problem in the Willcox Groundwater Basin and have impacted a natural gas pipeline, roads, and powerlines. The Arizona Geological Survey (AZGS) has mapped 42 miles of earth fissures in the Basin. A protruding well casing (Photo 4) two miles north of Parker Ranch Rd on Robison Rd, and numerous earth fissures located in the Willcox Groundwater Basin (Photo 5), further document the amount of historical land subsidence that has occurred in the immediate area, as well as the need to continue GNSS surveying for land subsidence in the Basin.

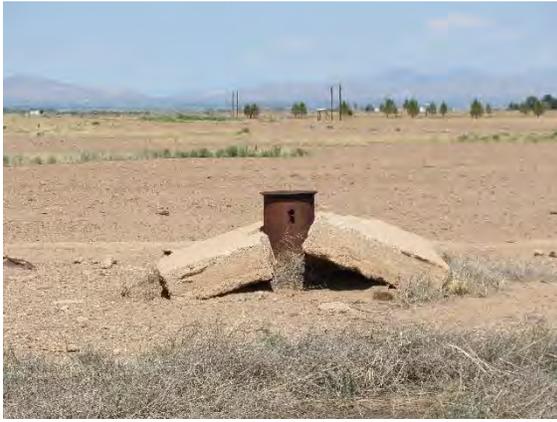
Photo 4 - Protruding well casing in Cochise County
(Photo credit AZGS)

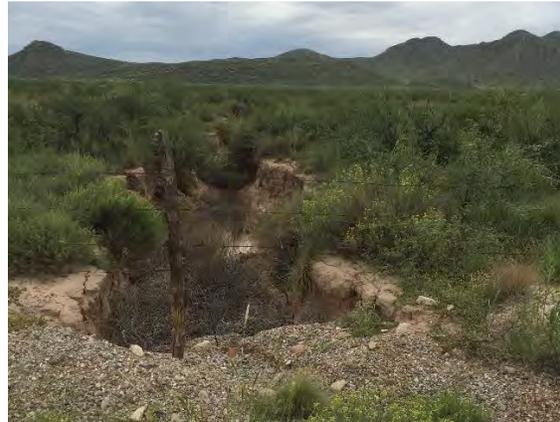
Photo 5 - Sulfur Hills earth fissure in Cochise County

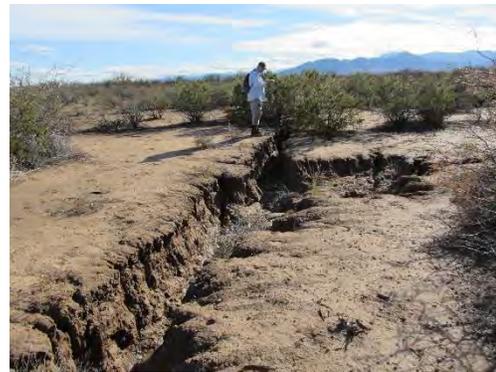
Photo 7 – Earth fissure in the Bowie/San Simon feature (Photo Credit AZGS)

Earth fissures (Photo 7) have developed in the San Simon and Bowie area over many years and have crossed I-10 and a natural gas pipeline. The AZGS has mapped 19.9 miles of earth fissures in this area.

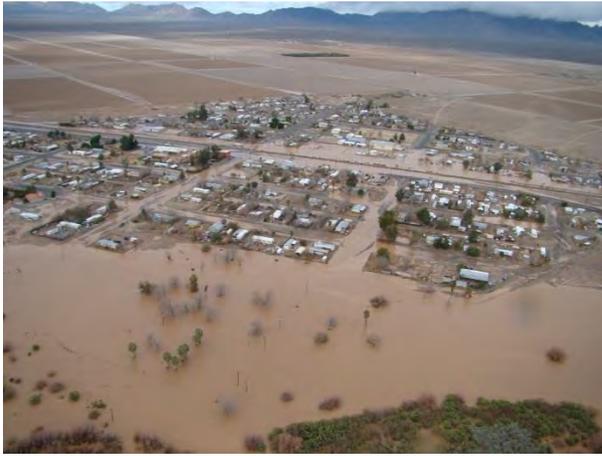
ADWR first delineated land subsidence in the McMullen Valley Groundwater Basin in 2008 with InSAR data. In 2010, the Town of Wenden, located in the McMullen Valley, was flooded for the second time in ten years by Centennial Wash. The Town of Wenden is located within a land subsidence bowl which has exacerbated the recent flooding events. ADWR recently recovered three historical NGS monuments (A 480, Y 479, X 479) in the Wenden Area that will be used for on-going ground-truthing of the InSAR data and for land subsidence monitoring in the McMullen Valley Basin.

Photo 8 - Centennial Wash flooding the Town of Wenden in 2010 (Photo credit La Paz County)

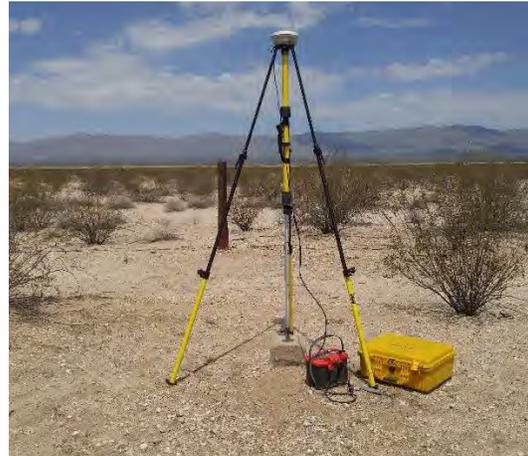
Photo 9 - GNSS Surveying in the McMullen Valley

Comparing recent ADWR GNSS survey data collected during February 2013 and April 2016 at monument X 479, indicated that there was 18.7 centimeters (7.3 inches) of land subsidence. ADWR will continue to survey all three survey monuments for monitoring land subsidence in the McMullen Valley (Figure 10).

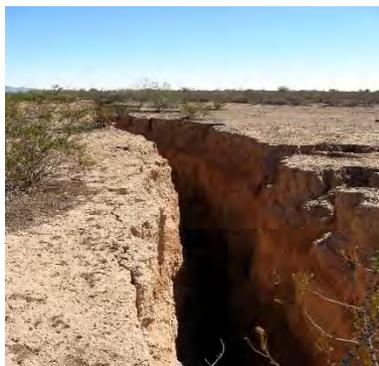
Photo 10 – Rogers Earth Fissure

ADWR last delineated land subsidence in the Harquahala Valley in 2008 with InSAR data. Land subsidence was first documented in the Harquahala Valley with the opening of the Rogers earth fissure in September 1997 following a large rain event during Hurricane Nora. ADWR has been collecting survey-grade GNSS data on a survey monument, 4BR1, within the Harquahala Valley since 2014 (Figure 11). Between 2014 and 2016, GNSS data measured 1.4 cm (0.55 in) of land subsidence. Comparing 2016 ADWR GNSS data with the historical 2000 data for 4BR1, a total of 10.1 centimeters (3.98 inches) of land subsidence has occurred since 2000. ADWR will continue to survey the 4BR1 survey monument for monitoring land subsidence in the Harquahala Valley. The Roger’s earth fissure (Photo10) continues to be active, extending at the eastern end. Since 2014, the earth fissure has extended 500 feet.

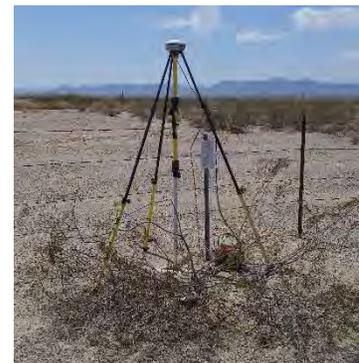
Photo 11 – GNSS Surveying in the Ranegras Plain

ADWR first discovered land subsidence in the Ranegras Plain Groundwater Basin in 2008 with InSAR data. Before 2008, land subsidence had never been documented in the basin. In 2016, ADWR began collecting survey grade GNSS data on a survey monument, H 478 (Photo 11), within the Ranegras Plain area. The monument was last surveyed in 1991 and between 1991 and 2016, ADWR GNSS data measured 11.5 cm (4.53 in) of land subsidence. ADWR will continue to survey H 478 for land subsidence. A comparison of InSAR data between the historical 1992 - 1997 dataset and the recently acquired 2016 dataset, show that land subsidence rates have tripled in some areas.

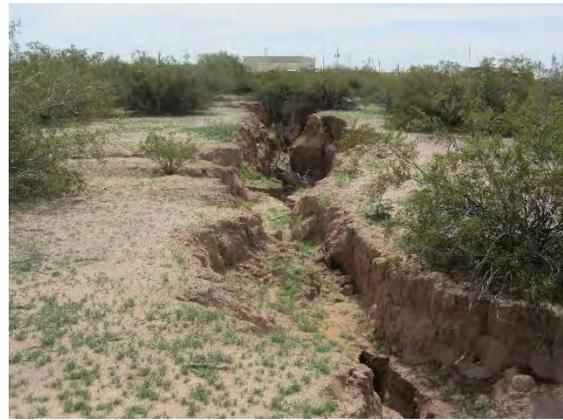
Photo 12 - Earth Fissure located at Baseline Rd and Meridian Rd in the Hawk Rock feature

The monument, SGC 17, located at US 60 and Meridian Rd, has subsided more than 5 feet since it was first installed and measured in 1973. Numerous earth fissures (Photo 12) have also been identified and mapped by the AZGS in the Hawk Rock area (Figure 5).

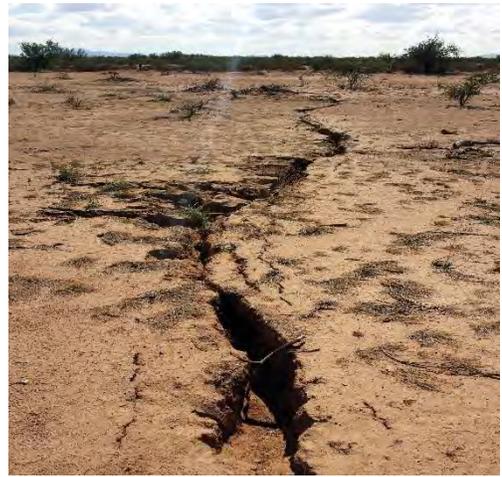
The Picacho land subsidence feature has had earth fissures since the 1950s. The AZGS has mapped 70.2 miles of earth fissures (Photo 13) in the area. Several new earth fissures recently formed during the winter of 2015. Land subsidence and earth fissures have affected the Santa Cruz floodplain and many types of infrastructure in the area (roads, pipelines, canals, and railroads).

Photo 13 – Earth Fissures in the Picacho Feature

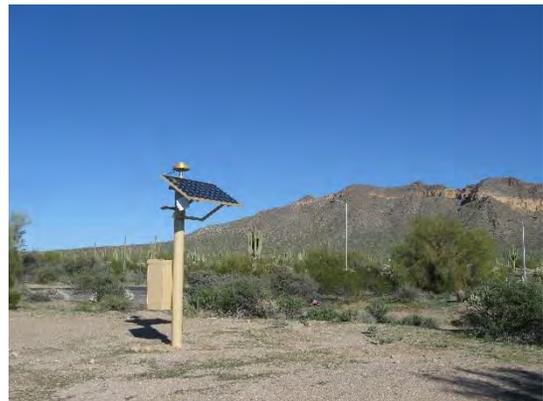
Over the past seven years, ADWR has played an important role in site-selection and installation of several GNSS Continuous Operating Reference Station (CORS) sites in Arizona. Many of the CORS sites are operated by the Arizona Department of Transportation (ADOT) and all the data is managed by the National Geodetic Survey. There are more than twenty CORS sites located throughout Arizona that provide precise GNSS data that are then used for both real-time and post-processed surveying projects. For those projects that require accurate and precise elevations, it is crucial that the survey control is stable and not subsiding. As a result, ADWR has provided guidance to ADOT and other entities for locating stable sites away from land subsidence areas.

Photo 15 - Usery Mountain Bedrock CORS
