**Total Land Subsidence in the Elfrida Area, Cochise County**  
**Based on Radarsat-2 Satellite Interferometric Synthetic Aperture Radar (InSAR) Data**  
**Time Period of Analysis: 2.0 Years 03/26/2013 To 04/09/2015**

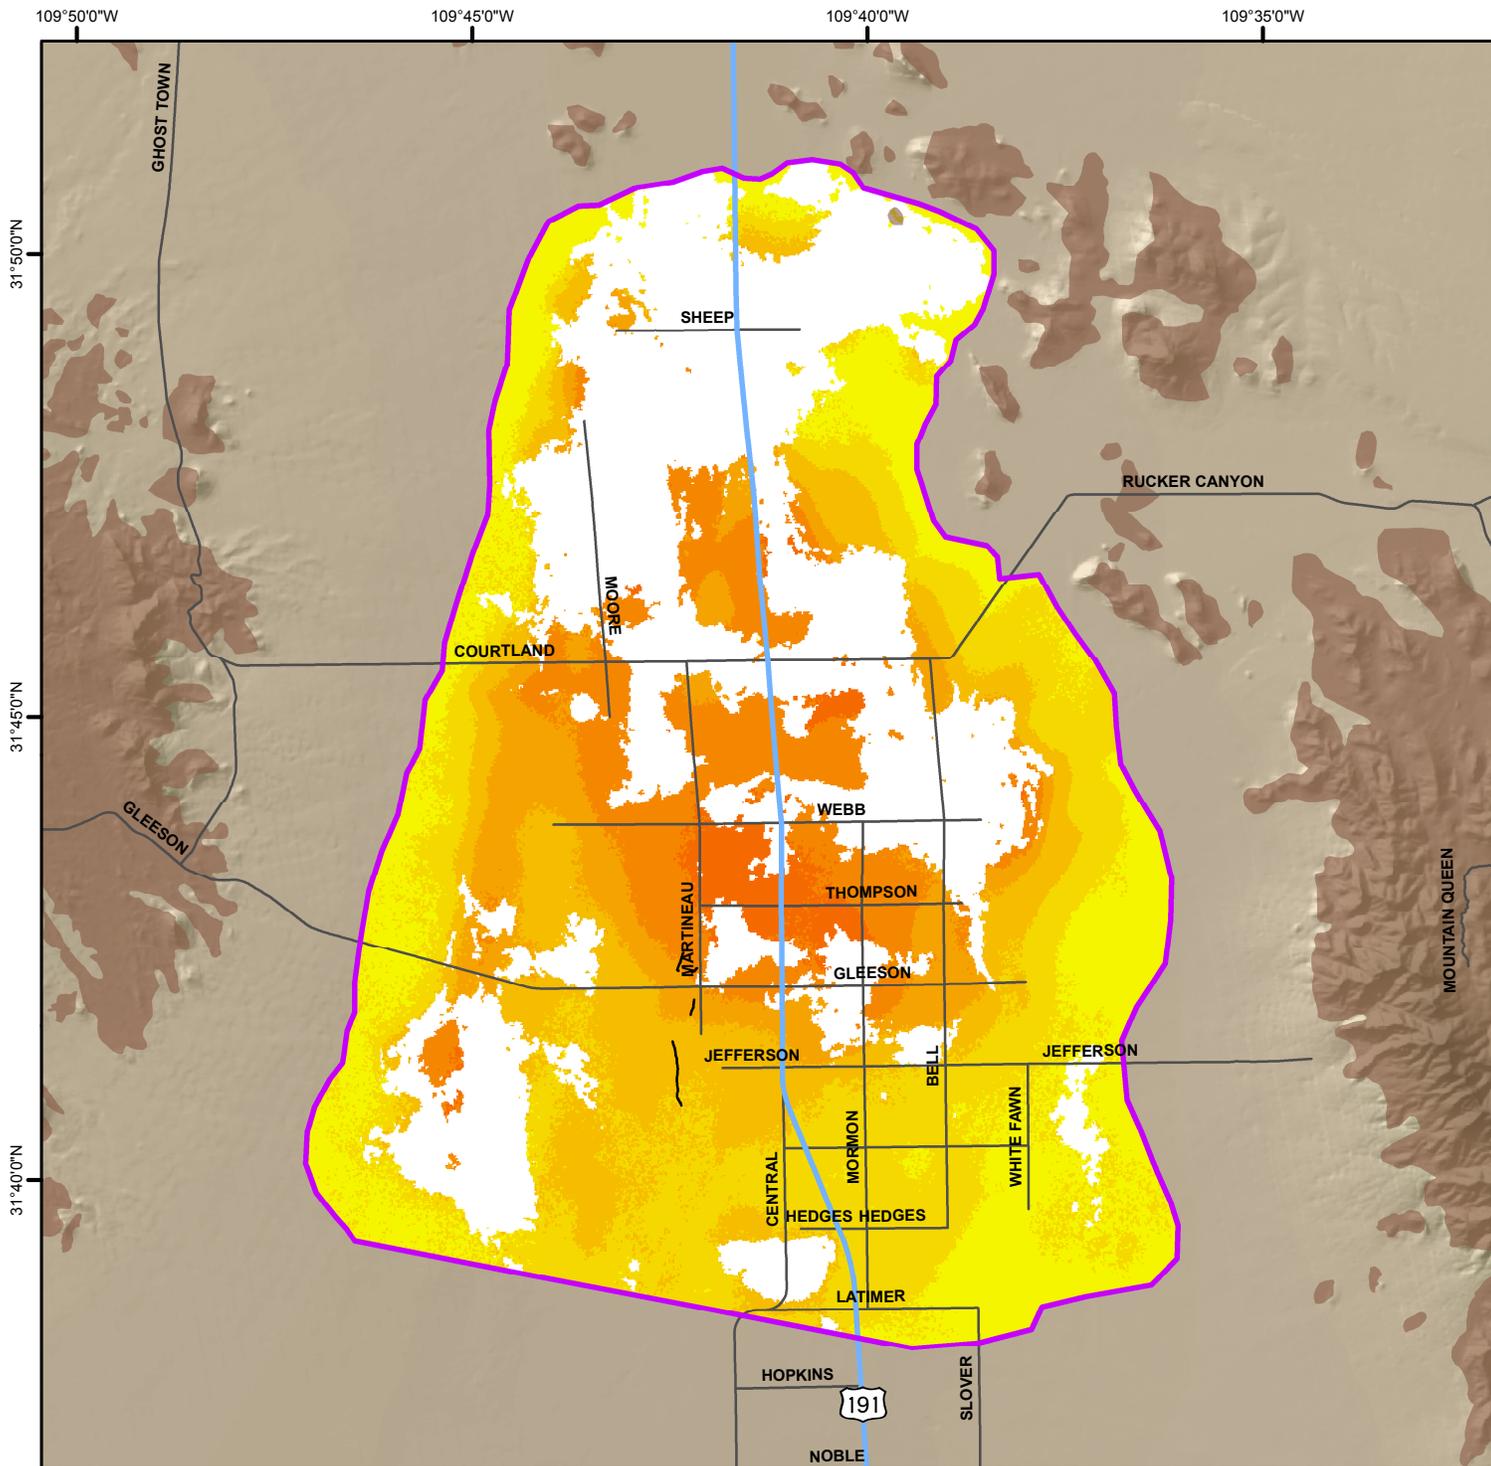
Decorrelation (white areas) are areas where the phase of the received satellite signal changed between satellite passes, causing the data to be unusable. This occurs in areas where the land surface has been disturbed (i.e. bodies of water, snow, agriculture areas, areas of development, etc).

Earth fissures were mapped by the Arizona Geological Survey. For information on earth fissures visit: [www.azgs.gov/EFC](http://www.azgs.gov/EFC)
