Total Land Subsidence in the Elfrida Area, Cochise County
Based on Radarsat-2 Satellite Interferometric Synthetic Aperture Radar (InSAR) Data
Time Period of Analysis: 6.0 Years 05/05/2010 To 04/03/2016

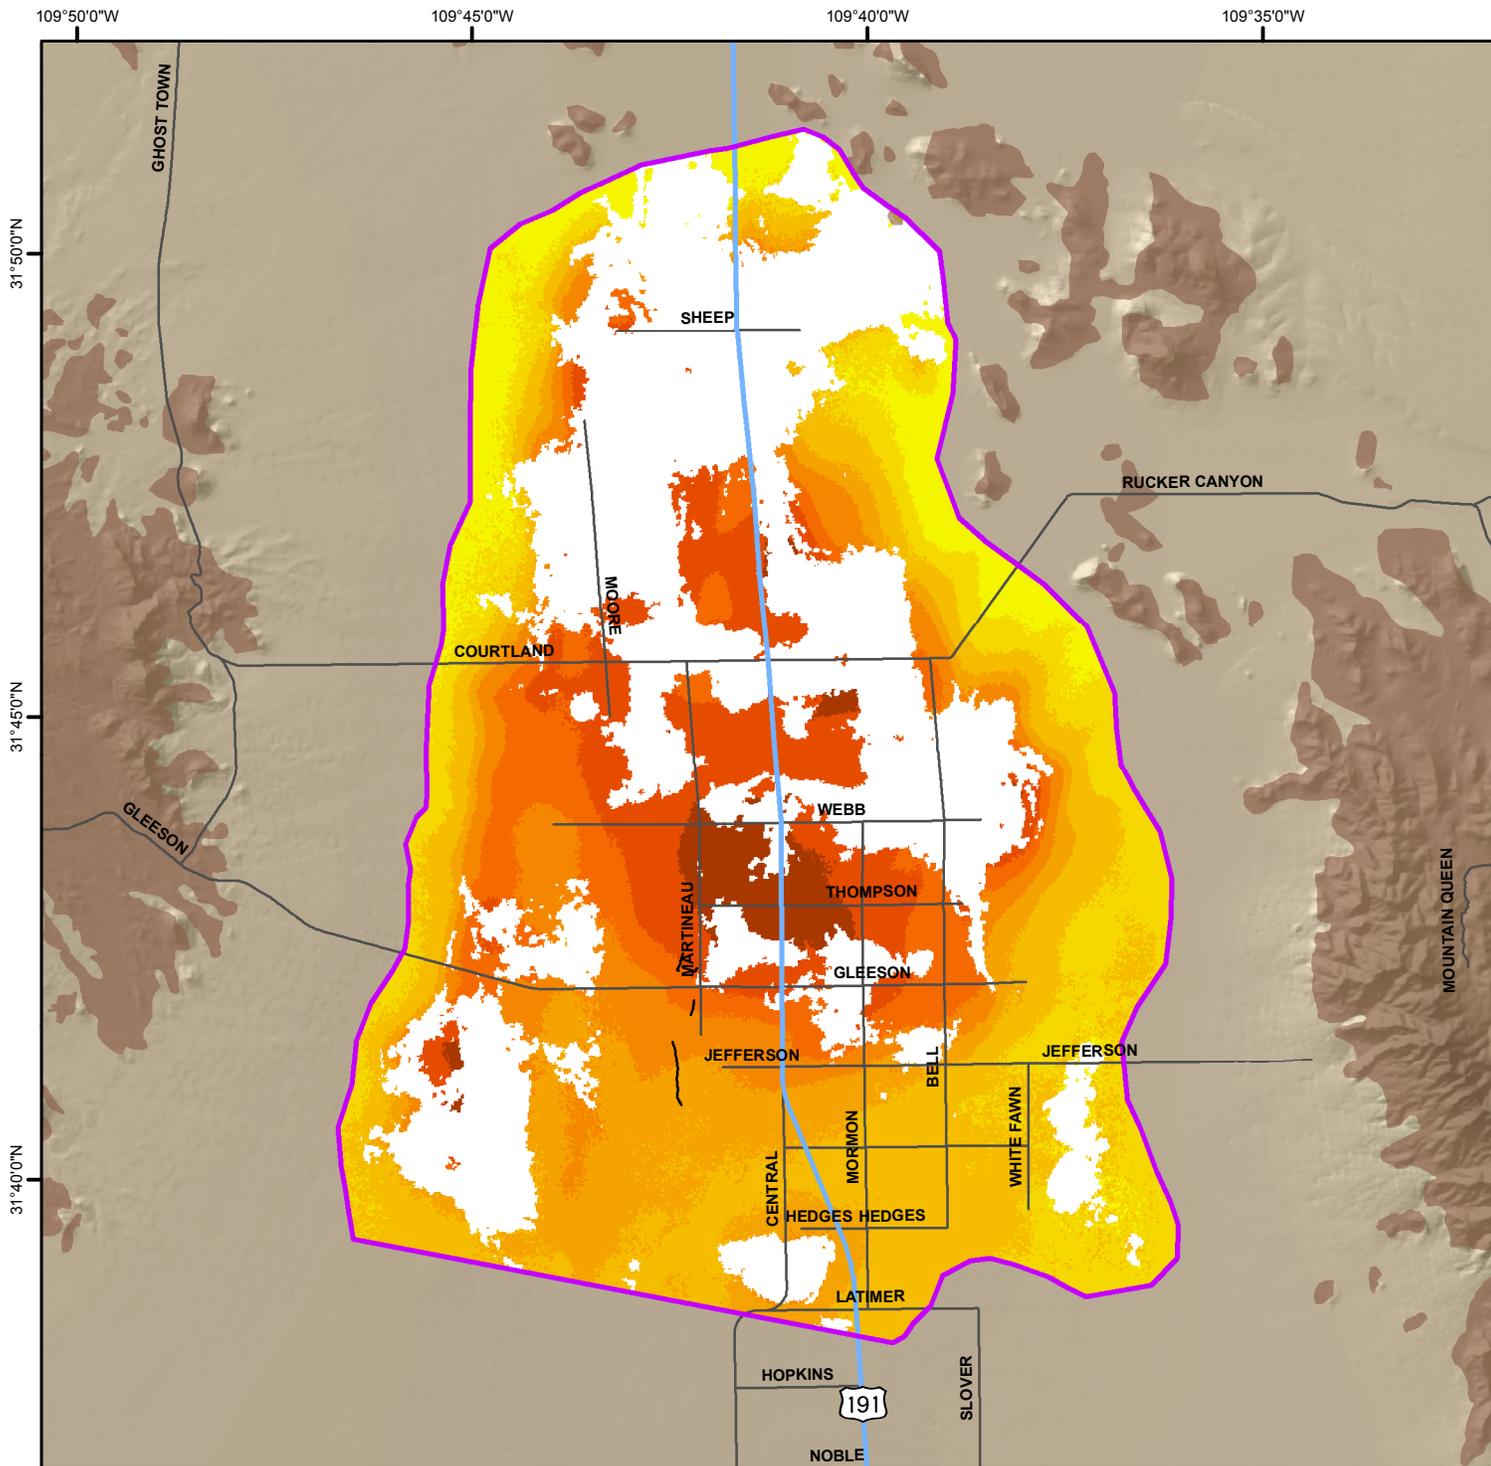
Decorrelation (white areas) are areas where the phase of the received satellite signal changed between satellite passes, causing the data to be unusable. This occurs in areas where the land surface has been disturbed (i.e. bodies of water, snow, agriculture areas, areas of development, etc).

Earth fissures were mapped by the Arizona Geological Survey. For information on earth fissures visit: www.azgs.gov/EFC
