**Total Land Subsidence in the Elfrida Area, Cochise County**  
 Based on ALOS-2 and Radarsat-2 Satellite Interferometric Synthetic Aperture Radar (InSAR) Data  
**Time Period of Analysis: 8.4 Years 12/06/2006 To 04/09/2015**

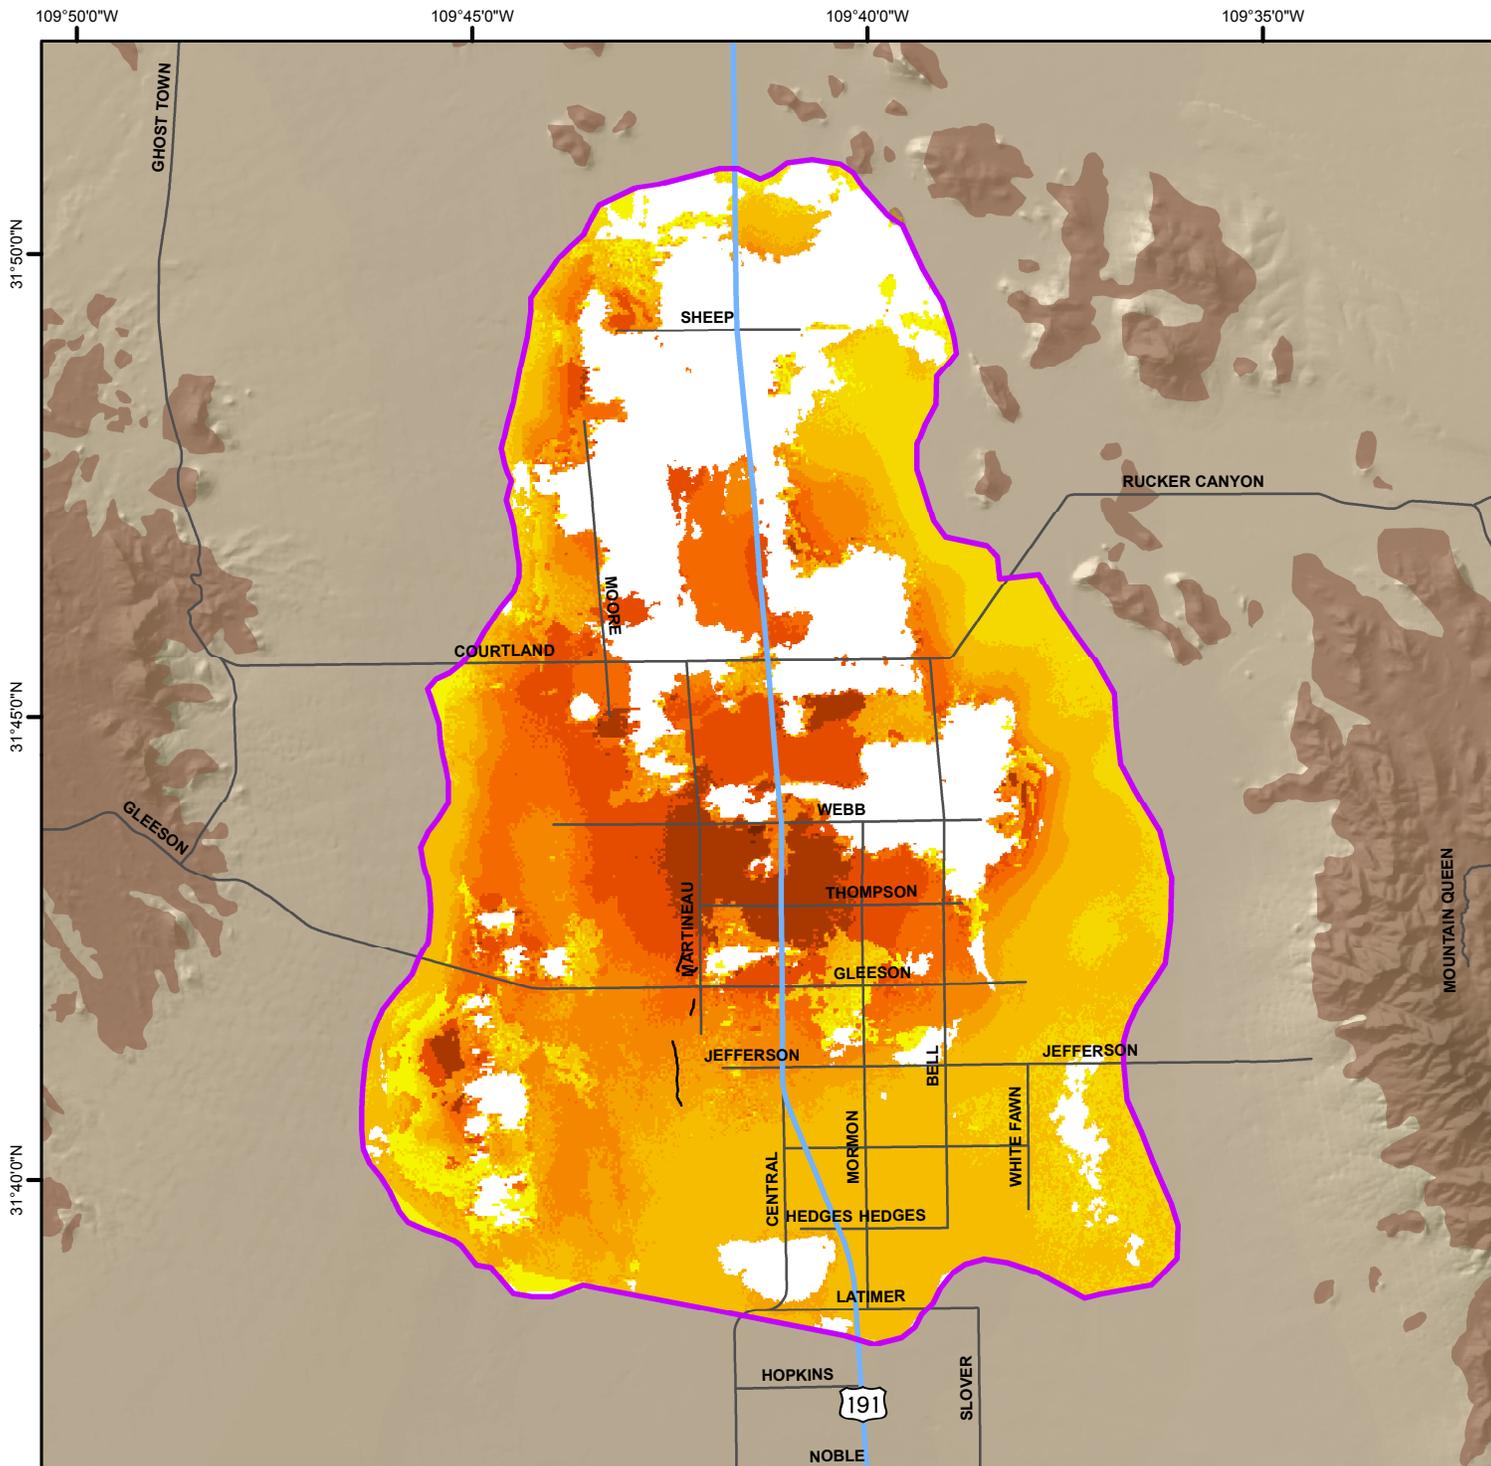
Decorrelation (white areas) are areas where the phase of the received satellite signal changed between satellite passes, causing the data to be unusable. This occurs in areas where the land surface has been disturbed (i.e. bodies of water, snow, agriculture areas, areas of development, etc).

Earth fissures were mapped by the Arizona Geological Survey. For information on earth fissures visit: [www.azgs.gov/EFC](http://www.azgs.gov/EFC)
