Land Subsidence Rate (cm/yr) in the Elfrida Area, Cochise County
 Based on Envisat Satellite Interferometric Synthetic Aperture Radar (InSAR) Data
 Time Period of Analysis: 1.0 Years 01/20/2009 To 01/05/2010

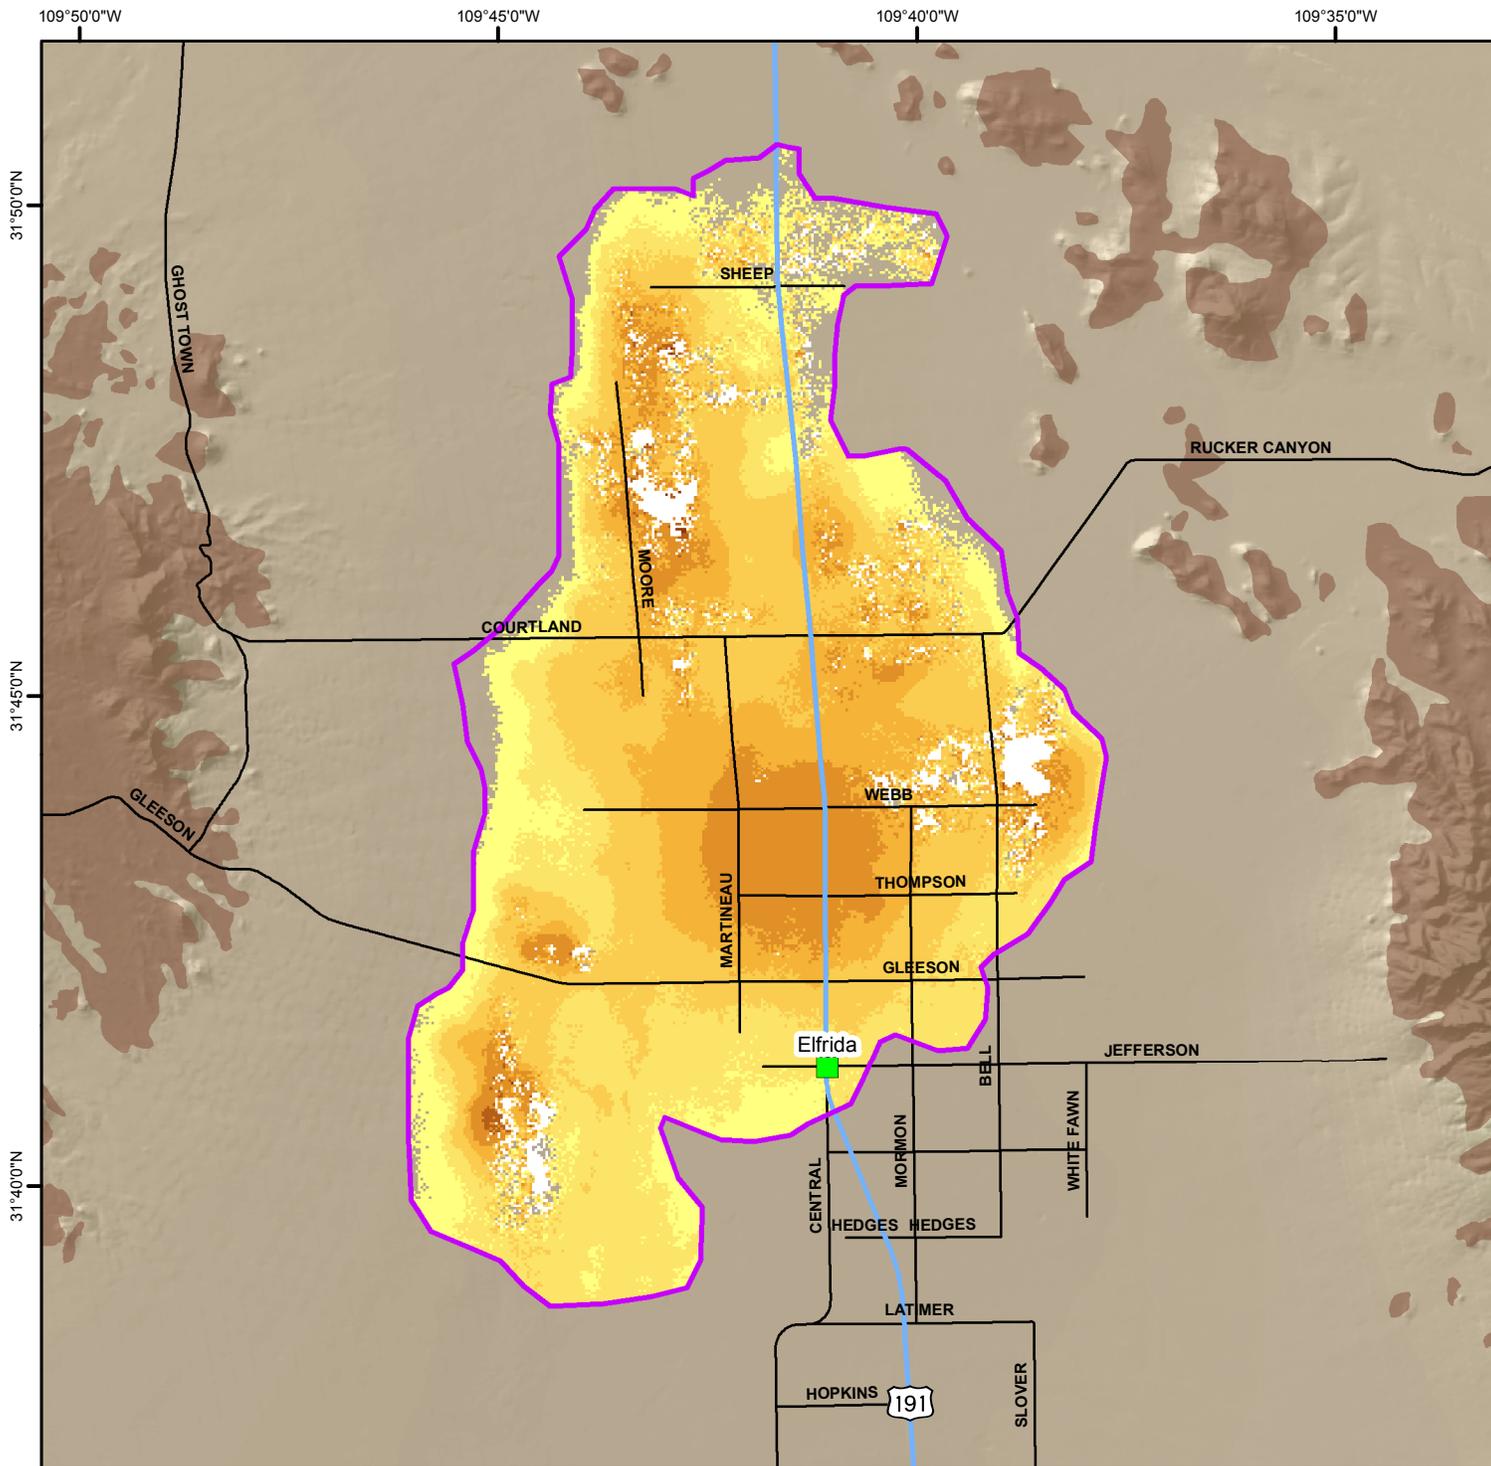
Decorrelation (white areas) are areas where the phase of the received satellite signal changed between satellite passes, causing the data to be unusable. This occurs in areas where the land surface has been disturbed (i.e. bodies of water, snow, agriculture areas, areas of development, etc).
