Land Subsidence Rate in the Elfrida Area, Cochise County
 Based on Radarsat-2 Satellite Interferometric Synthetic Aperture Radar (InSAR) Data
 Time Period of Analysis: 1.1 Years 02/25/2014 To 04/09/2015

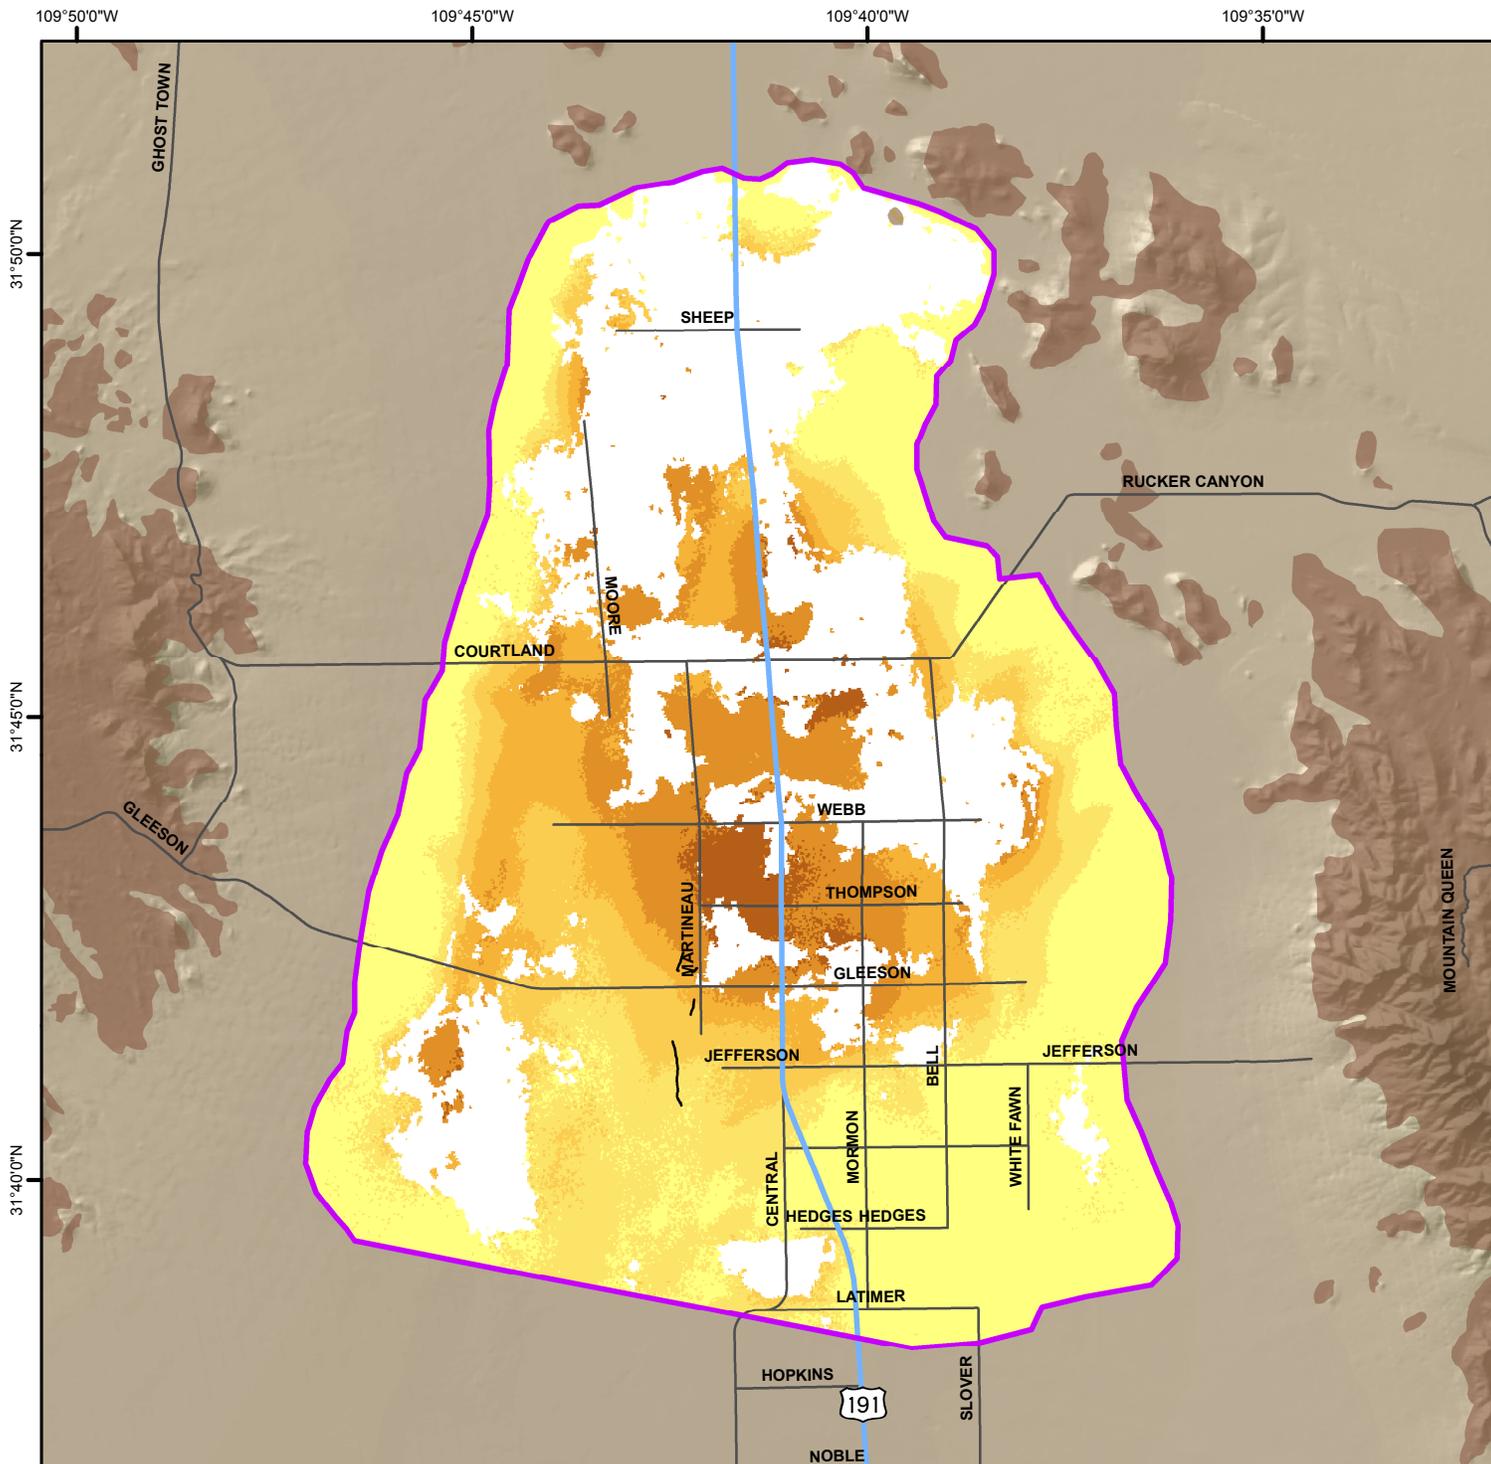
White	Decorrelation/No Data
Dark Brown	Greater 7 cm/yr (2.8 in/yr)
Brown	5 - 7 cm/yr (2.0 - 2.8 in/yr)
Orange-Brown	3 - 5 cm/yr (1.2 - 2.0 in/yr)
Orange	2 - 3 cm/yr (0.8 - 1.2 in/yr)
Light Orange	1 - 2 cm/yr (0.4 - 0.8 in/yr)
Yellow-Orange	0.5 - 1 cm/yr (0.2 - 0.4 in/yr)
Yellow	0 - 0.5 cm/yr (0 - 0.2 in/yr)

Decorrelation (white areas) are areas where the phase of the received satellite signal changed between satellite passes, causing the data to be unusable. This occurs in areas where the land surface has been disturbed (i.e. bodies of water, snow, agriculture areas, areas of development, etc).
