Land Subsidence Rate in the Elfrida Area, Cochise County
 Based on Radarsat-2 Satellite Interferometric Synthetic Aperture Radar (InSAR) Data
 Time Period of Analysis: 1.0 Years 04/09/2015 To 04/03/2016

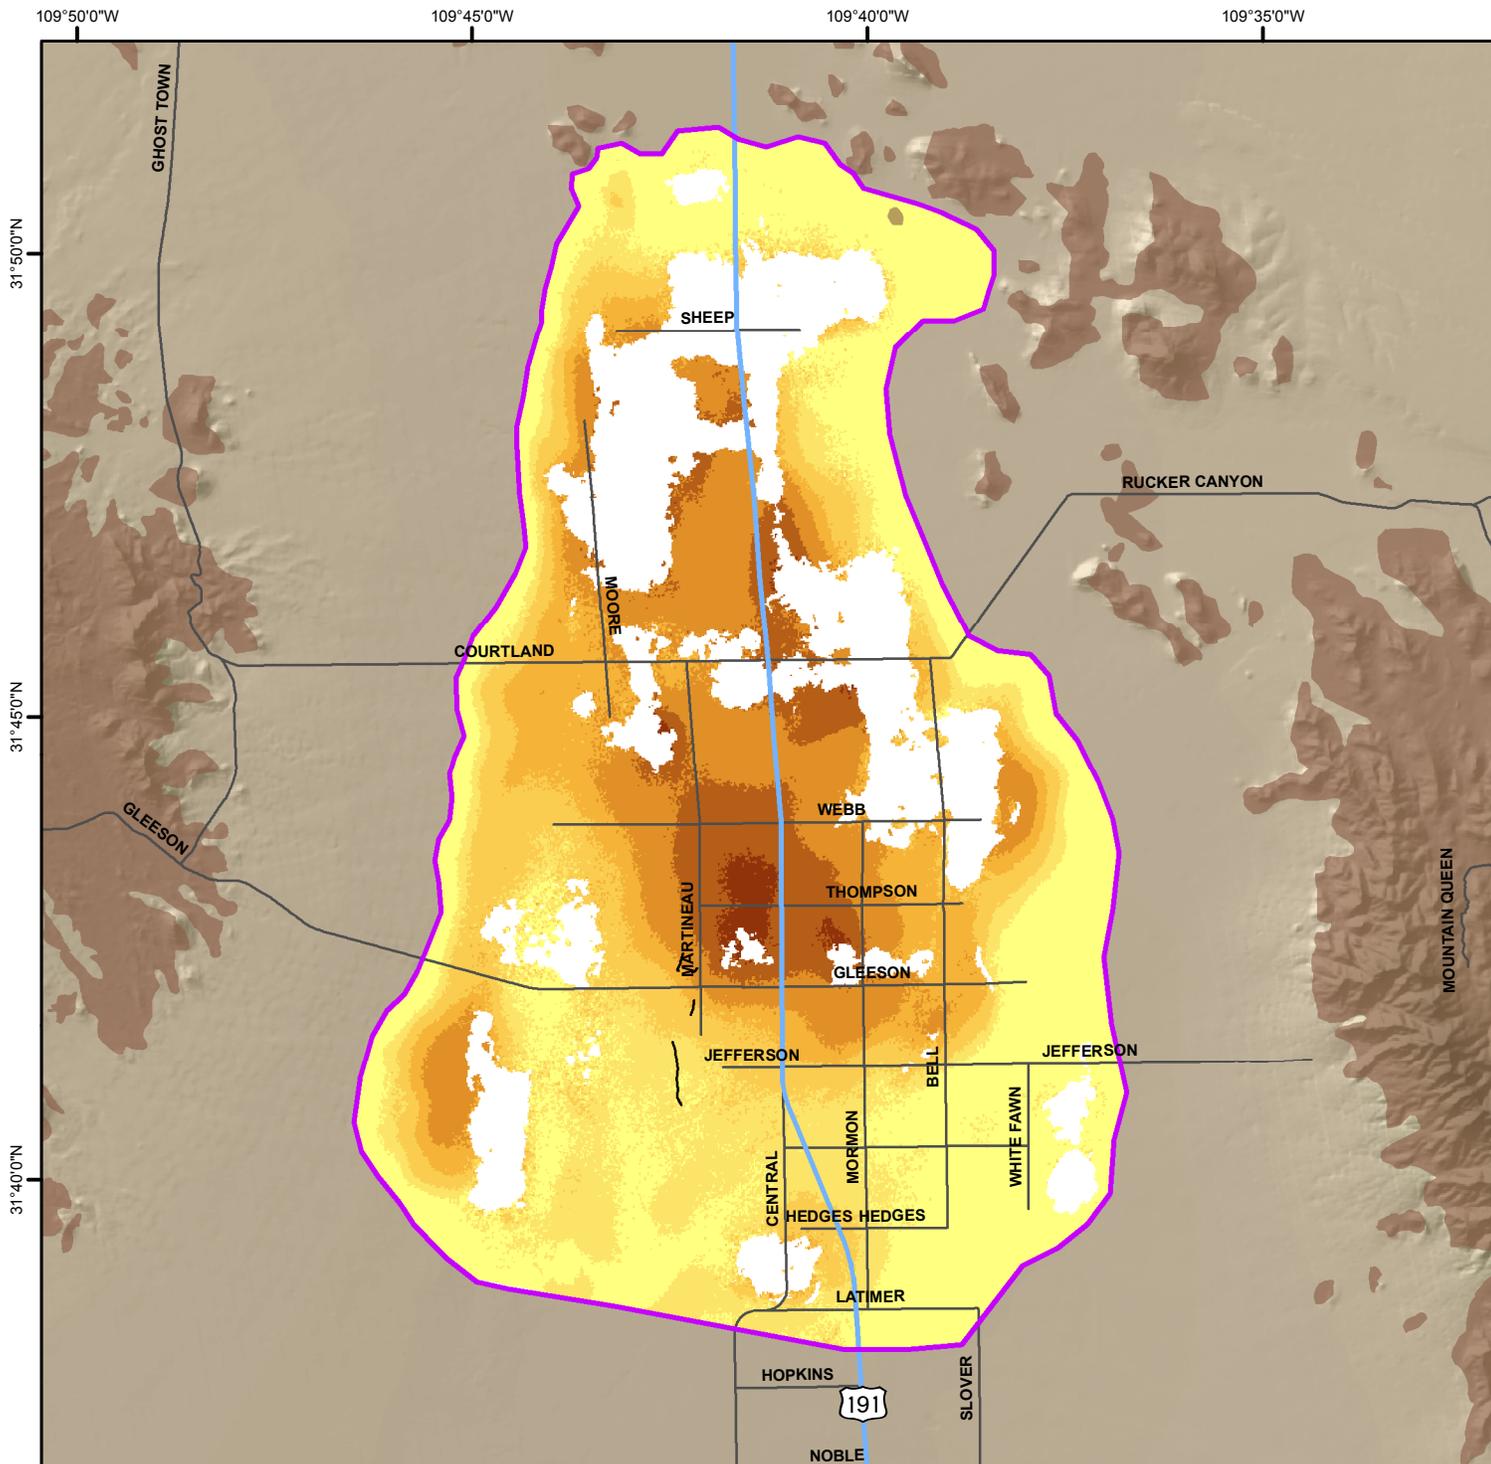
Decorrelation (white areas) are areas where the phase of the received satellite signal changed between satellite passes, causing the data to be unusable. This occurs in areas where the land surface has been disturbed (i.e. bodies of water, snow, agriculture areas, areas of development, etc).
