Total Land Subsidence in the Sahuarita and Green Valley Areas, Pima County  
Based on Envisat Satellite Interferometric Synthetic Aperture Radar (InSAR) Data  
Time Period of Analysis: 0.9 Years 02/27/2009 To 01/08/2010

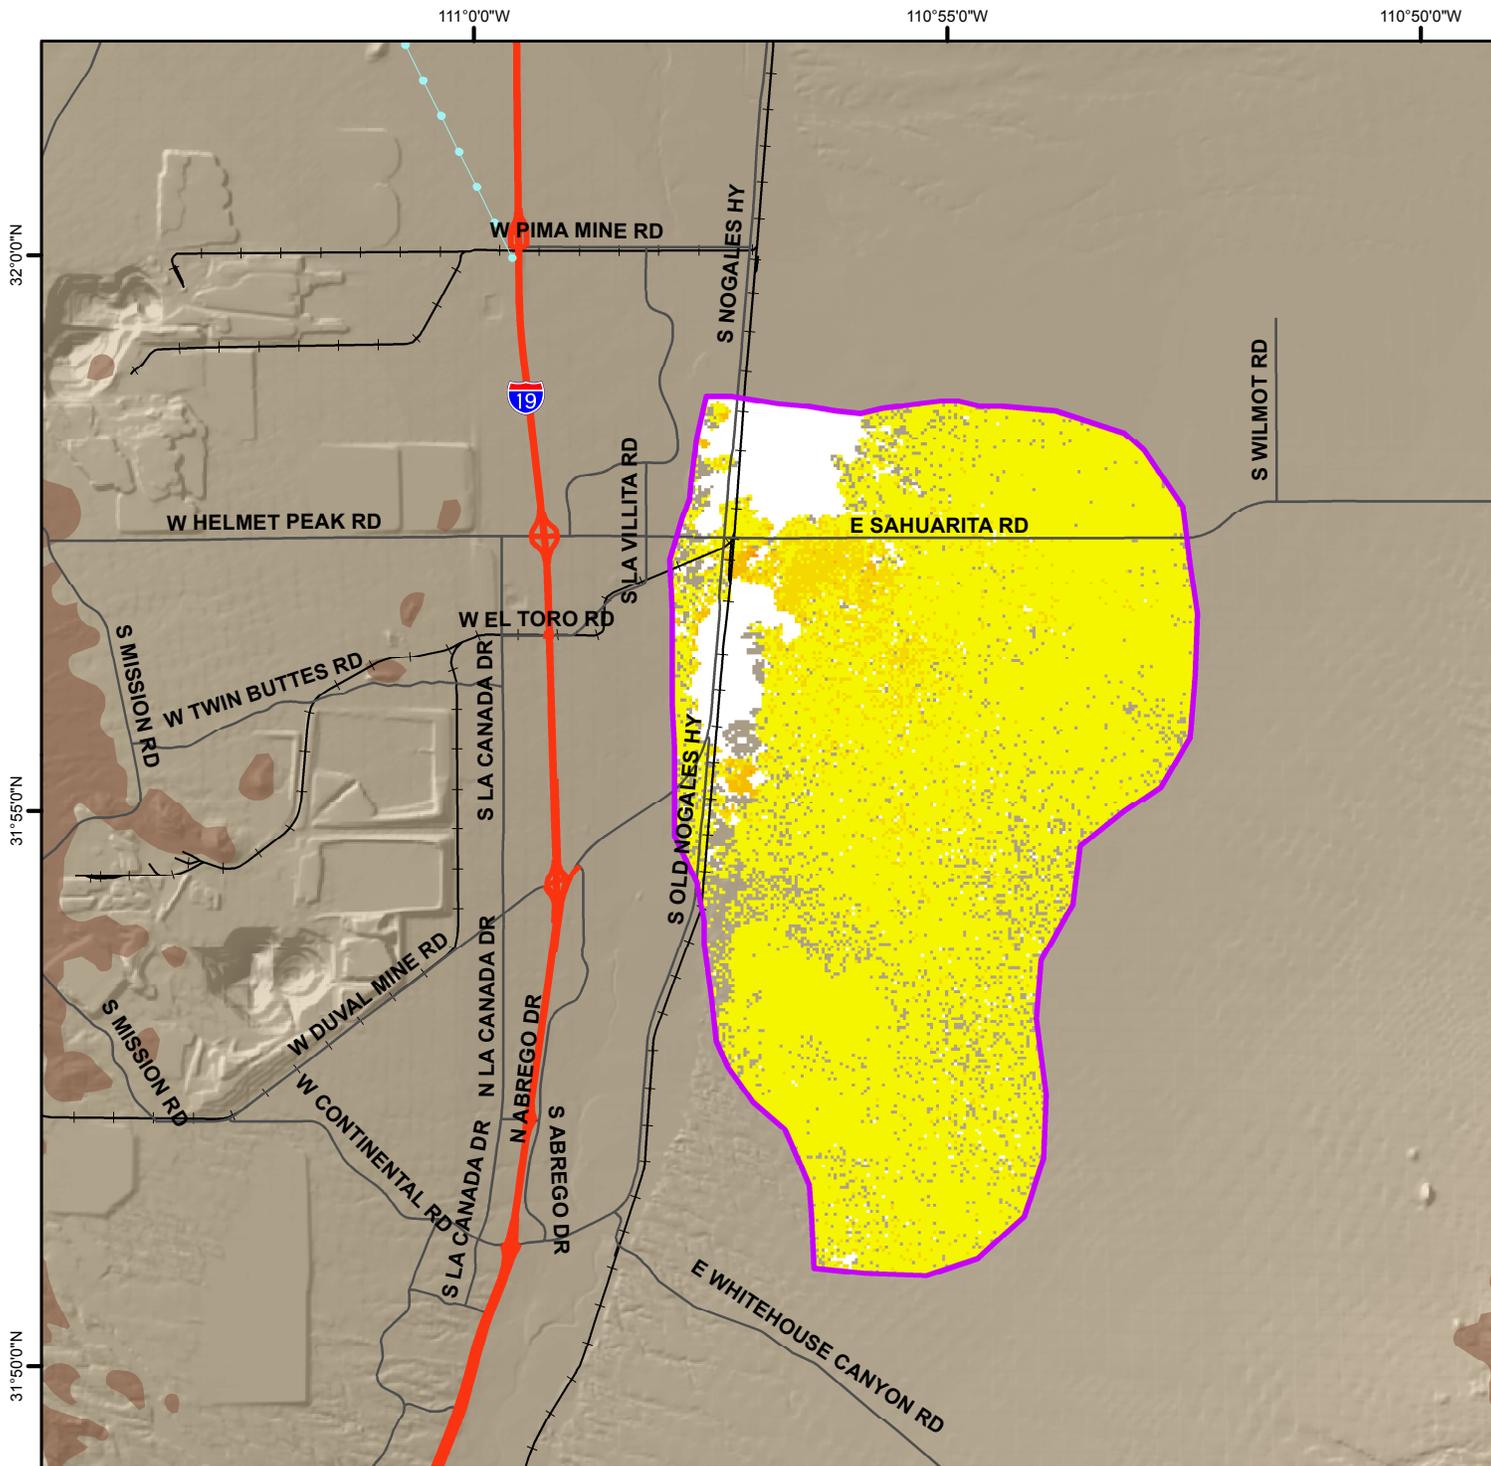
Decorrelation (white areas) are areas where the phase of the received satellite signal changed between satellite passes, causing the data to be unusable. This occurs in areas where the land surface has been disturbed (i.e. bodies of water, snow, agriculture areas, areas of development, etc).
