Land Subsidence Rate in the Sahuarita and Green Valley Areas, Pima County
 Based on Radarsat-2 Satellite Interferometric Synthetic Aperture Radar (InSAR) Data
 Time Period of Analysis: 1.2 Years 02/16/2013 To 05/18/2014

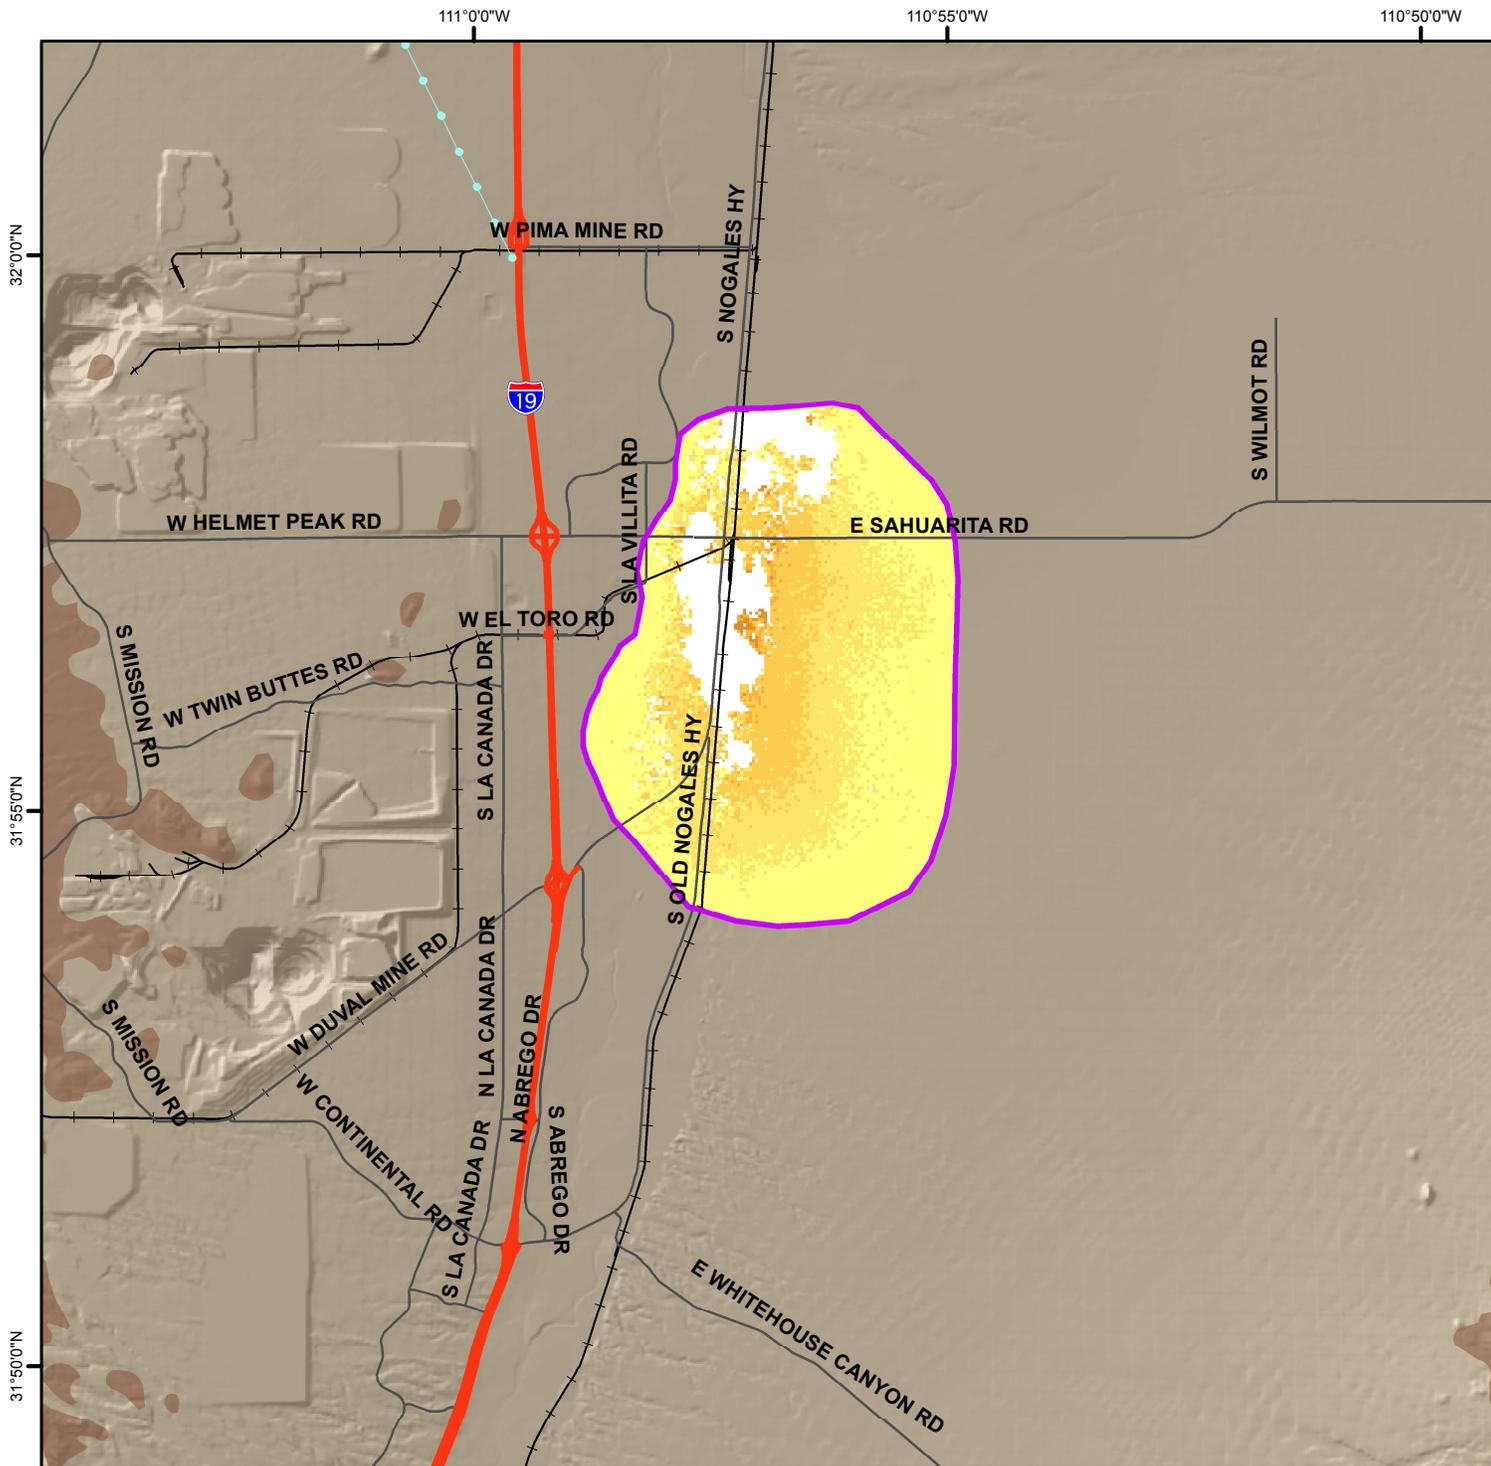
- Decorrelation/No Data
- Greater 7 cm/yr (2.8 in/yr)
- 5 - 7 cm/yr (2.0 - 2.8 in/yr)
- 3 - 5 cm/yr (1.2 - 2.0 in/yr)
- 2 - 3 cm/yr (0.8 - 1.2 in/yr)
- 1 - 2 cm/yr (0.4 - 0.8 in/yr)
- 0.5 - 1 cm/yr (0.2 - 0.4 in/yr)
- 0 - 0.5 cm/yr (0 - 0.2 in/yr)

Decorrelation (white areas) are areas where the phase of the received satellite signal changed between satellite passes, causing the data to be unusable. This occurs in areas where the land surface has been disturbed (i.e. bodies of water, snow, agriculture areas, areas of development, etc).
