Land Subsidence Rate in the Harquahala Valley, Maricopa County
 Based on Envisat Satellite Interferometric Synthetic Aperture Radar (InSAR) Data
 Time Period of Analysis: 1.0 Years 01/29/2009 To 02/18/2010

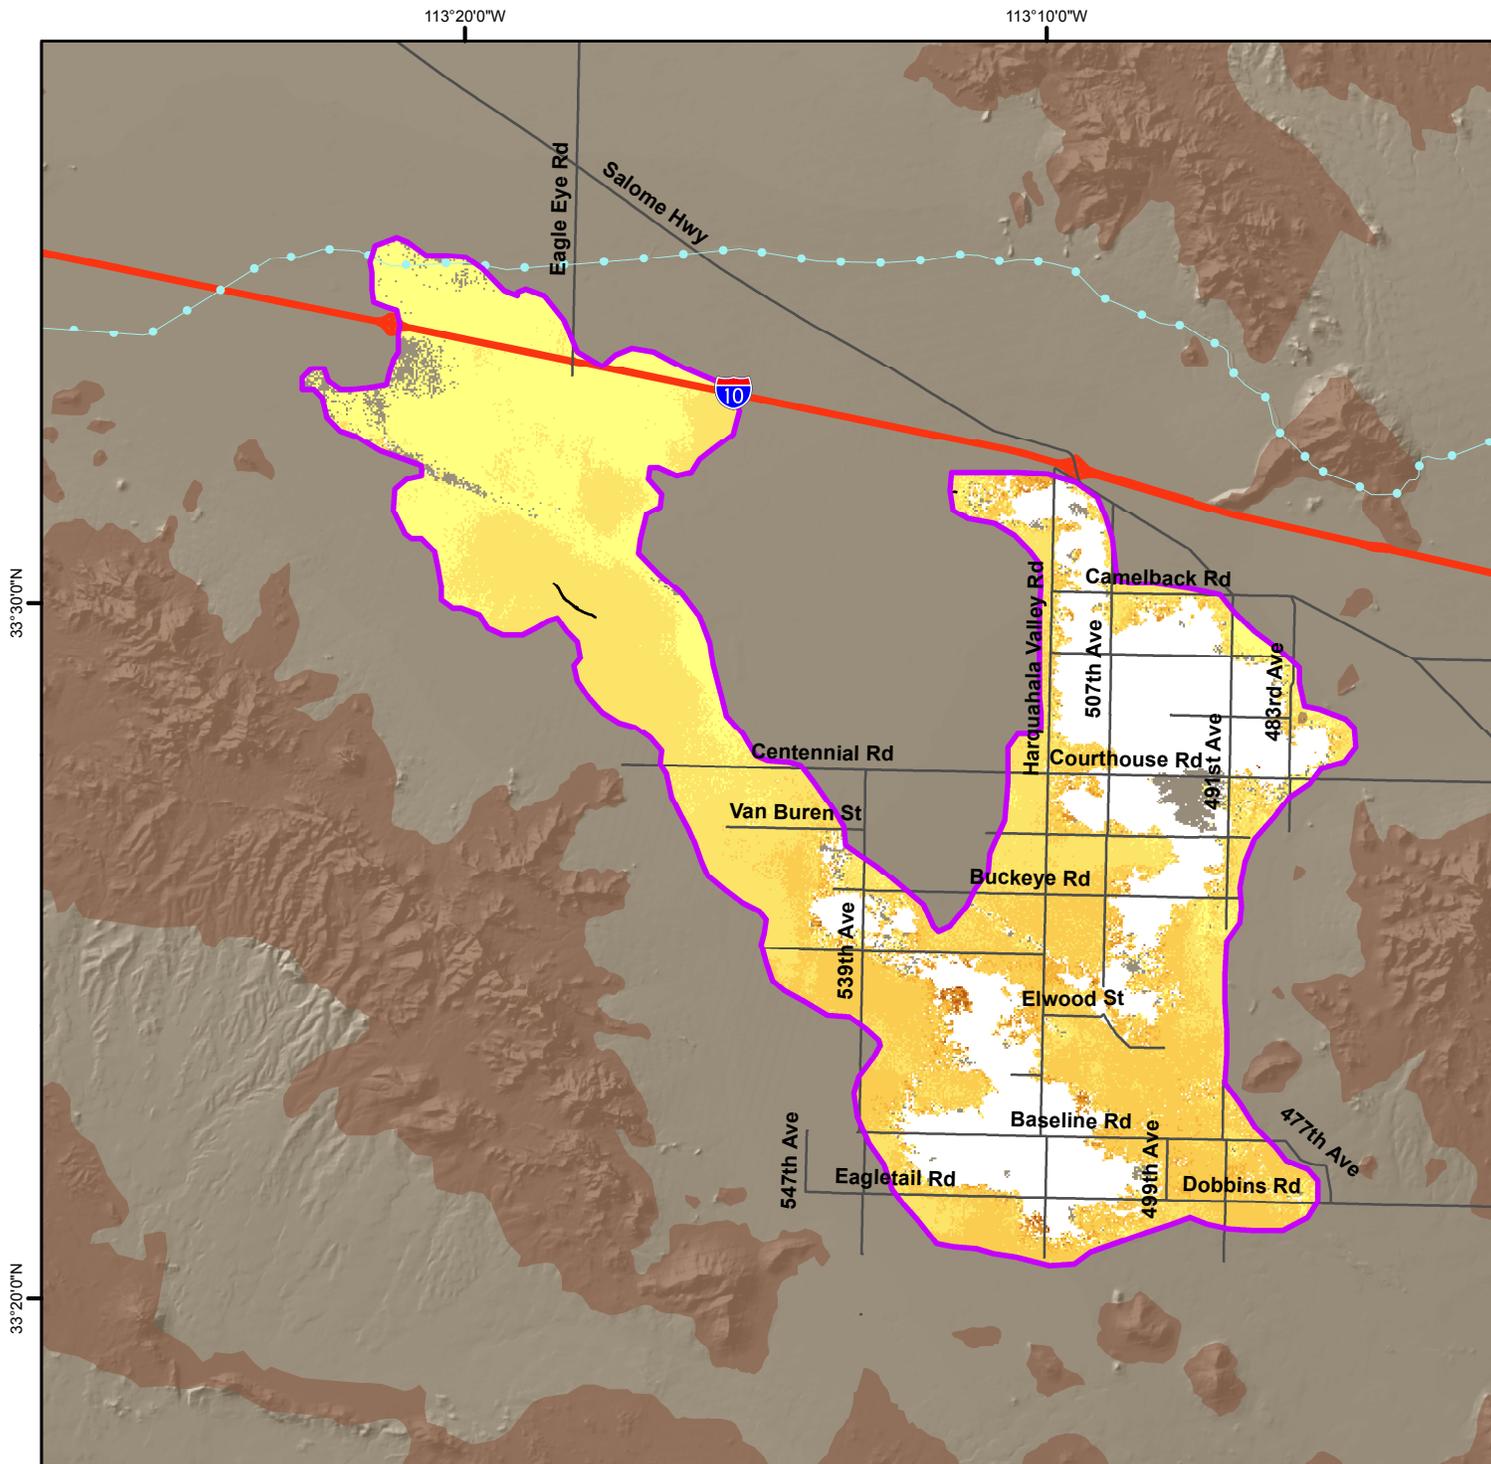
Decorrelation (white areas) are areas where the phase of the received satellite signal changed between satellite passes, causing the data to be unusable. This occurs in areas where the land surface has been disturbed (i.e. bodies of water, snow, agriculture areas, areas of development, etc).
