Land Subsidence Rate in the Harquahala Valley, Maricopa County
 Based on Radarsat-2 Satellite Interferometric Synthetic Aperture Radar (InSAR) Data
 Time Period of Analysis: 1.0 Years 03/17/2014 To 04/05/2015

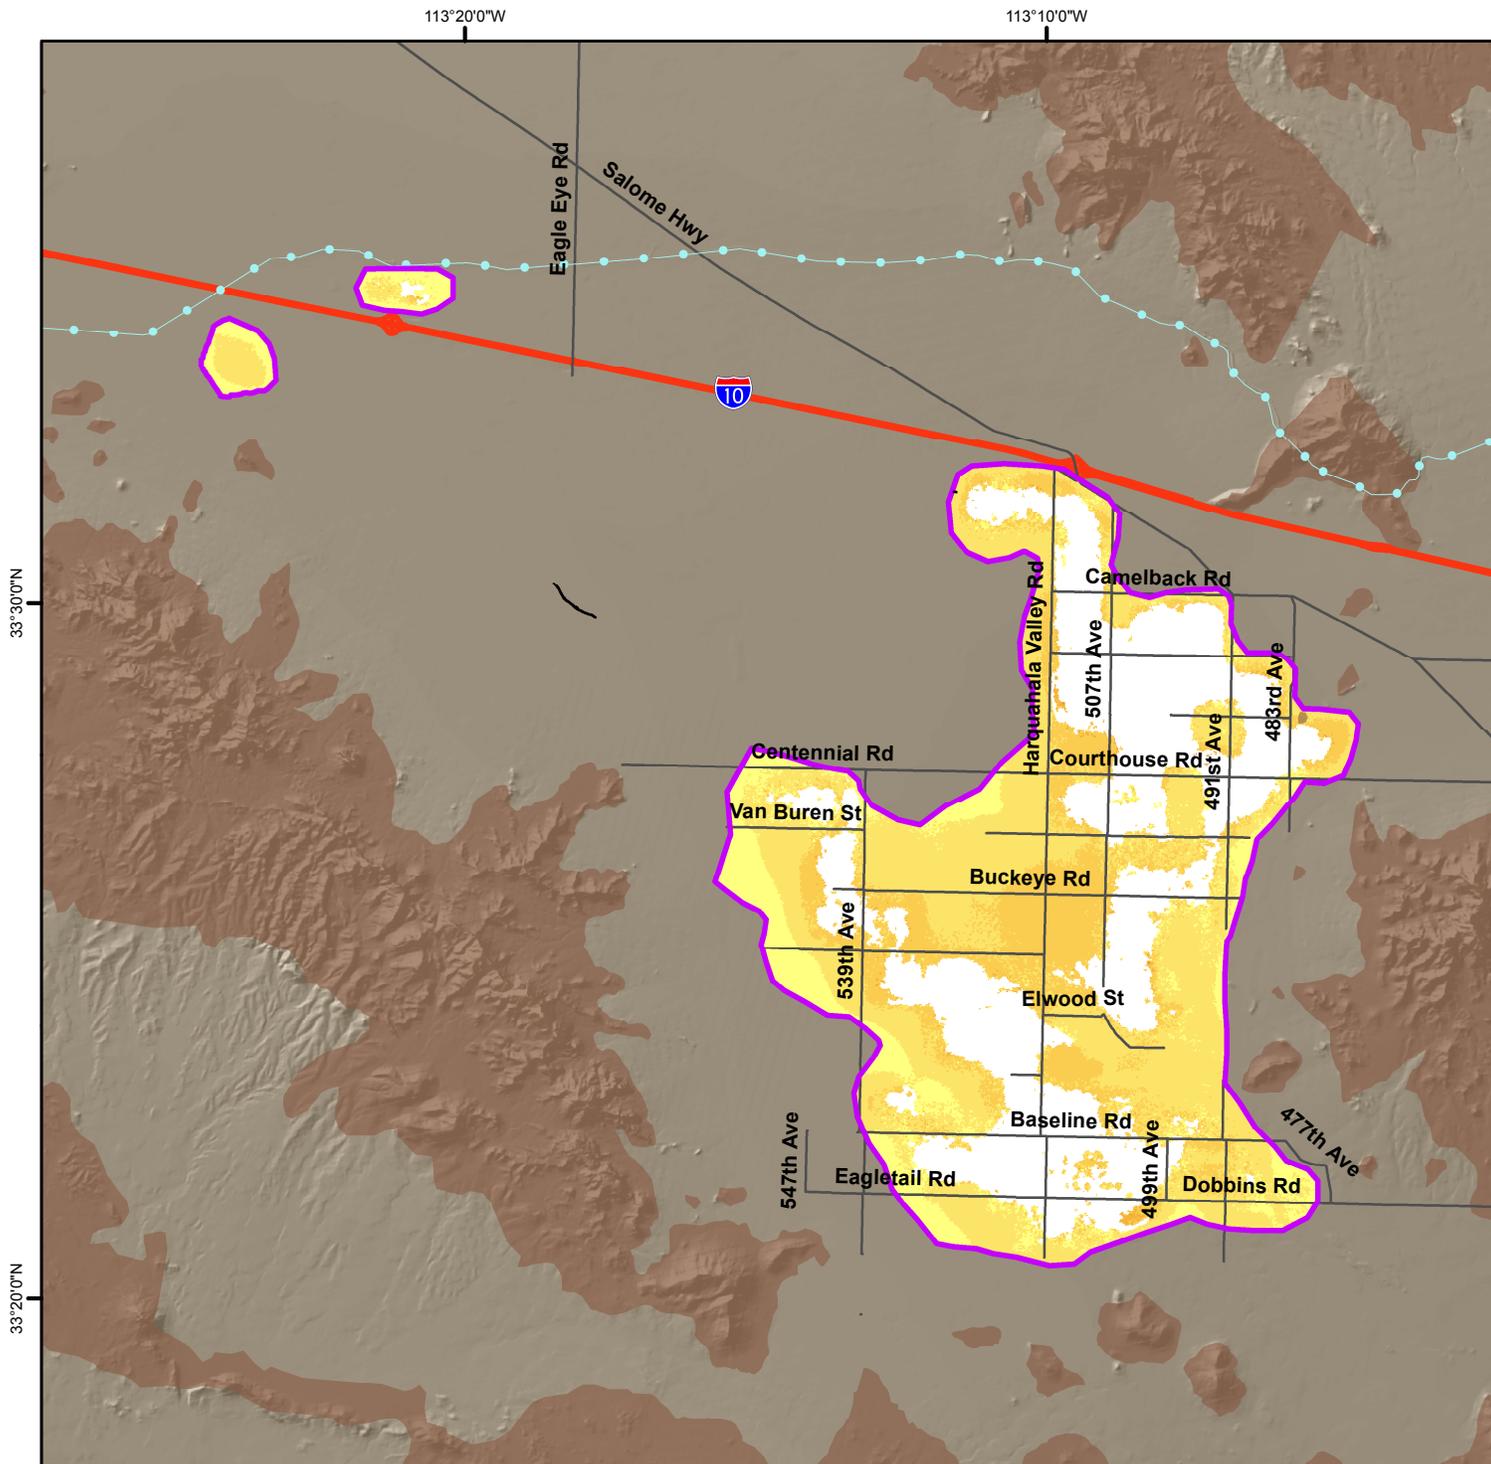
Decorrelation (white areas) are areas where the phase of the received satellite signal changed between satellite passes, causing the data to be unusable. This occurs in areas where the land surface has been disturbed (i.e. bodies of water, snow, agriculture areas, areas of development, etc).
