Land Subsidence Rate (cm/yr) in the Harquahala Valley, Maricopa County
 Based on Envisat Satellite Interferometric Synthetic Aperture Radar (InSAR) Data
 Time Period of Analysis: 4.7 Years 06/08/1992 To 03/13/1997

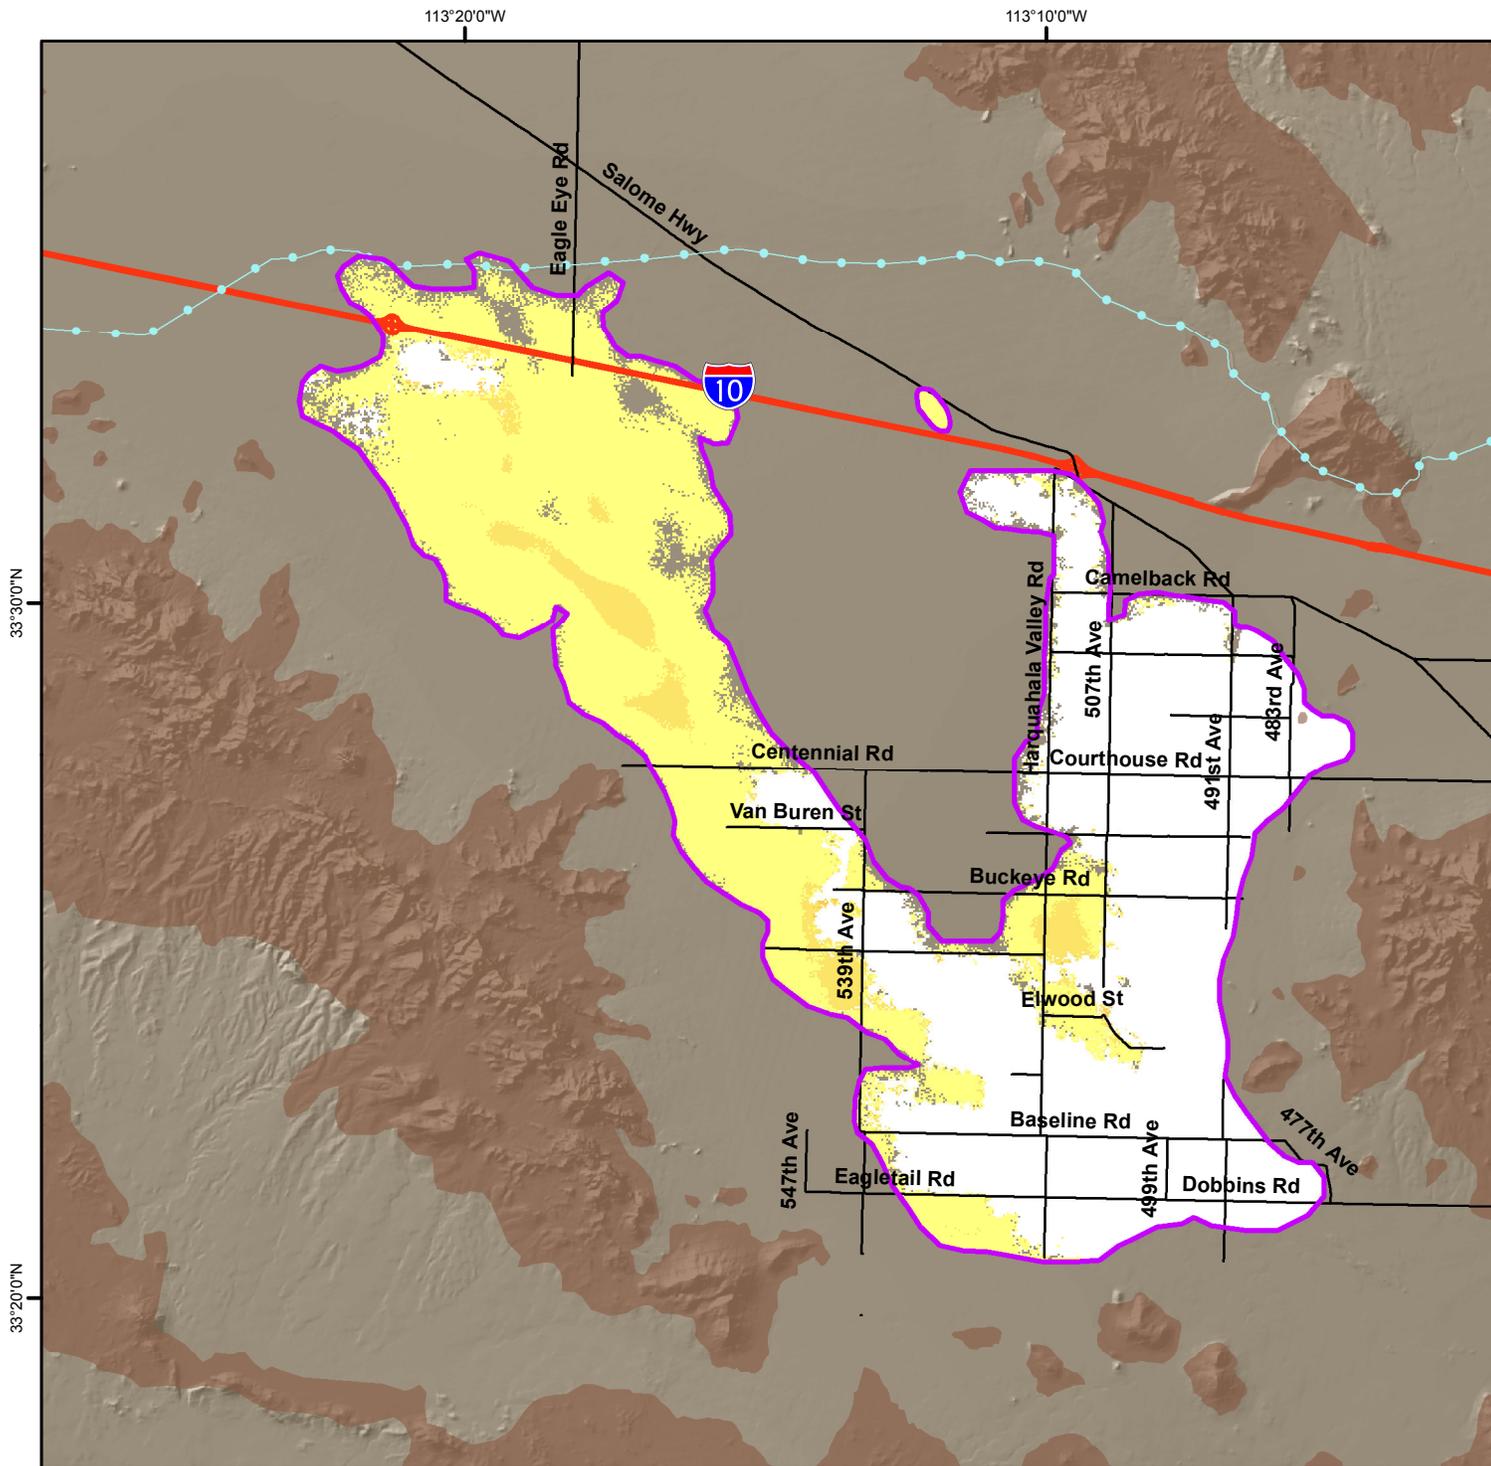
Decorrelation (white areas) are areas where the phase of the received satellite signal changed between satellite passes, causing the data to be unusable. This occurs in areas where the land surface has been disturbed (i.e. bodies of water, snow, agriculture areas, areas of development, etc).
