Total Land Subsidence in the Ranegras Valley, La Paz County
Based on Envisat Satellite Interferometric Synthetic Aperture Radar (InSAR) Data
Time Period of Analysis: 1.0 Years 01/29/2009 To 02/18/2010

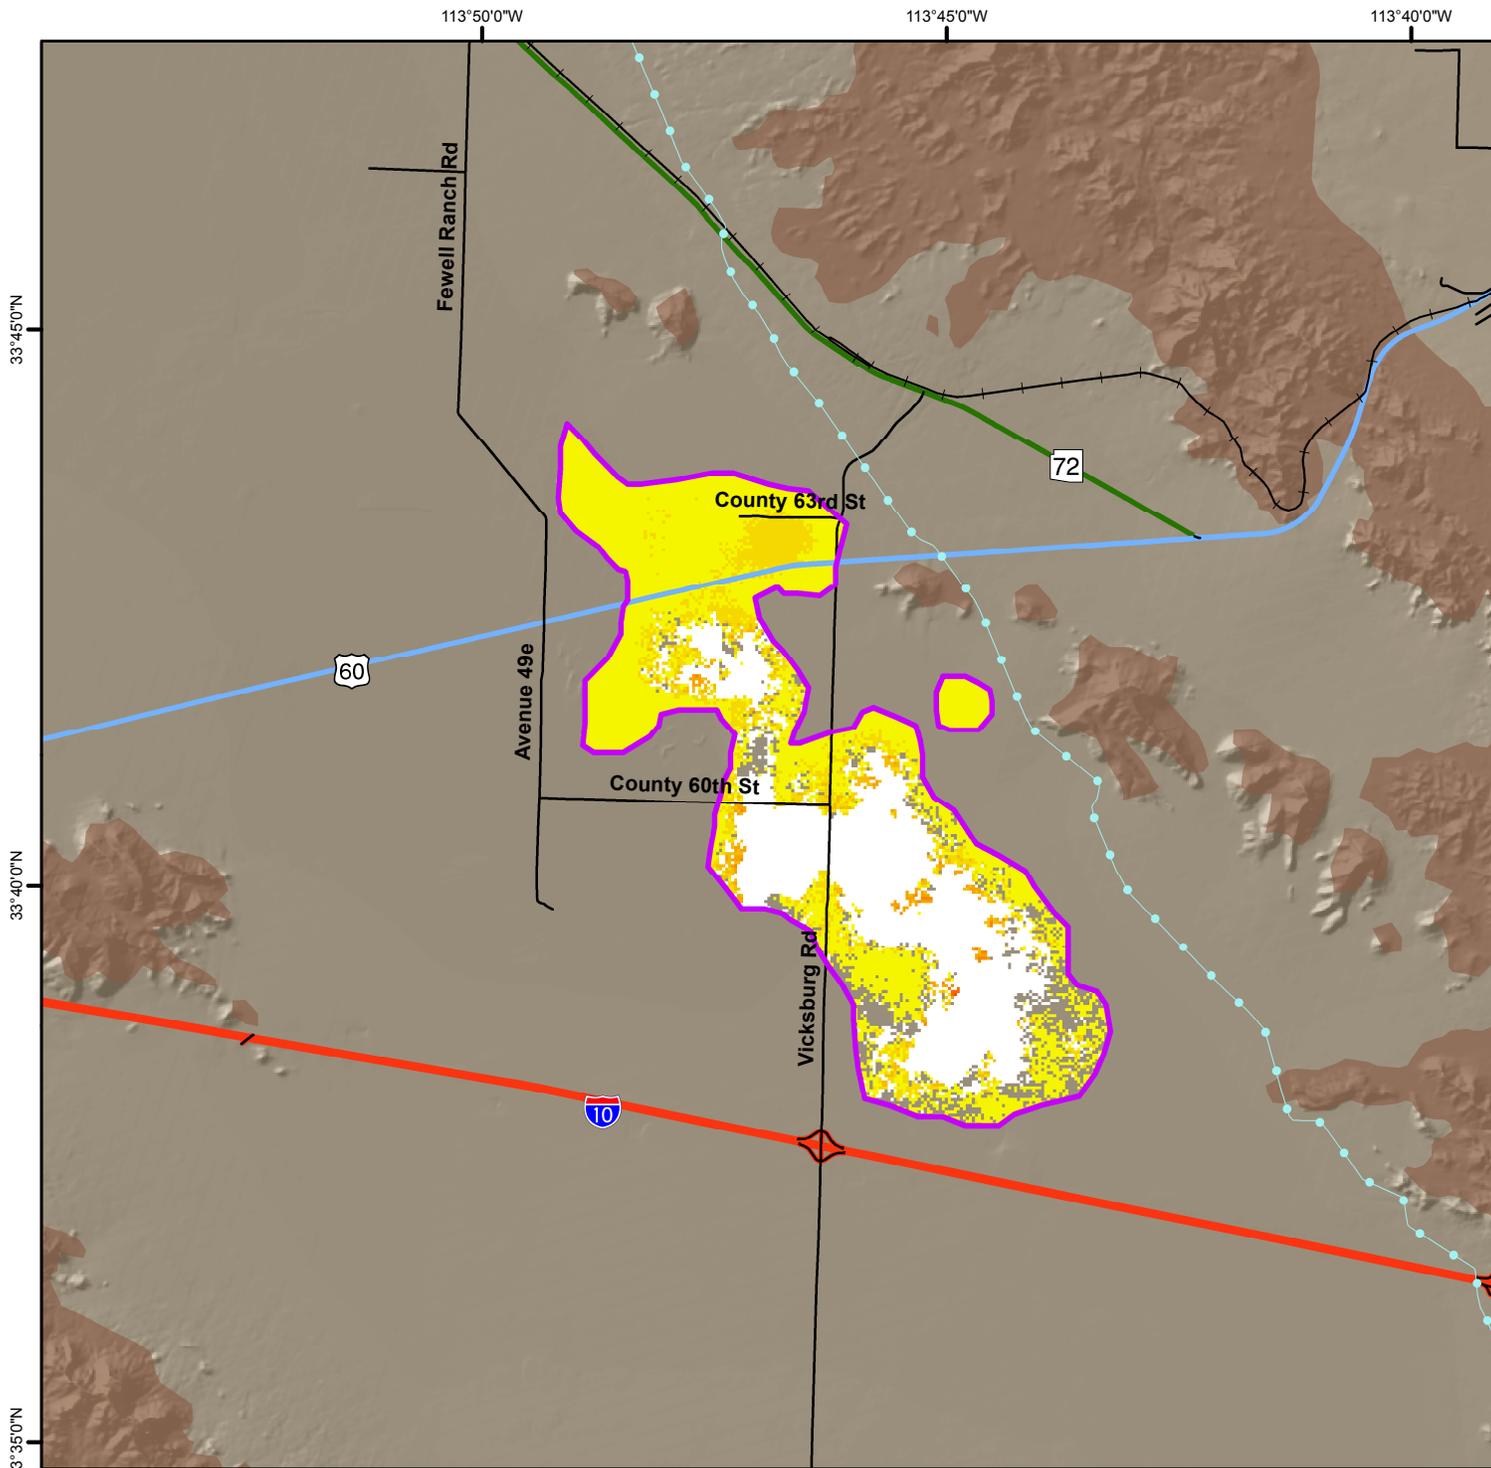
Decorrelation (white areas) are areas where the phase of the received satellite signal changed between satellite passes, causing the data to be unusable. This occurs in areas where the land surface has been disturbed (i.e. bodies of water, snow, agriculture areas, areas of development, etc).
