Total Land Subsidence in the Ranegras Valley, La Paz County
Based on Envisat Satellite Interferometric Synthetic Aperture Radar (InSAR) Data
Time Period of Analysis: 2.0 Years 02/14/2008 To 02/18/2010

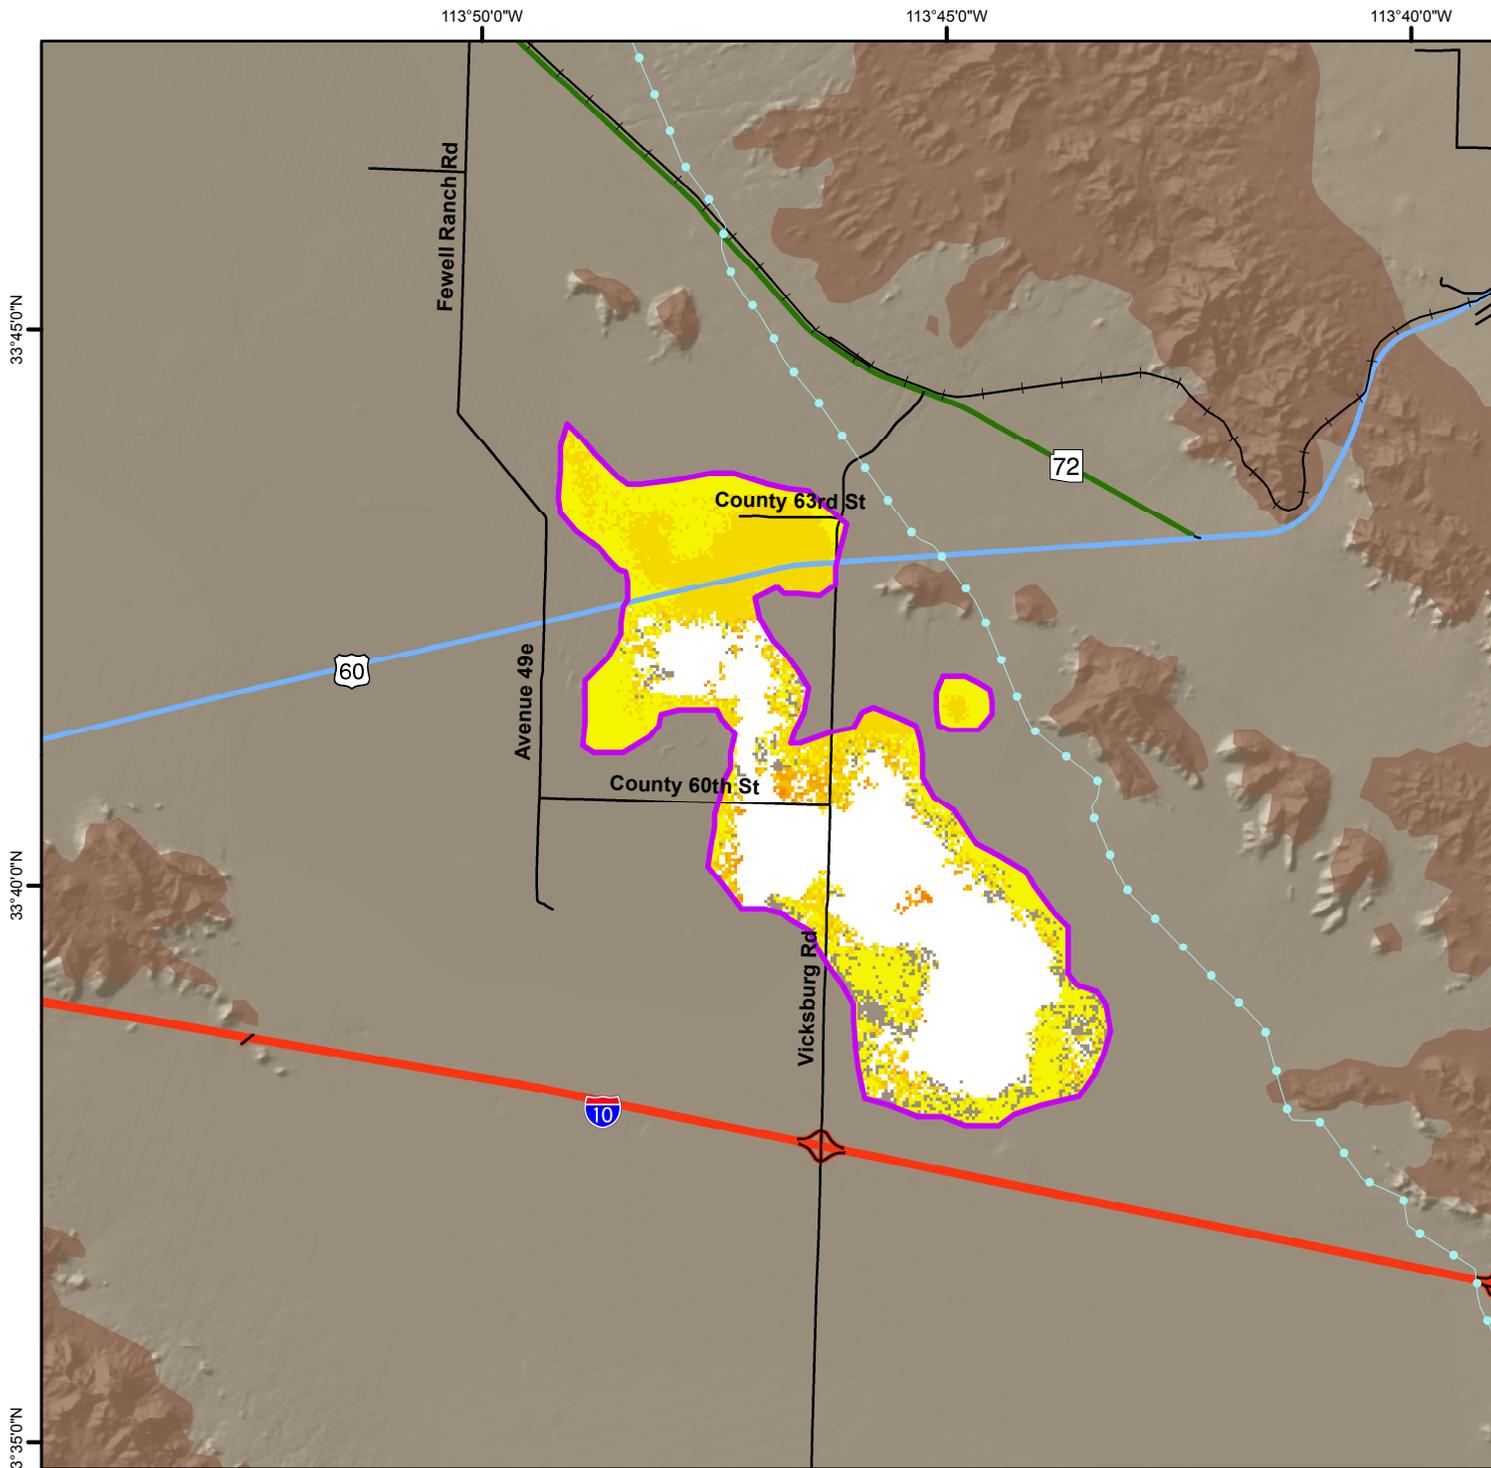
Decorrelation (white areas) are areas where the phase of the received satellite signal changed between satellite passes, causing the data to be unusable. This occurs in areas where the land surface has been disturbed (i.e. bodies of water, snow, agriculture areas, areas of development, etc).
