Total Land Subsidence in the Ranegras Valley, La Paz County
Based on Radarsat-2 Satellite Interferometric Synthetic Aperture Radar (InSAR) Data
Time Period of Analysis: 1.0 Years 03/27/2012 To 03/22/2013

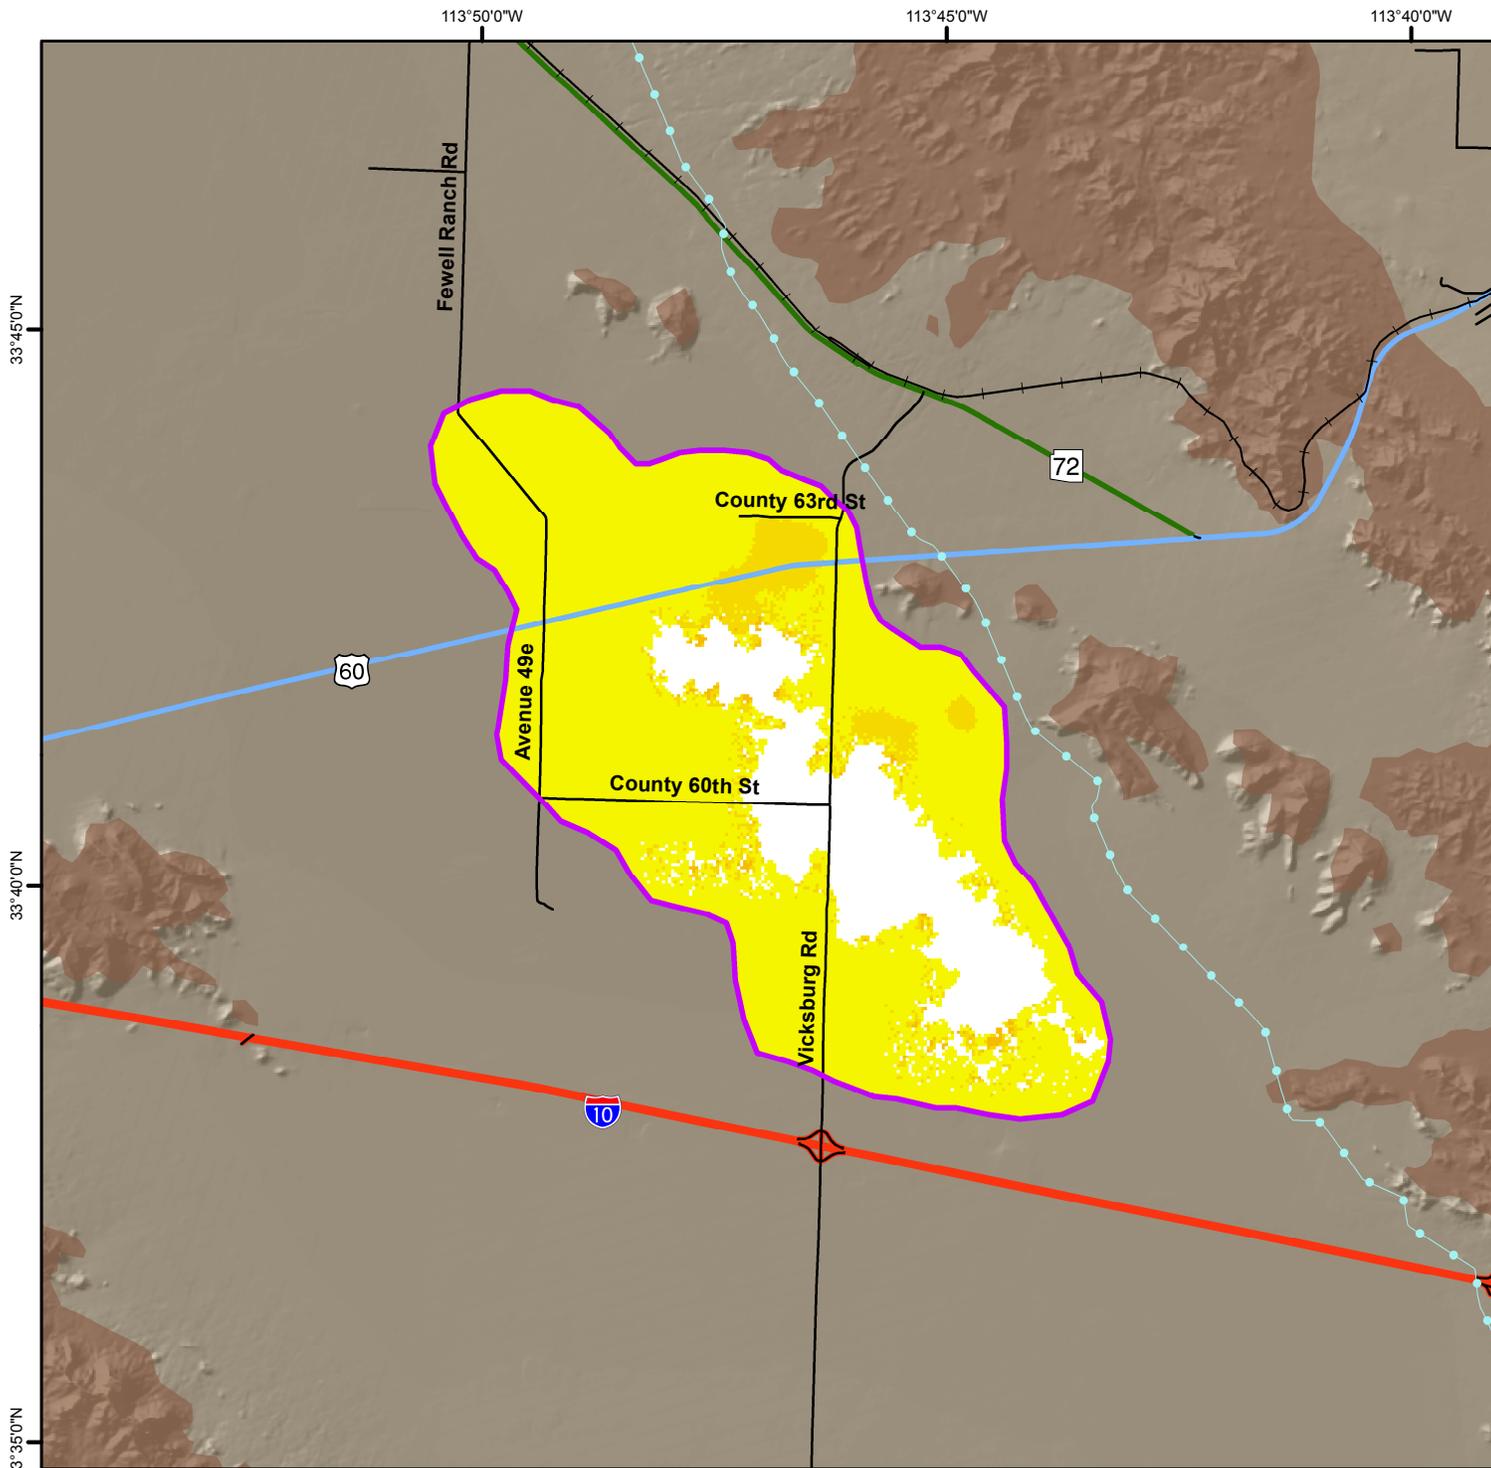
Decorrelation (white areas) are areas where the phase of the received satellite signal changed between satellite passes, causing the data to be unusable. This occurs in areas where the land surface has been disturbed (i.e. bodies of water, snow, agriculture areas, areas of development, etc).
