Arizona Department of Water Resources

Land Subsidence Monitoring Report No. 2

August 2014

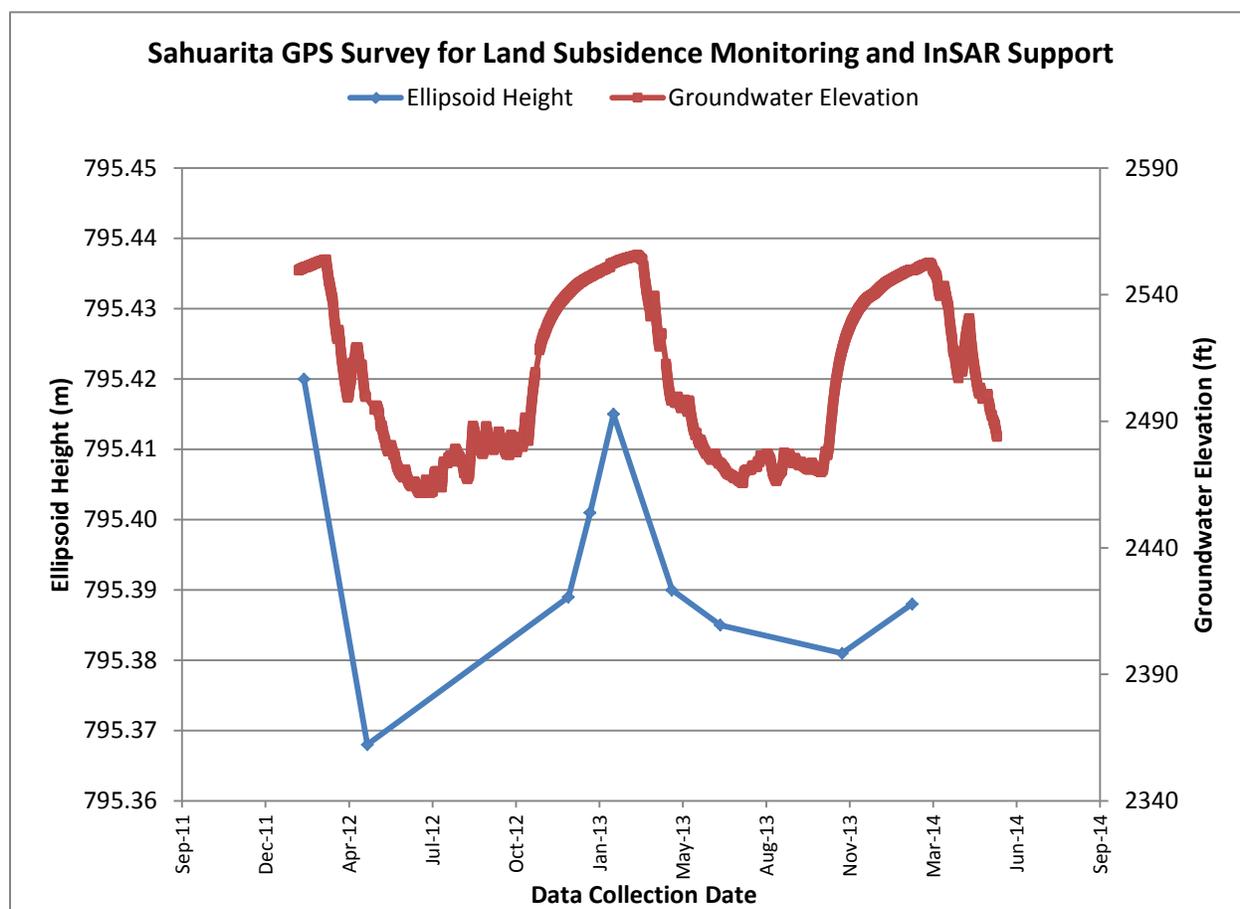
Graph 1 – GPS Survey and transducer groundwater data for the Green Valley Land Subsidence Feature

Comparison of recent GPS surveying data (Photo 1) with ADWR groundwater elevation data (Photo 2) from the Sahuarita/Green Valley Area has shown a striking correlation. Seasonal groundwater pumping demands have caused both seasonal groundwater declines and subsequent recoveries of approximately 110 feet between February and May (period of decline) and November and February (period of recovery). The groundwater level changes have resulted in both seasonal land subsidence and uplift that reflect the groundwater level changes (Graph 1).

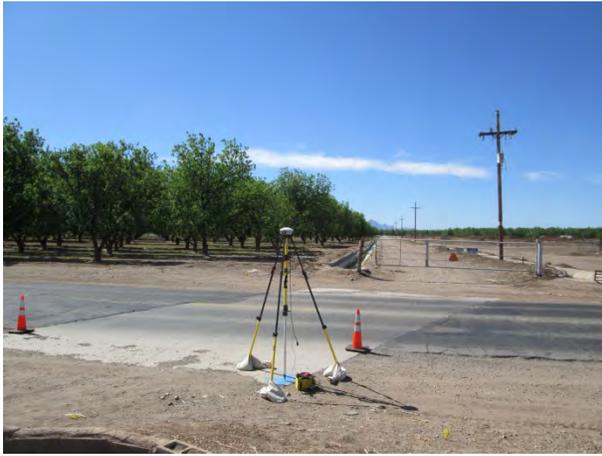
Photo 1 - GPS Surveying along Sahuarita Rd in Green Valley

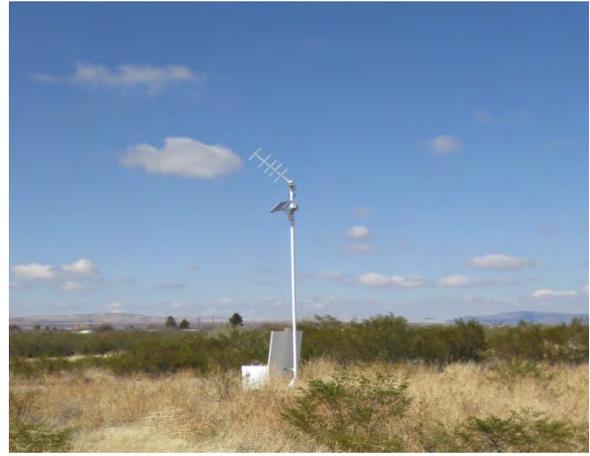
Photo 2 - Collecting groundwater elevation data at the Rosemont West transducer, Green Valley

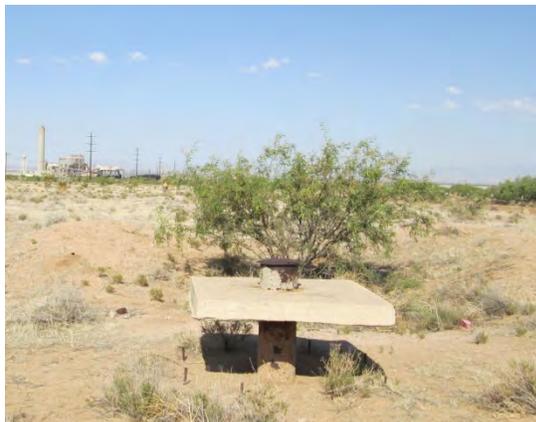
Photo 4 - Exposed well casing in Cochise County

A protruding well casing (Photo 4) about a mile northwest of the V 261 survey monument, and numerous earth fissures located in the Willcox Basin (Photo 5), further document the amount of historical land subsidence that has occurred in the immediate area, as well as the need to continue surveying V 261 for land subsidence in this area.

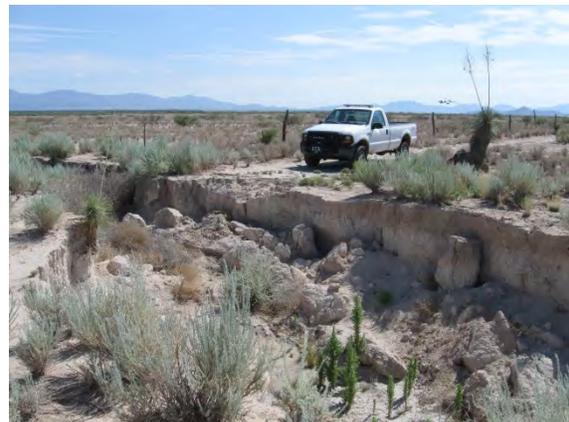
Photo 5 - Sulfur Hills earth fissure in Cochise County

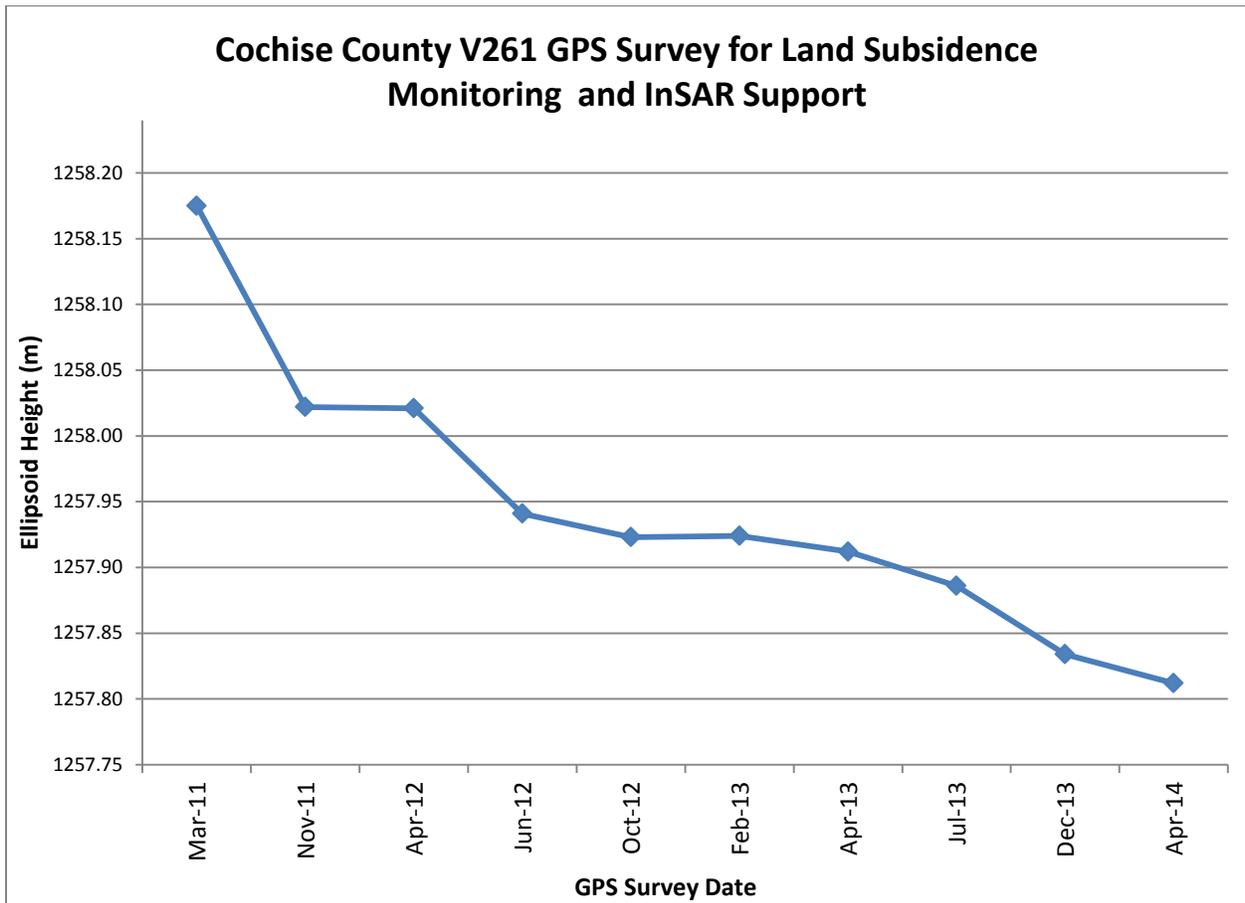
Graph 2 – GPS Survey data for land subsidence along Dragoon Rd in the Kansas Settlement Land Subsidence Feature

ADWR also collects survey-grade GPS data in the center of one of the subsidence-bowls, located along Dragoon Rd between the towns of Dragoon and Willcox, within the Kansas Settlement land subsidence feature. ADWR was able to recover and re-measure an old survey monument, V 261, which was established in 1945 by the National Geodetic Survey (NGS) along Dragoon Rd a mile west of US HWY 191 (Figure 17). Comparing recent (2014) ADWR GPS data with the historical 1945 data, ADWR was able to determine that a total of 1.26 meters (4.14 feet) of land subsidence has occurred at this location since 1945, and 36 centimeters (1.2 feet) of land subsidence has occurred between 2011 and 2014 (Graph 2).

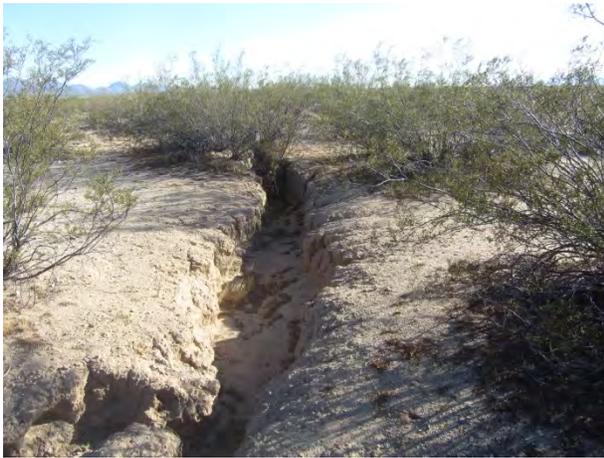
Photo 8 –Recently identified and mapped earth fissure in the McMullen Valley (Photo Credit AZGS)

The AZGS recently identified and mapped earth fissures in the McMullen Valley near the Town of Aguila (Photo 8).

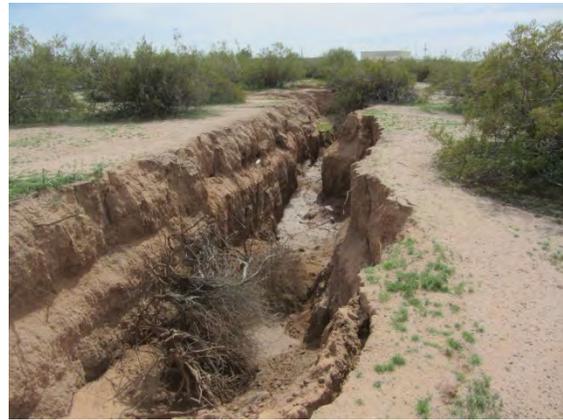
Photo 9 - Earth Fissure located at Baseline Rd and Meridian Rd in the Hawk Rock feature

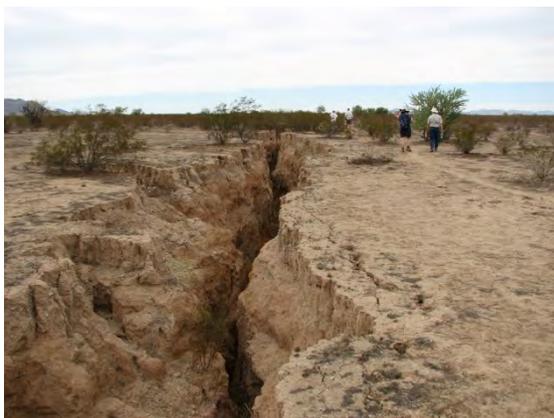
Photo 10 - Rogers earth fissure located in the Harquahala Valley (Photo Credit AZGS)

Comparing recent ADWR GPS data with the historical 2000 data for 4BR1, a total of 8.7 centimeters (3.4 inches) of land subsidence has occurred since 2000. ADWR will continue to survey the 4BR1 survey monument for monitoring land subsidence in the Harquahala Valley. The AZGS recently re-mapped the Roger’s earth fissure (Photo10) and discovered that the earth fissure has extended an additional 620 feet to the southeast since it was last mapped in 2008.

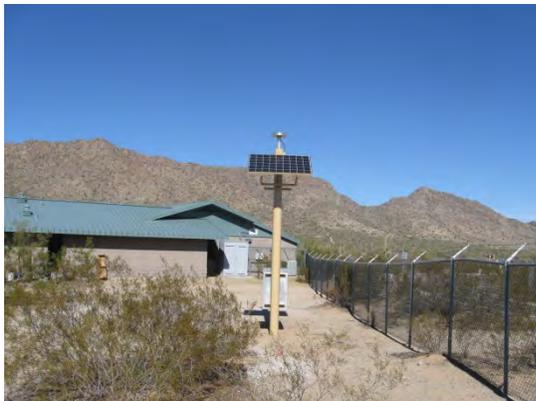
Photo 12 - San Tan Mountain Bedrock CORS

ADWR has worked with the ADOT, Central Arizona Project, Maricopa County Department of Transportation, and Maricopa County Parks to install two new stable CORS sites that are located on bedrock in Eastern Maricopa County at Usery Mountain and San Tan Mountain Parks (Photo 12). These sites will provide stable vertical control around the Hawk Rock land subsidence feature (Figure 20).

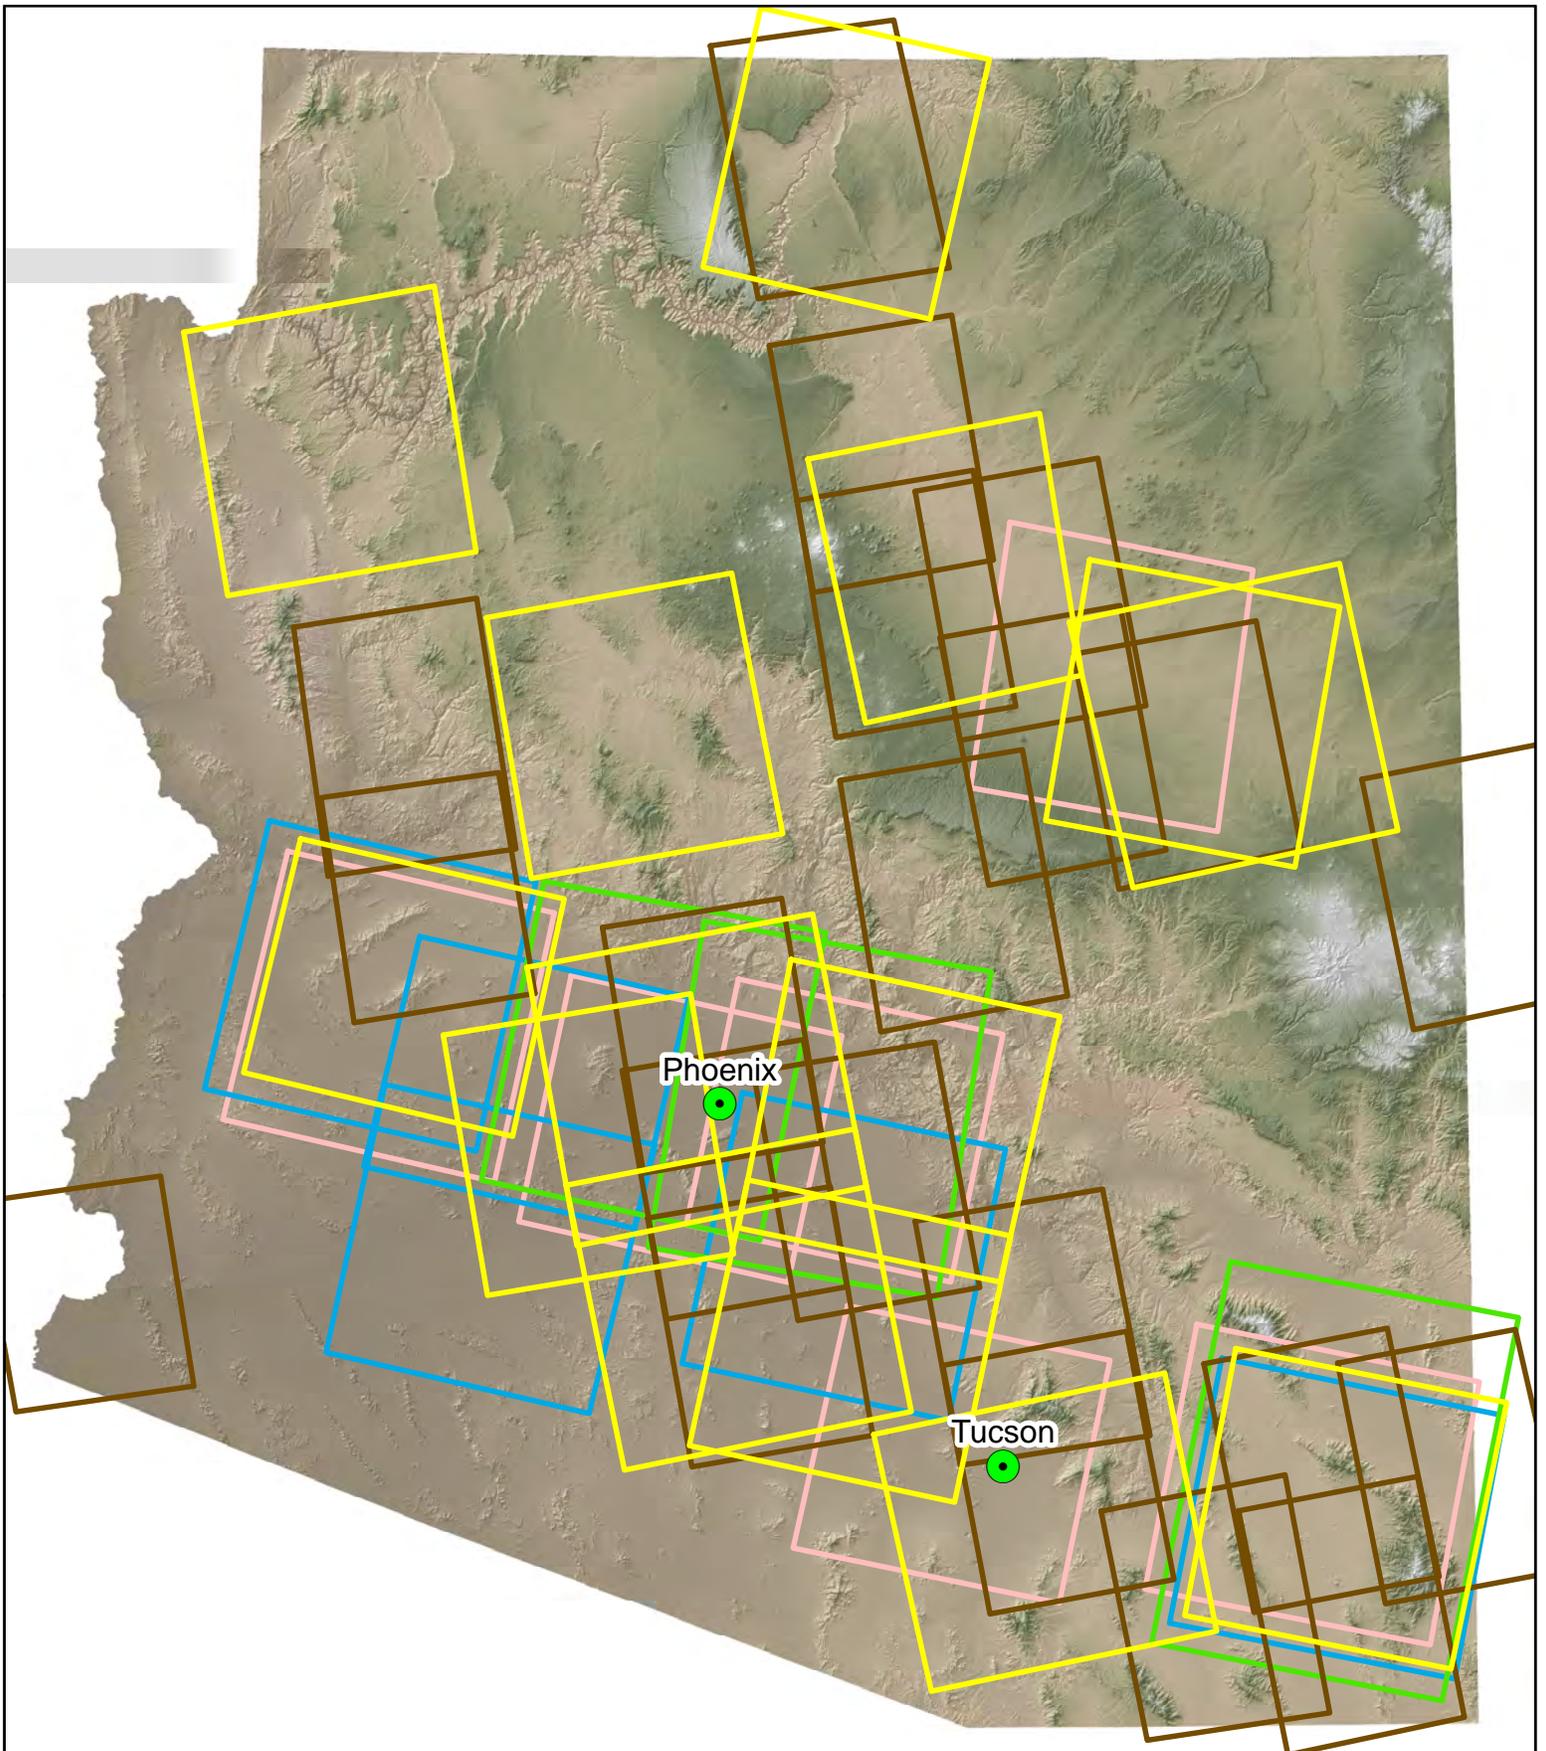
Figure 1 -All Satellite Frames Used to Collect InSAR Data in Arizona
 InSAR Data is Collected, Processed, and Analyzed
 by the Geophysics/Surveying Unit of the ADWR Hydrology Division

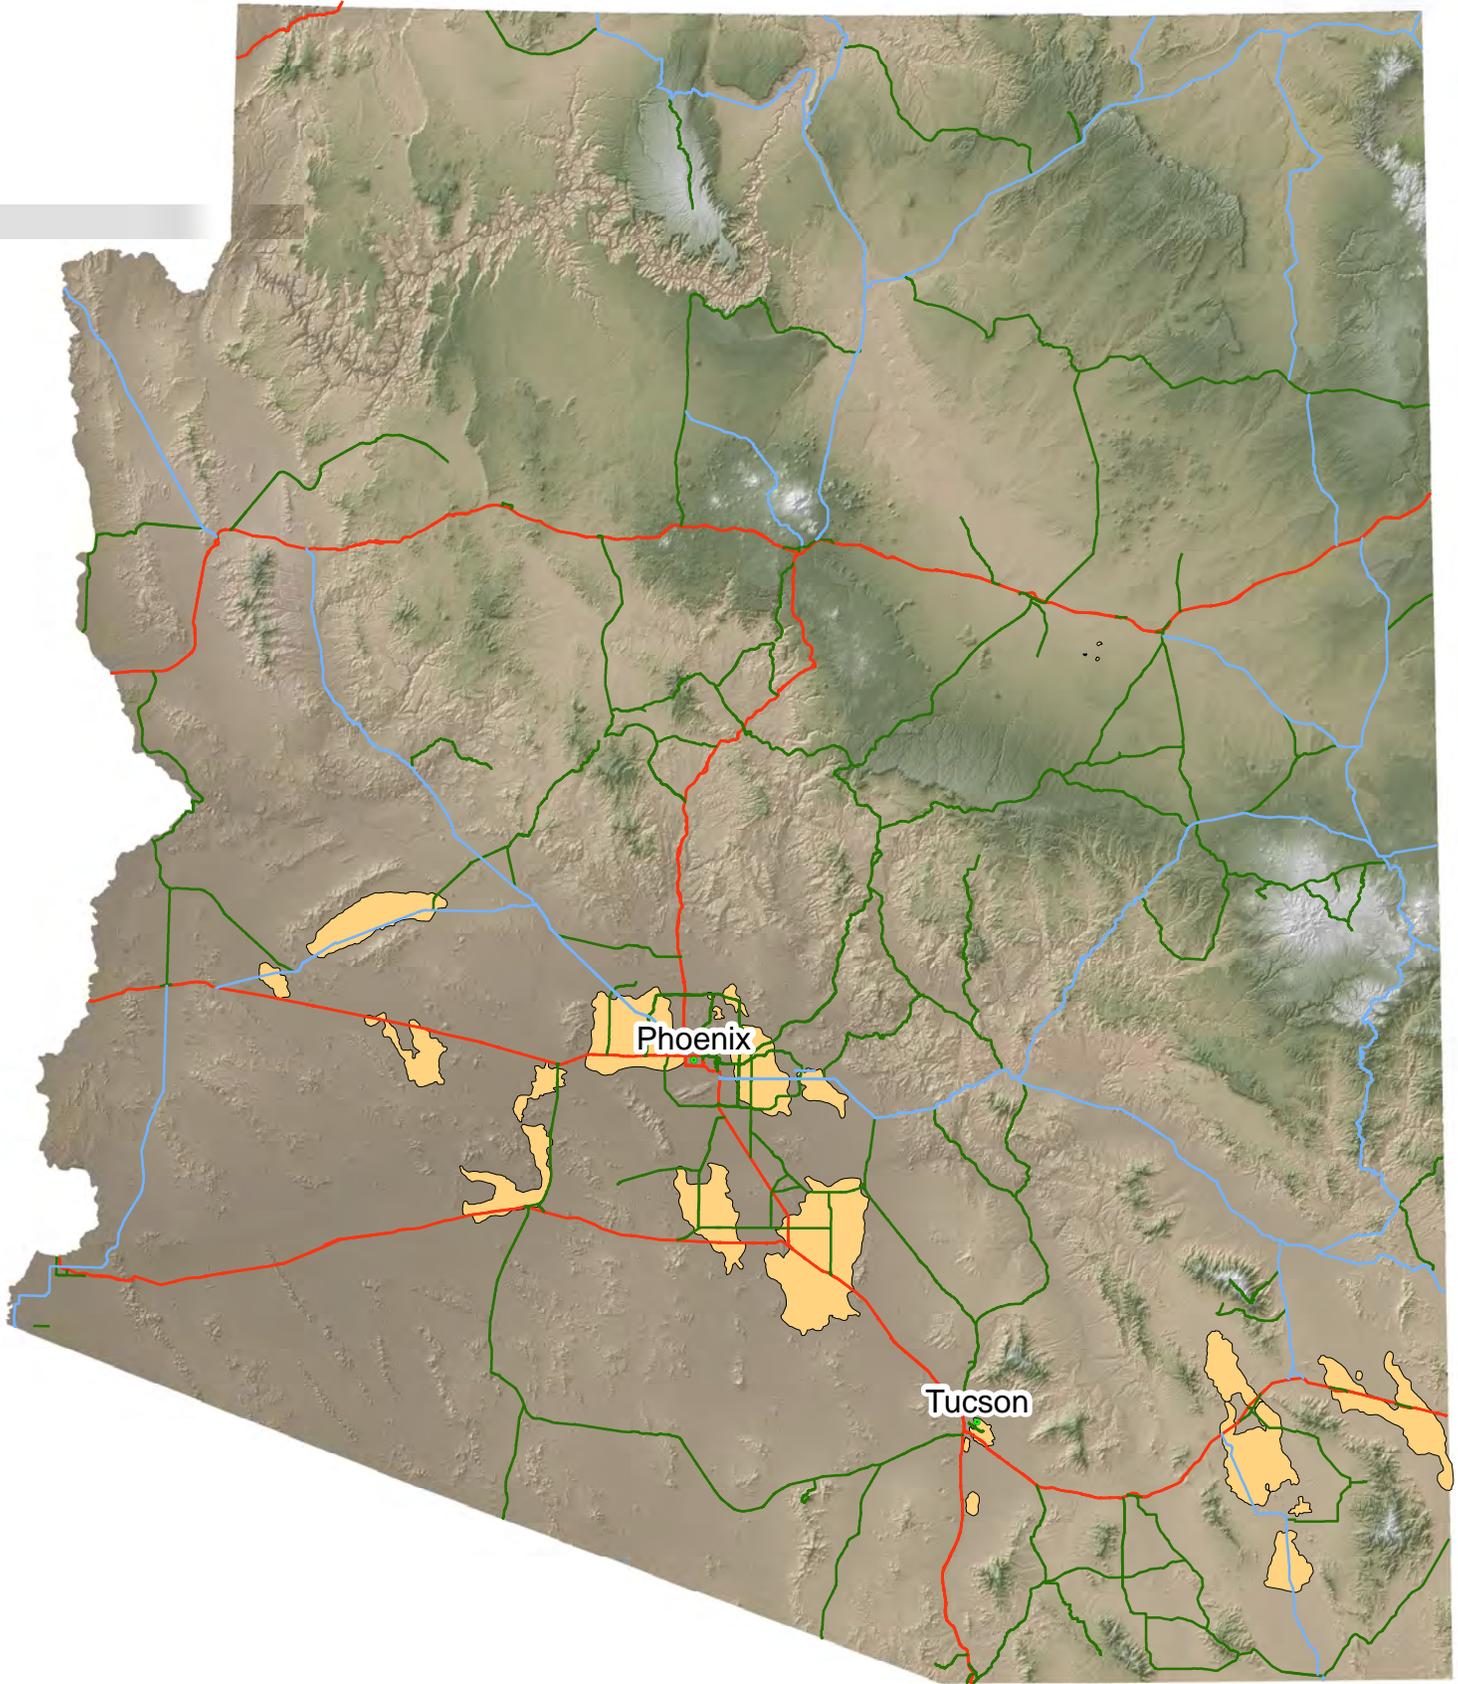
Figure 2 - Active Land Subsidence Areas in Arizona Based on InSAR Data
 InSAR Data is Collected, Processed, and Analyzed
 by the Geophysics/Surveying Unit of the ADWR Hydrology Division

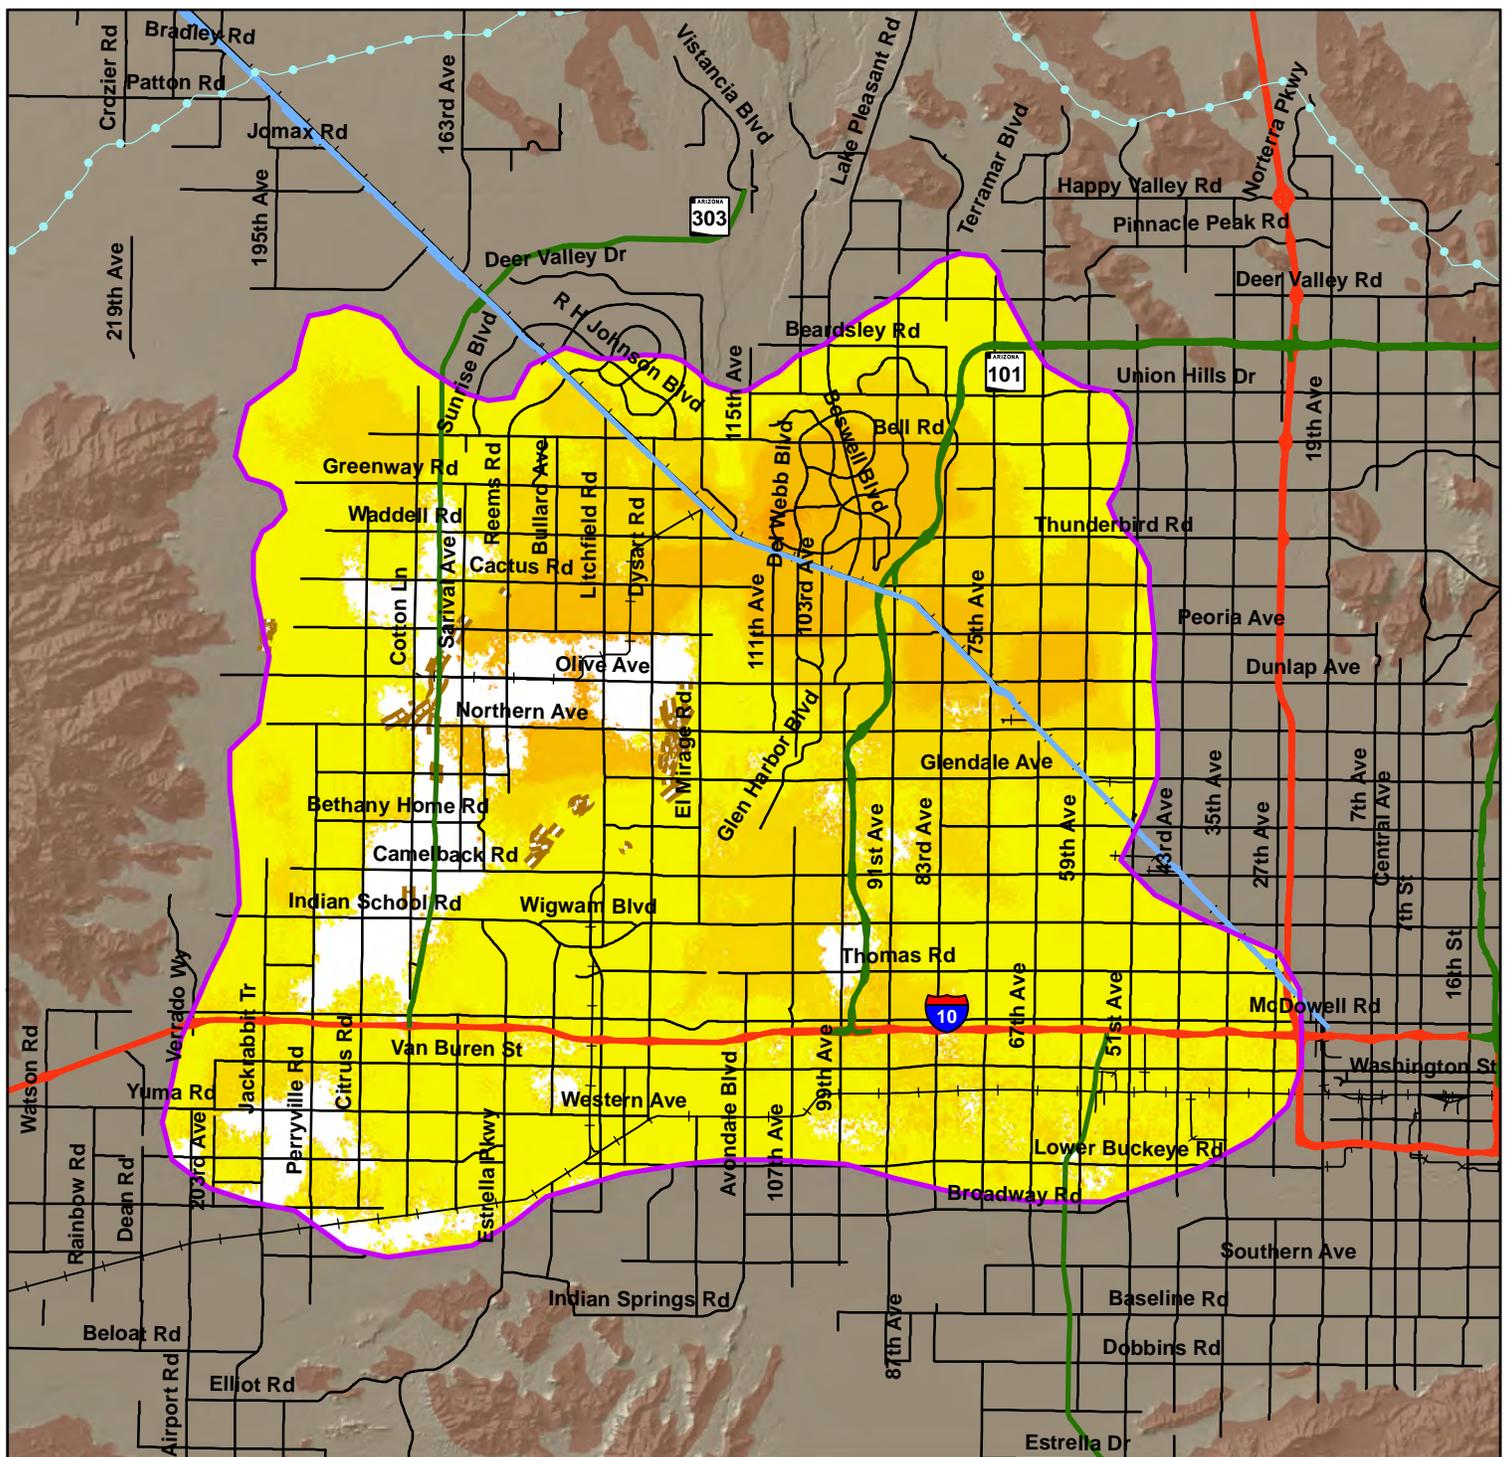
Figure 3 - Total Land Subsidence (cm) in Western Metropolitan Phoenix
 Based on Radarsat-2 Interferometric Synthetic Aperture Radar (InSAR) Data
 Time Period of Analysis: 4.0 Years 05/08/2010 To 04/17/2014

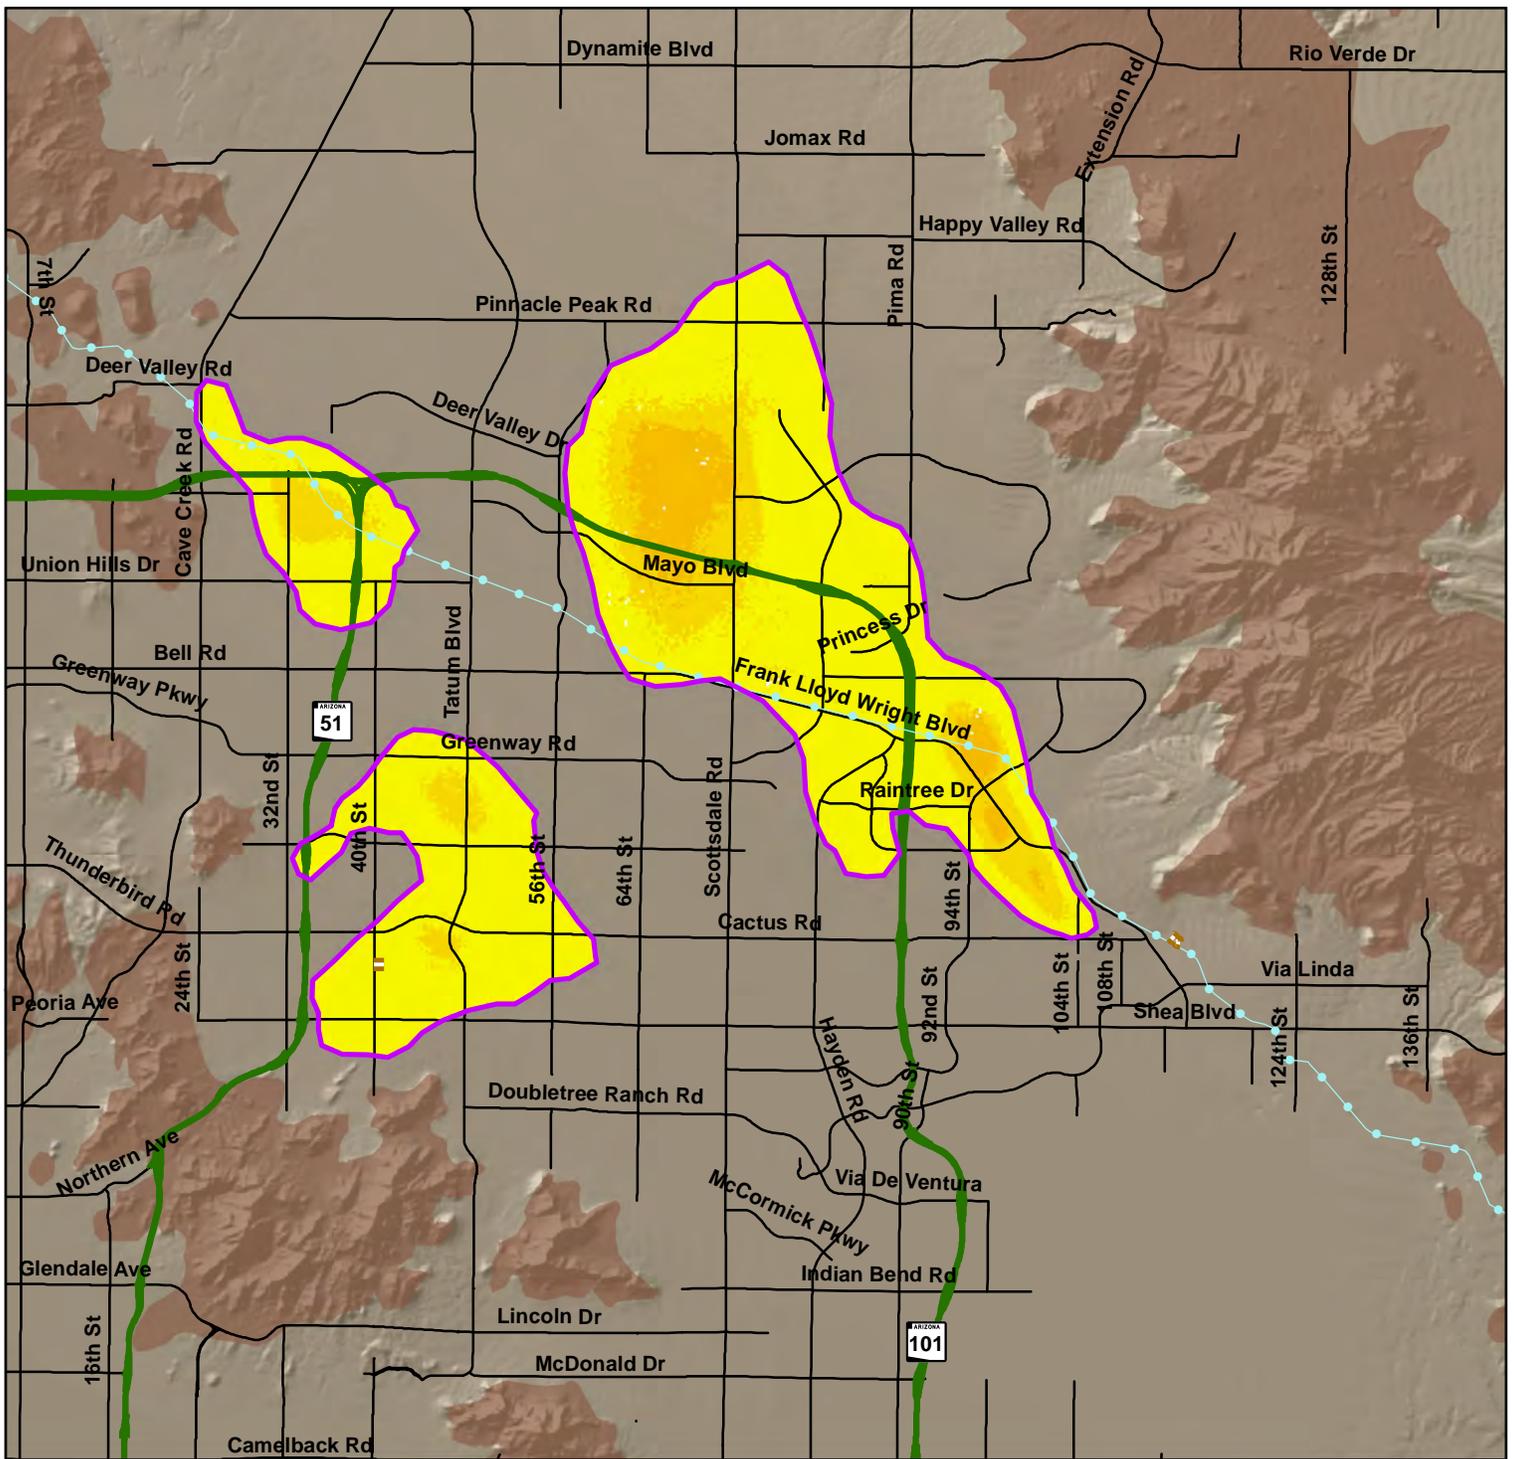
Figure 4 - Total Land Subsidence (cm) in Northeast Phoenix and Scottsdale Areas
 Based on Radarsat-2 Interferometric Synthetic Aperture Radar (InSAR) Data
 Time Period of Analysis: 4.0 Years 05/08/2010 To 04/17/2014

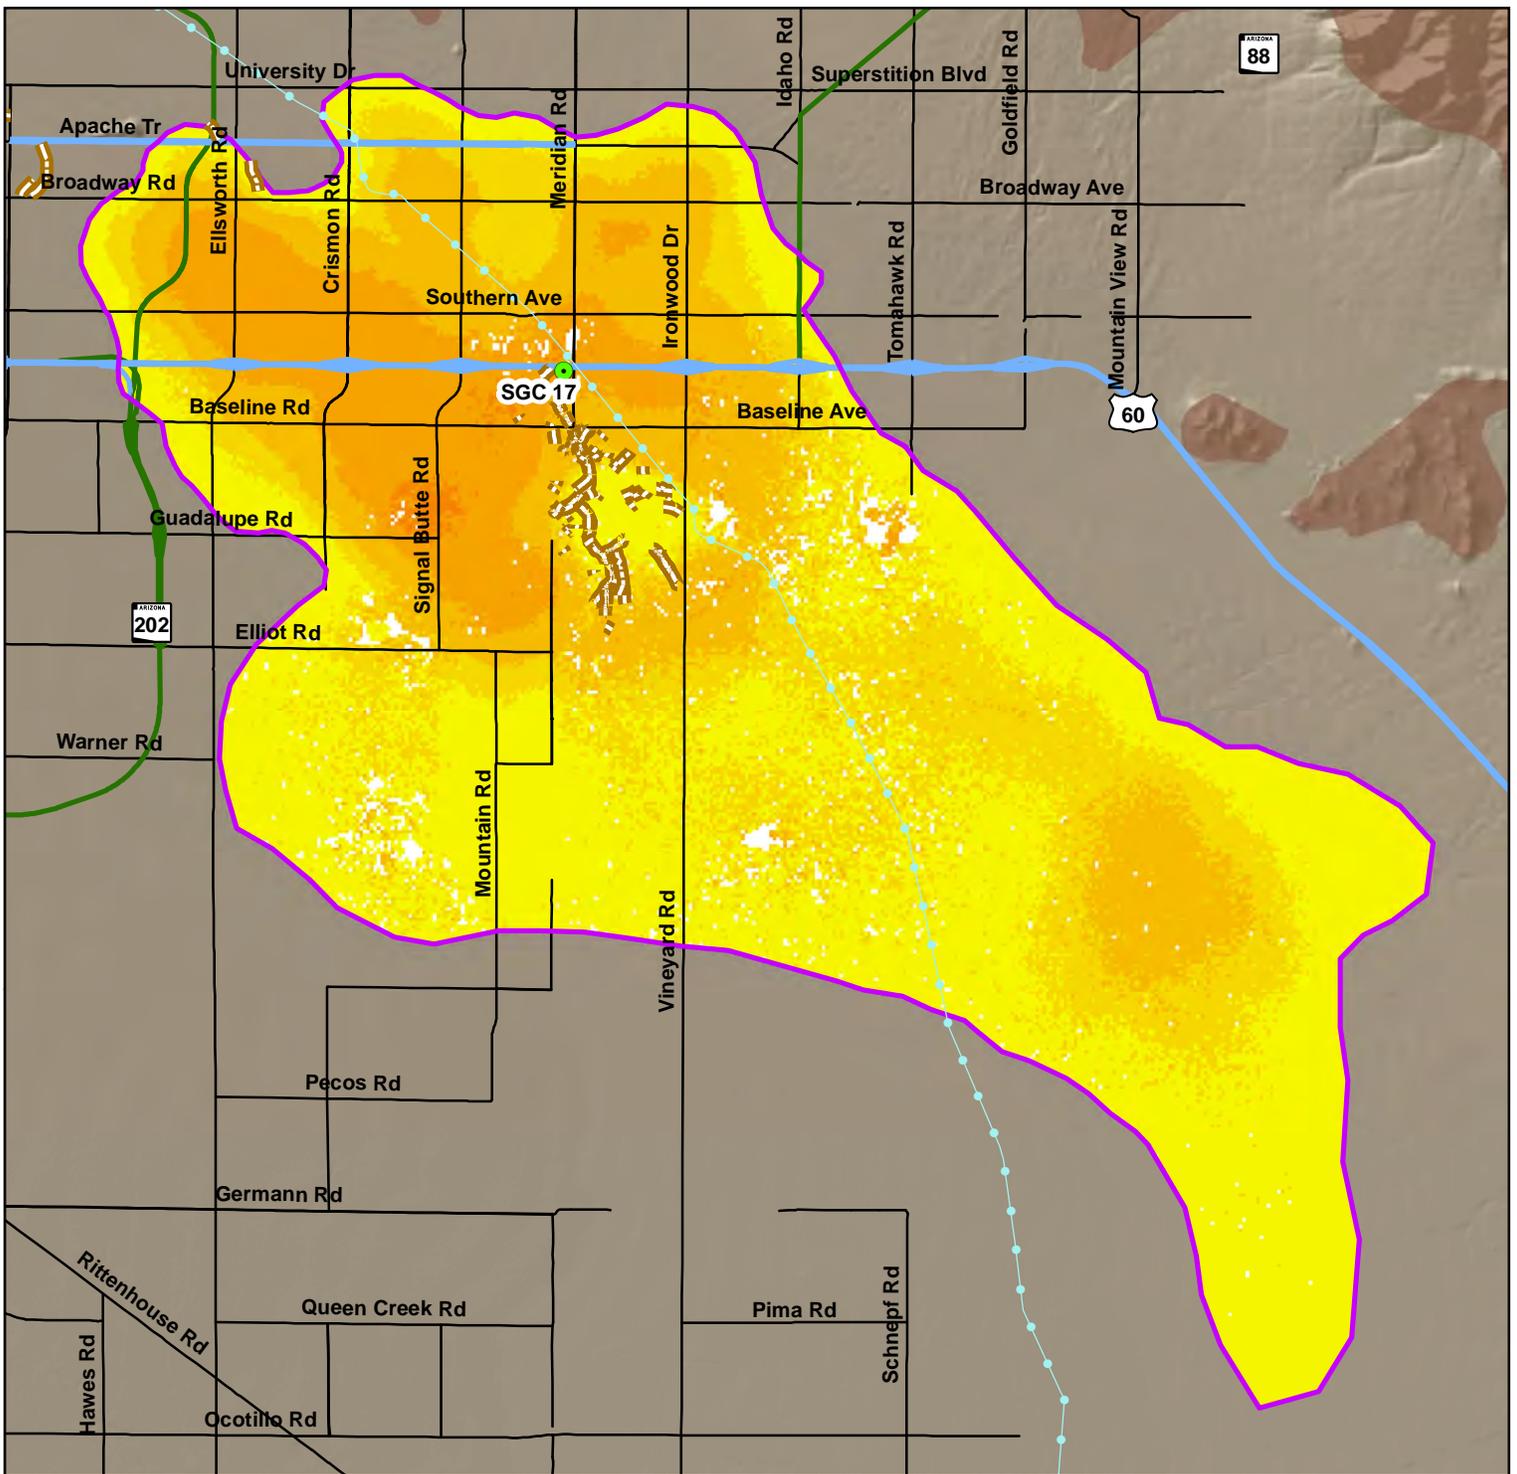
Figure 5 - Total Land Subsidence (cm) in the Hawk Rock Area of East Mesa and Apache Junction
 Based on Radarsat-2 Interferometric Synthetic Aperture Radar (InSAR) Data
 Time Period of Analysis: 3.9 Years 05/15/2010 To 03/31/2014

ADWR has conducted several GPS surveys in the Hawk Rock Area since 1997. The monument, SGC 17, was first measured in 1973. Comparing the SGC 17 elevation from 1973 and a re-surveyed elevation from 2014, SGC 17 has subsided just over 1.55 meters (5.1 feet) in over 40 years. Numerous earth fissures (Photo 9) have also been identified and mapped in the Hawk Rock area (Figure 5).

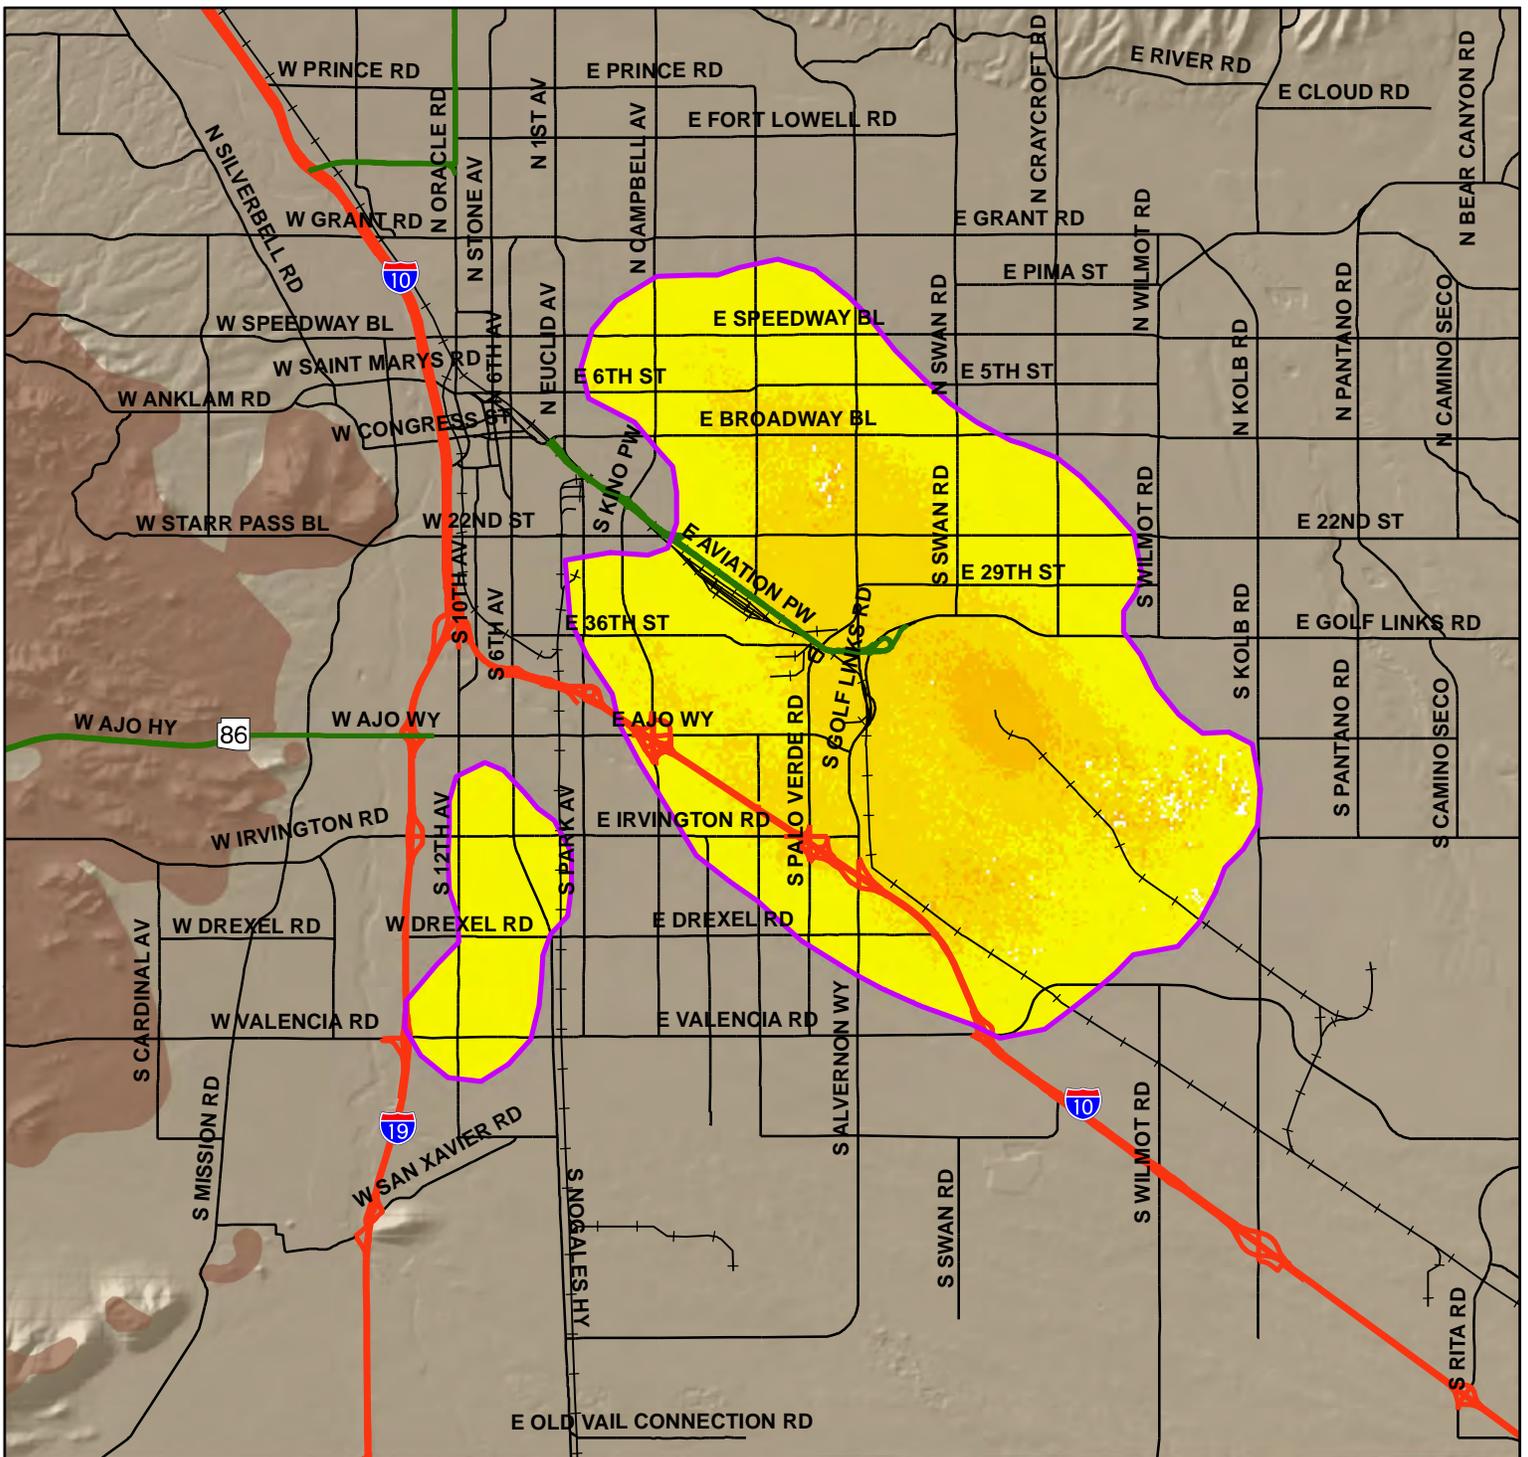
Figure 6 - Total Land Subsidence (cm) in the Tucson Metropolitan Area
 Based on Radarsat-2 Interferometric Synthetic Aperture Radar (InSAR) Data
 Time Period of Analysis: 4.0 Years 05/15/2010 To 05/18/2014

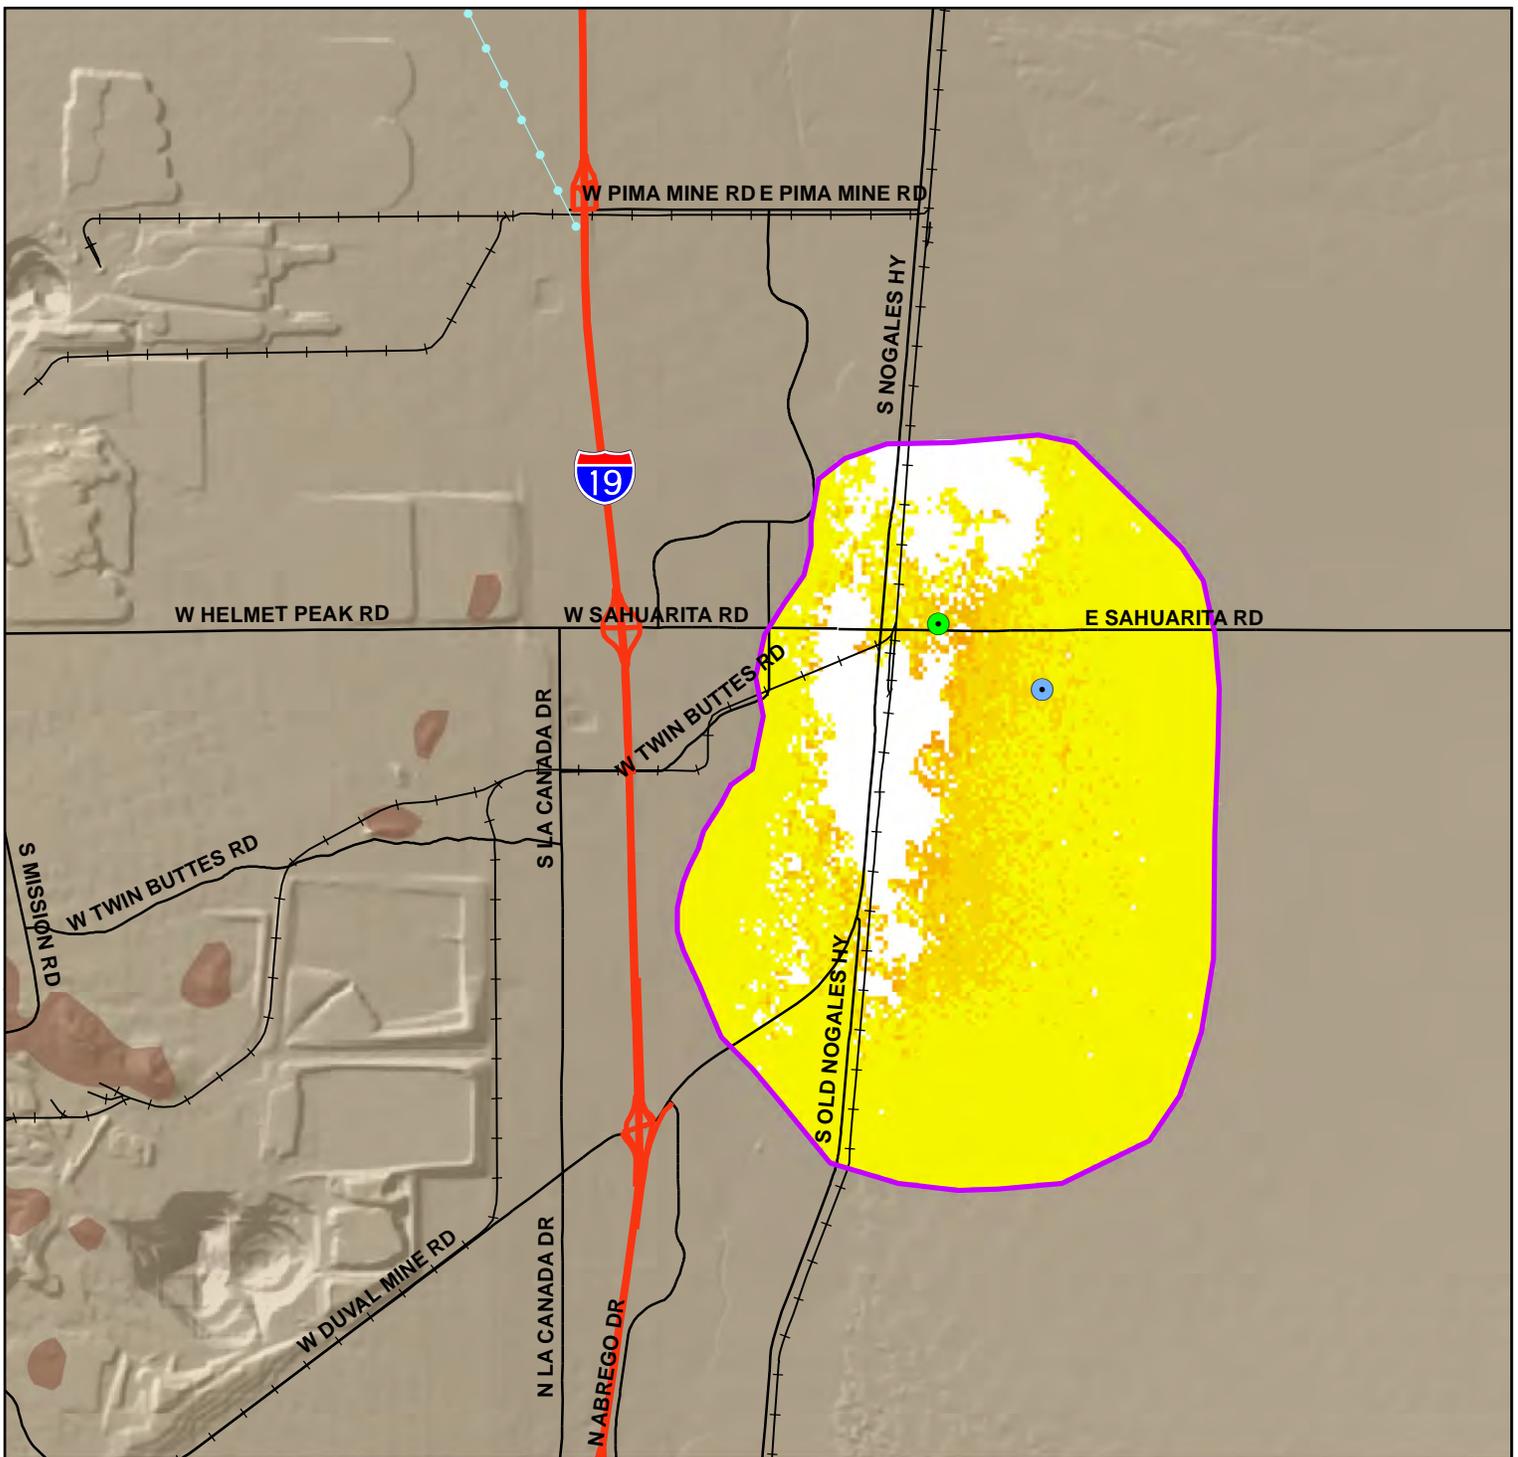
Figure 7 - Total Land Subsidence (cm) in the Sahuarita and Green Valley Areas, Pima County
 Based on Radarsat-2 Interferometric Synthetic Aperture Radar (InSAR) Data
 Time Period of Analysis: 2.2 Years 02/22/2012 To 05/18/2014
