Arizona Department of Water Resources

Land Subsidence Monitoring Report No. 2

August 2014

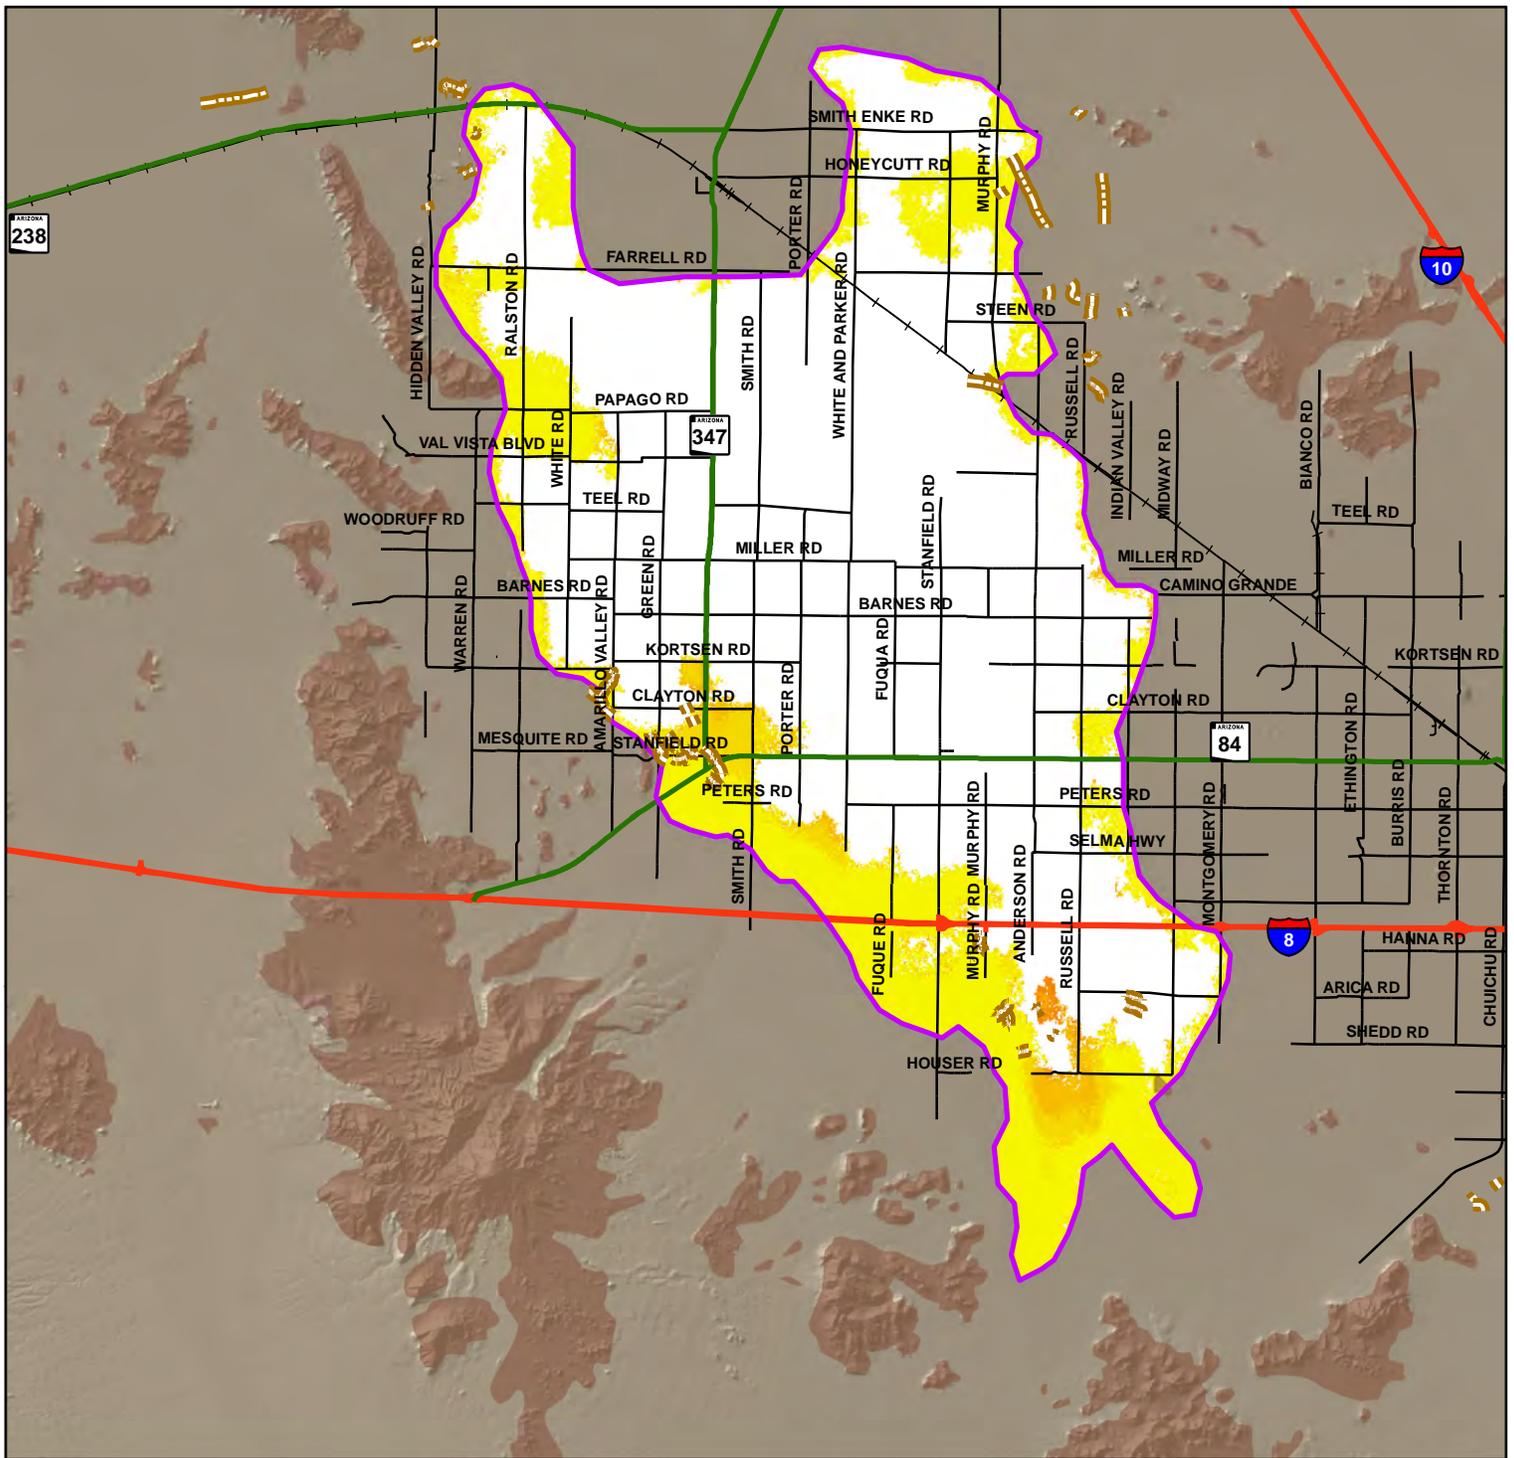
Figure 8 -Total Land Subsidence (cm) in the Maricopa-Stanfield Sub-Basin, Pinal County
 Based on Radarsat-2 Interferometric Synthetic Aperture Radar (InSAR) Data
 Time Period of Analysis: 4.0 Years 05/08/2010 To 04/17/2014

By cooperating with other federal, state, county, and local agencies and water companies, ADWR was able to greatly expand its data collection efforts to cover the entire State. The additional InSAR data provided ADWR the necessary resources to identify a dynamic land subsidence feature south of Tucson called the Green Valley (Figure 7) land subsidence feature that has seasonal uplift and land subsidence. InSAR data for the Pinal Active Management Area confirmed two well-documented land subsidence areas known as the Maricopa-Stanfield (Figure 8) and the Picacho-Eloy (Figure 9) land subsidence features.

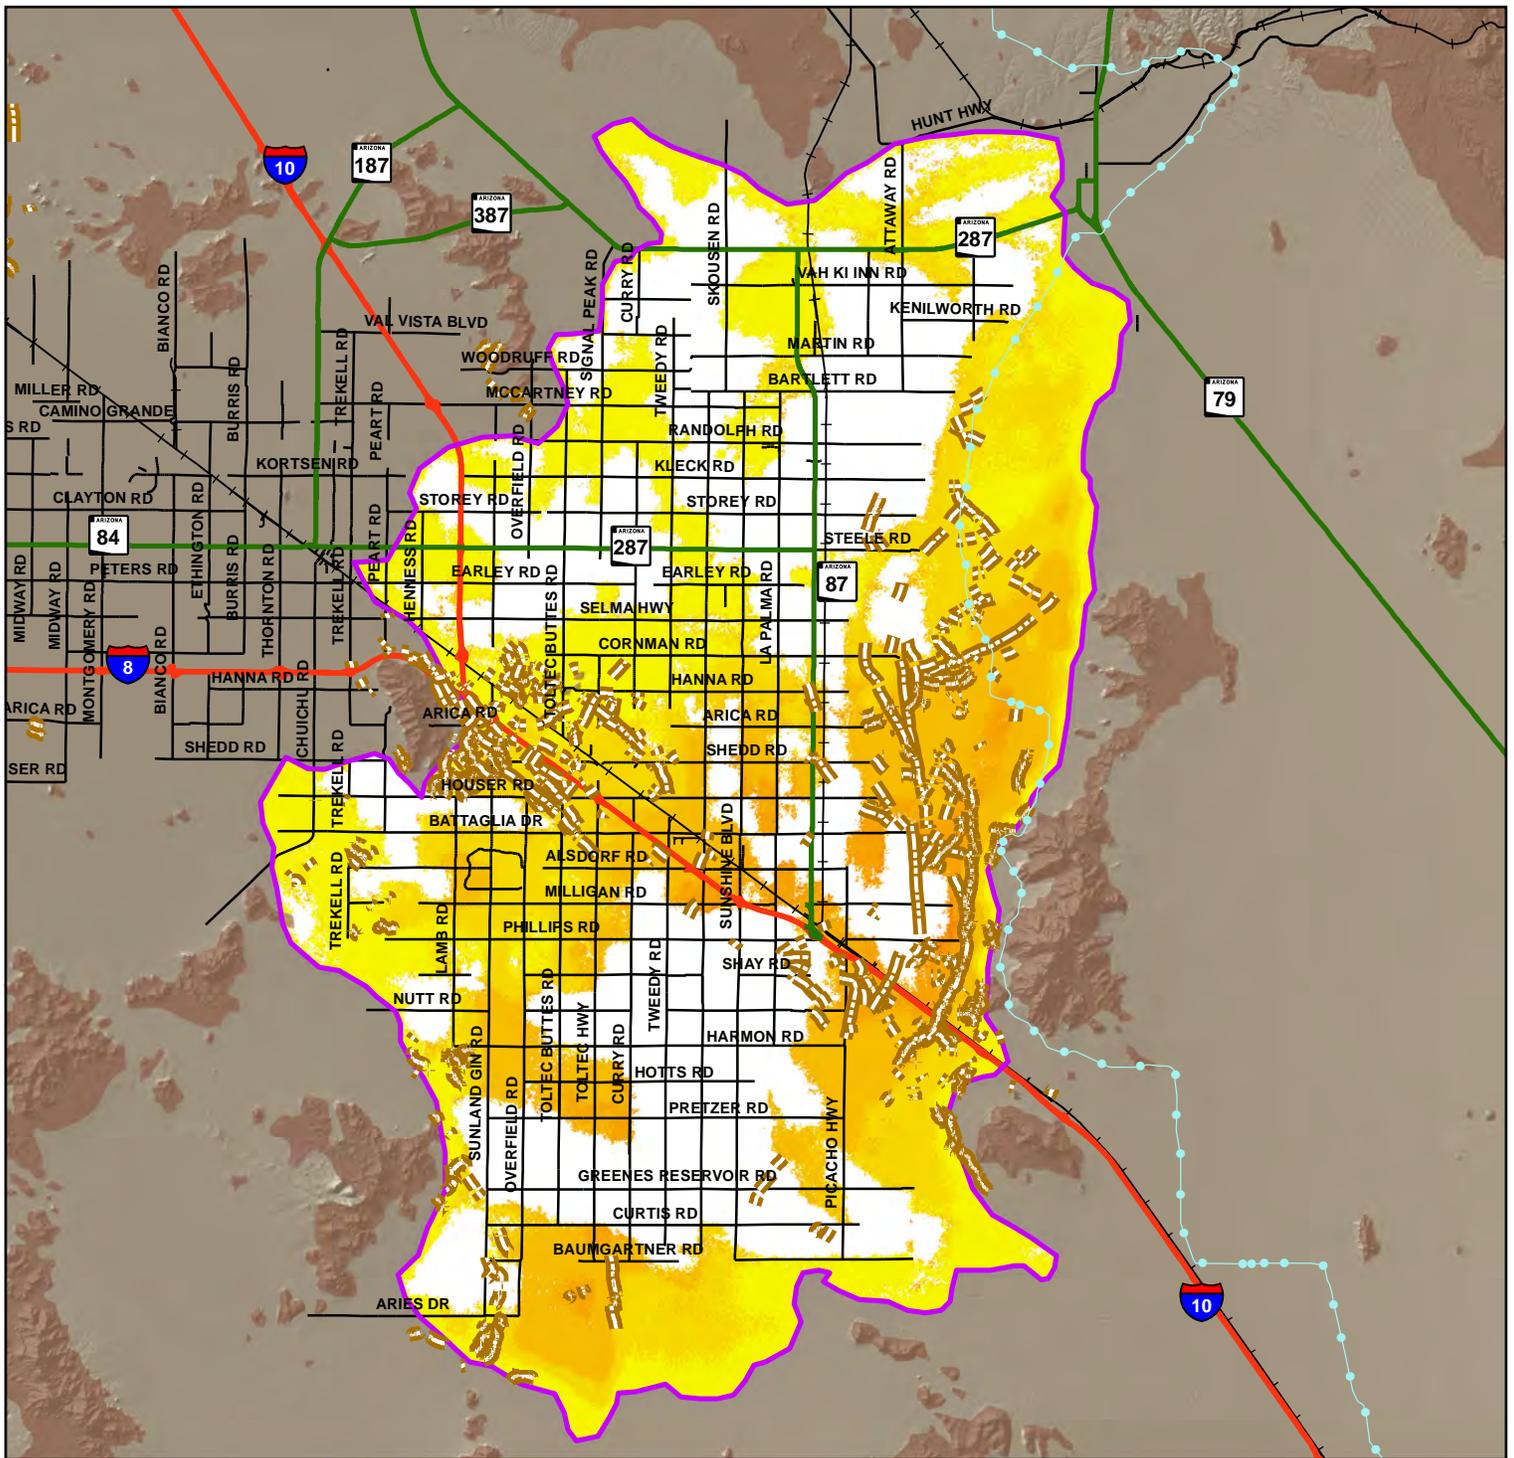
Figure 9 - Total Land Subsidence (cm) in the Picacho Sub-Basin, Pinal County Based on Radarsat-2 Interferometric Synthetic Aperture Radar (InSAR) Data
Time Period of Analysis: 3.9 Years 05/15/2010 To 03/31/2014

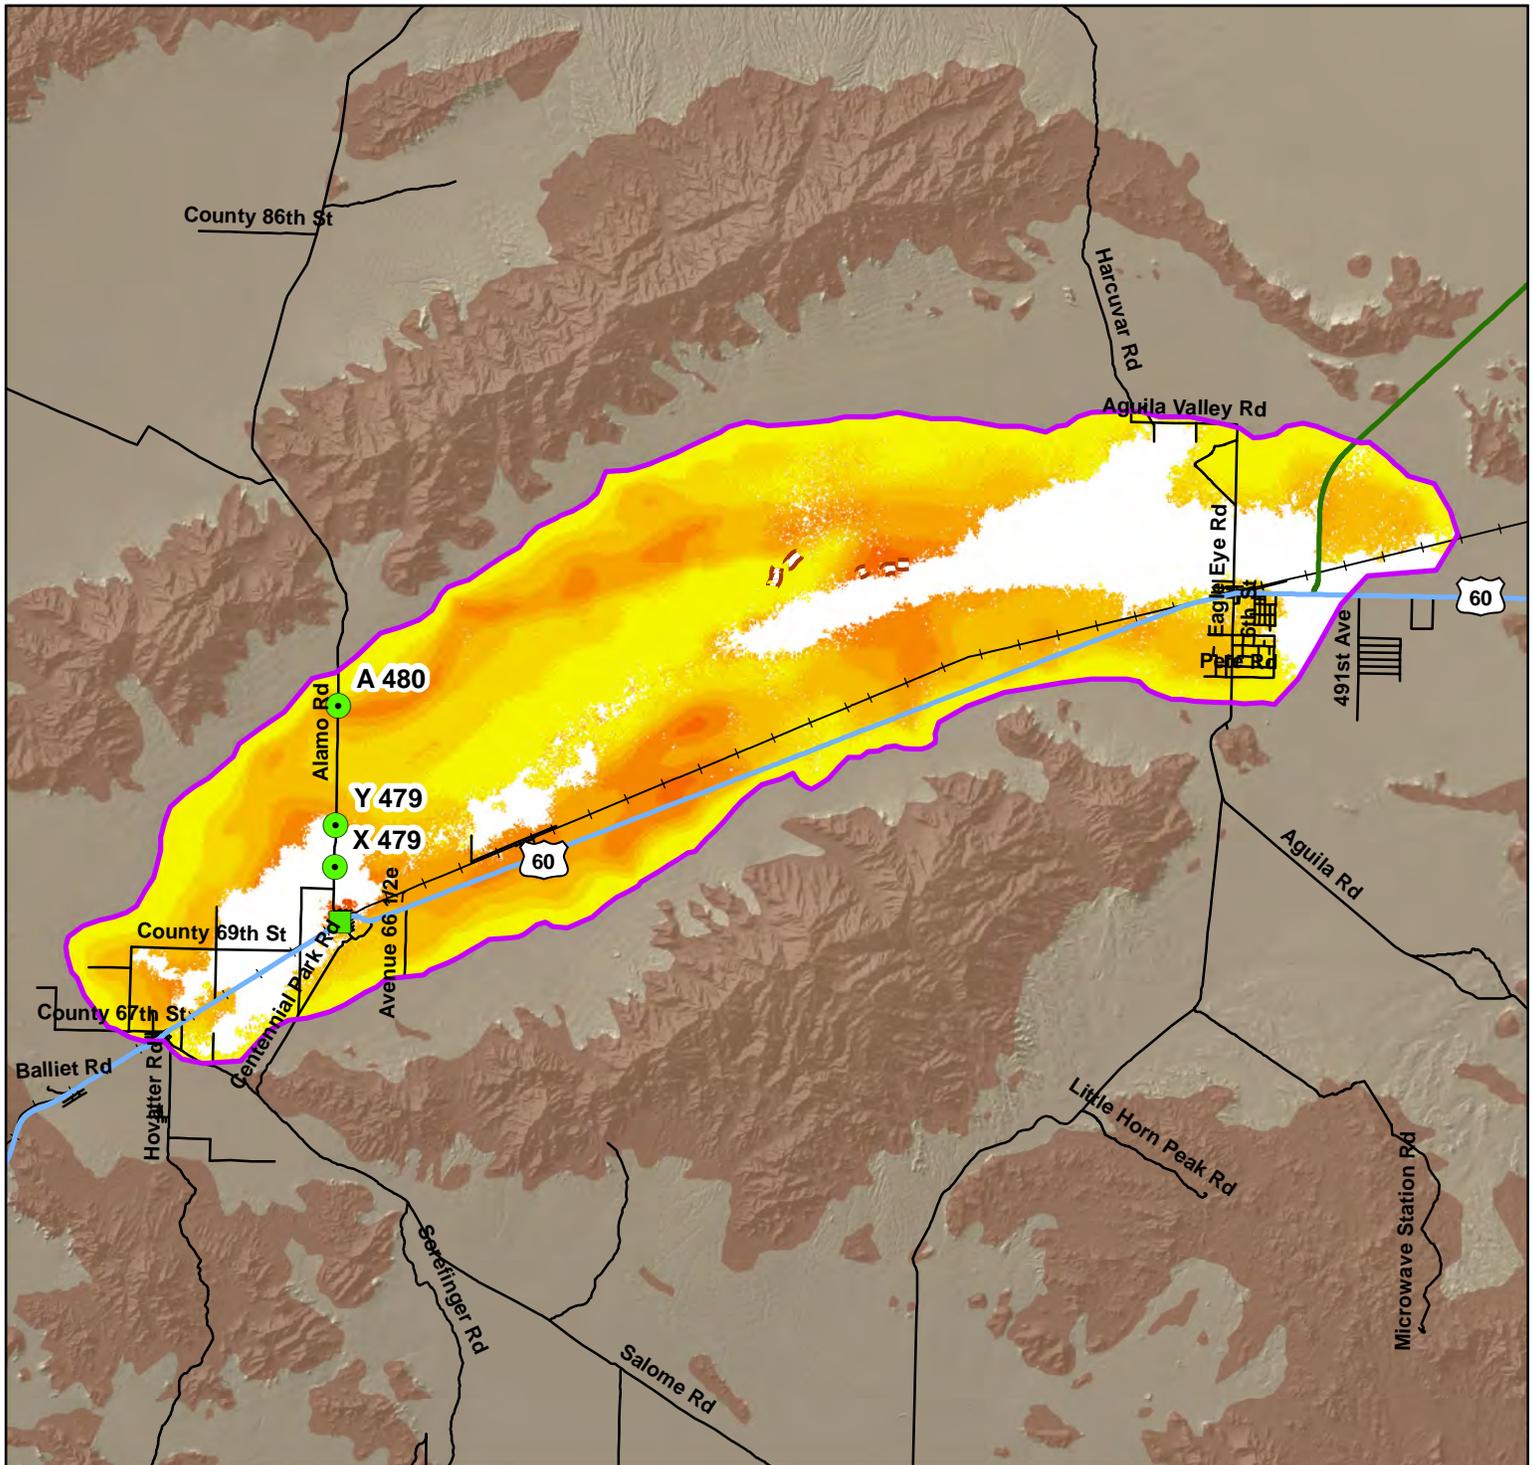
Figure 10 - Total Land Subsidence in the McMullen Valley, Maricopa and La Paz Counties
 Based on Radarsat-2 Interferometric Synthetic Aperture Radar (InSAR) Data
 Time Period of Analysis: 3.9 Years: 05/01/2010 To 03/17/2014

Comparing recent ADWR GPS survey data collected during February 2013 and March 2014 at monument X 479, demonstrates that there was 6.4 centimeters (2.5 inches) of land subsidence. ADWR will continue to survey all three survey monuments for monitoring land subsidence in the McMullen Valley (Figure 10).

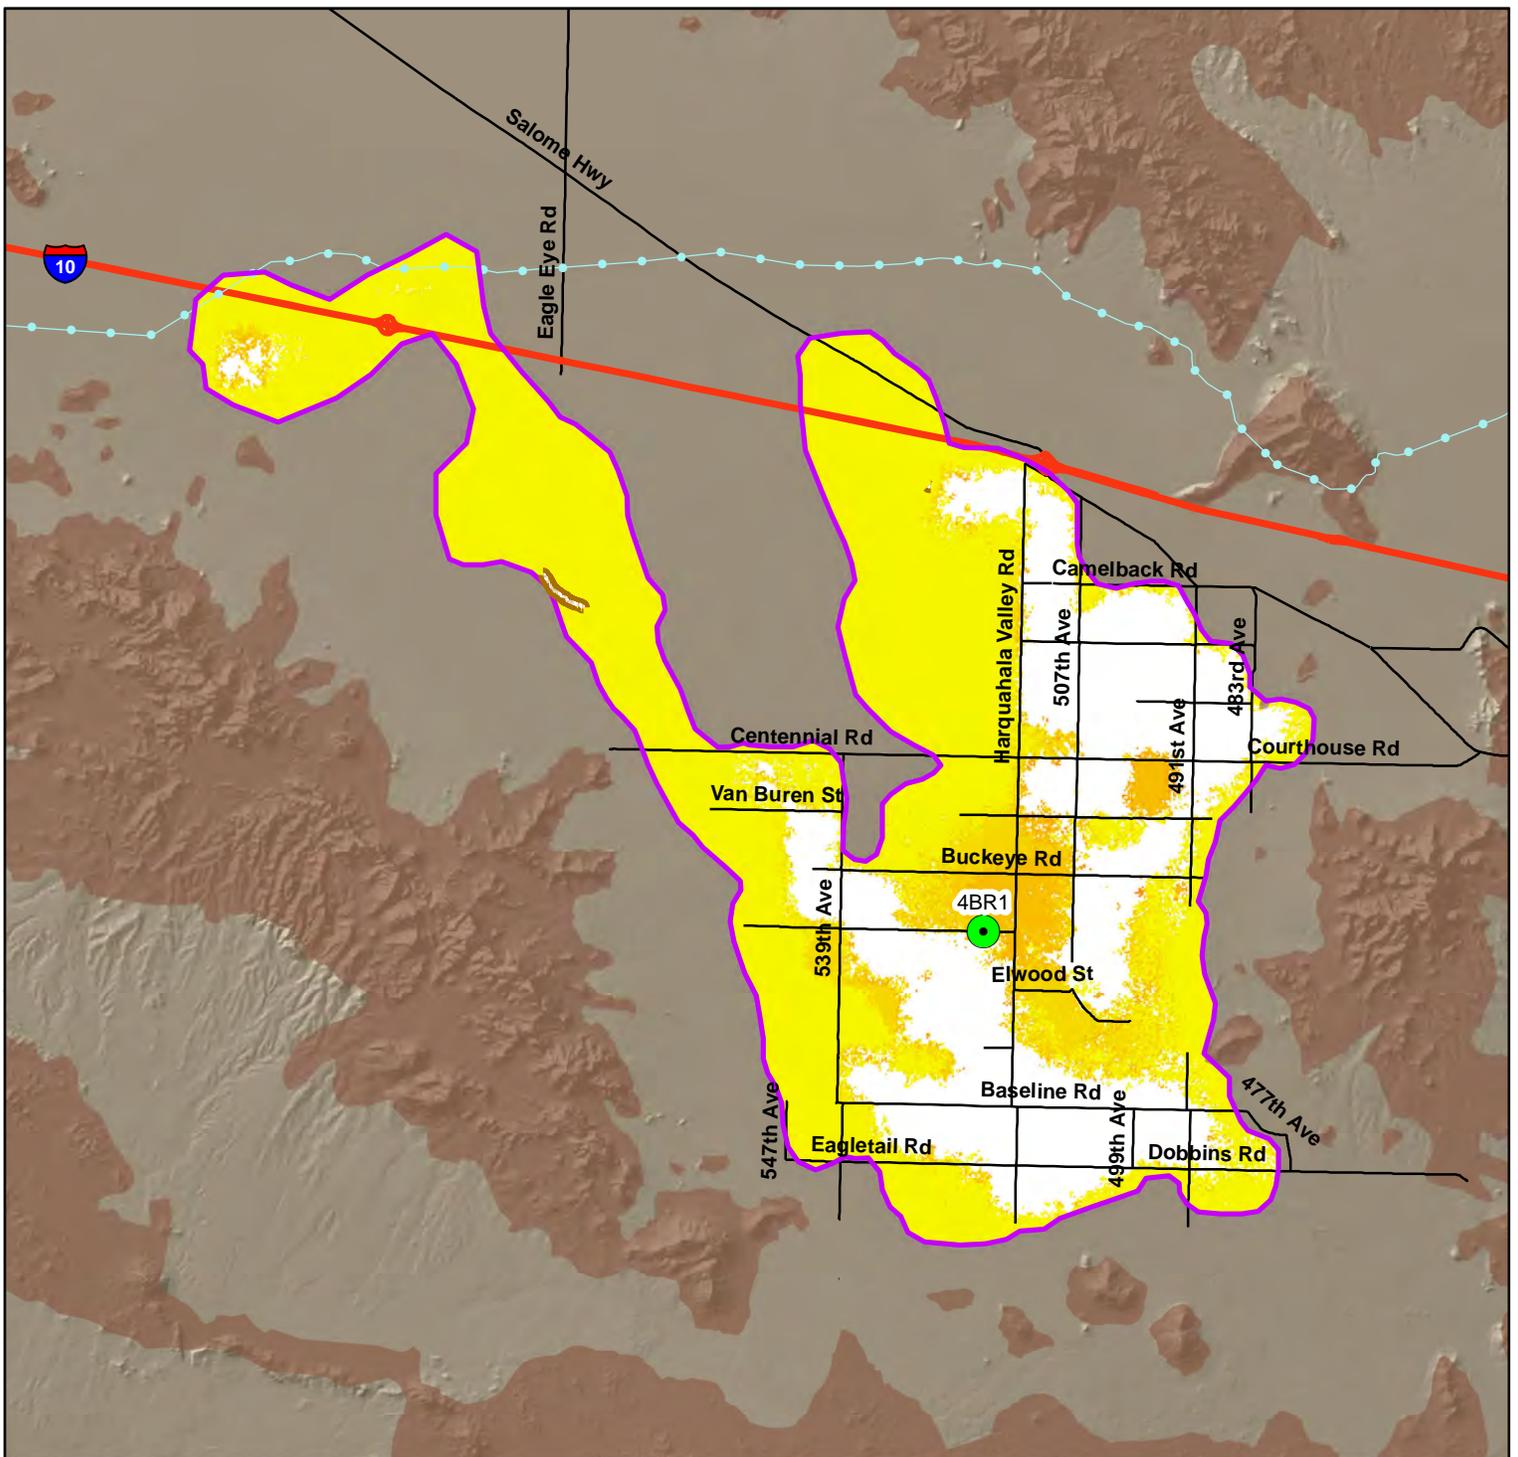
Figure 11 - Total Land Subsidence (cm) in the Harquahala Valley, Maricopa County
 Based on Radarsat-2 Interferometric Synthetic Aperture Radar (InSAR) Data
 Time Period of Analysis: 3.9 Years 05/01/2010 To 03/17/2014

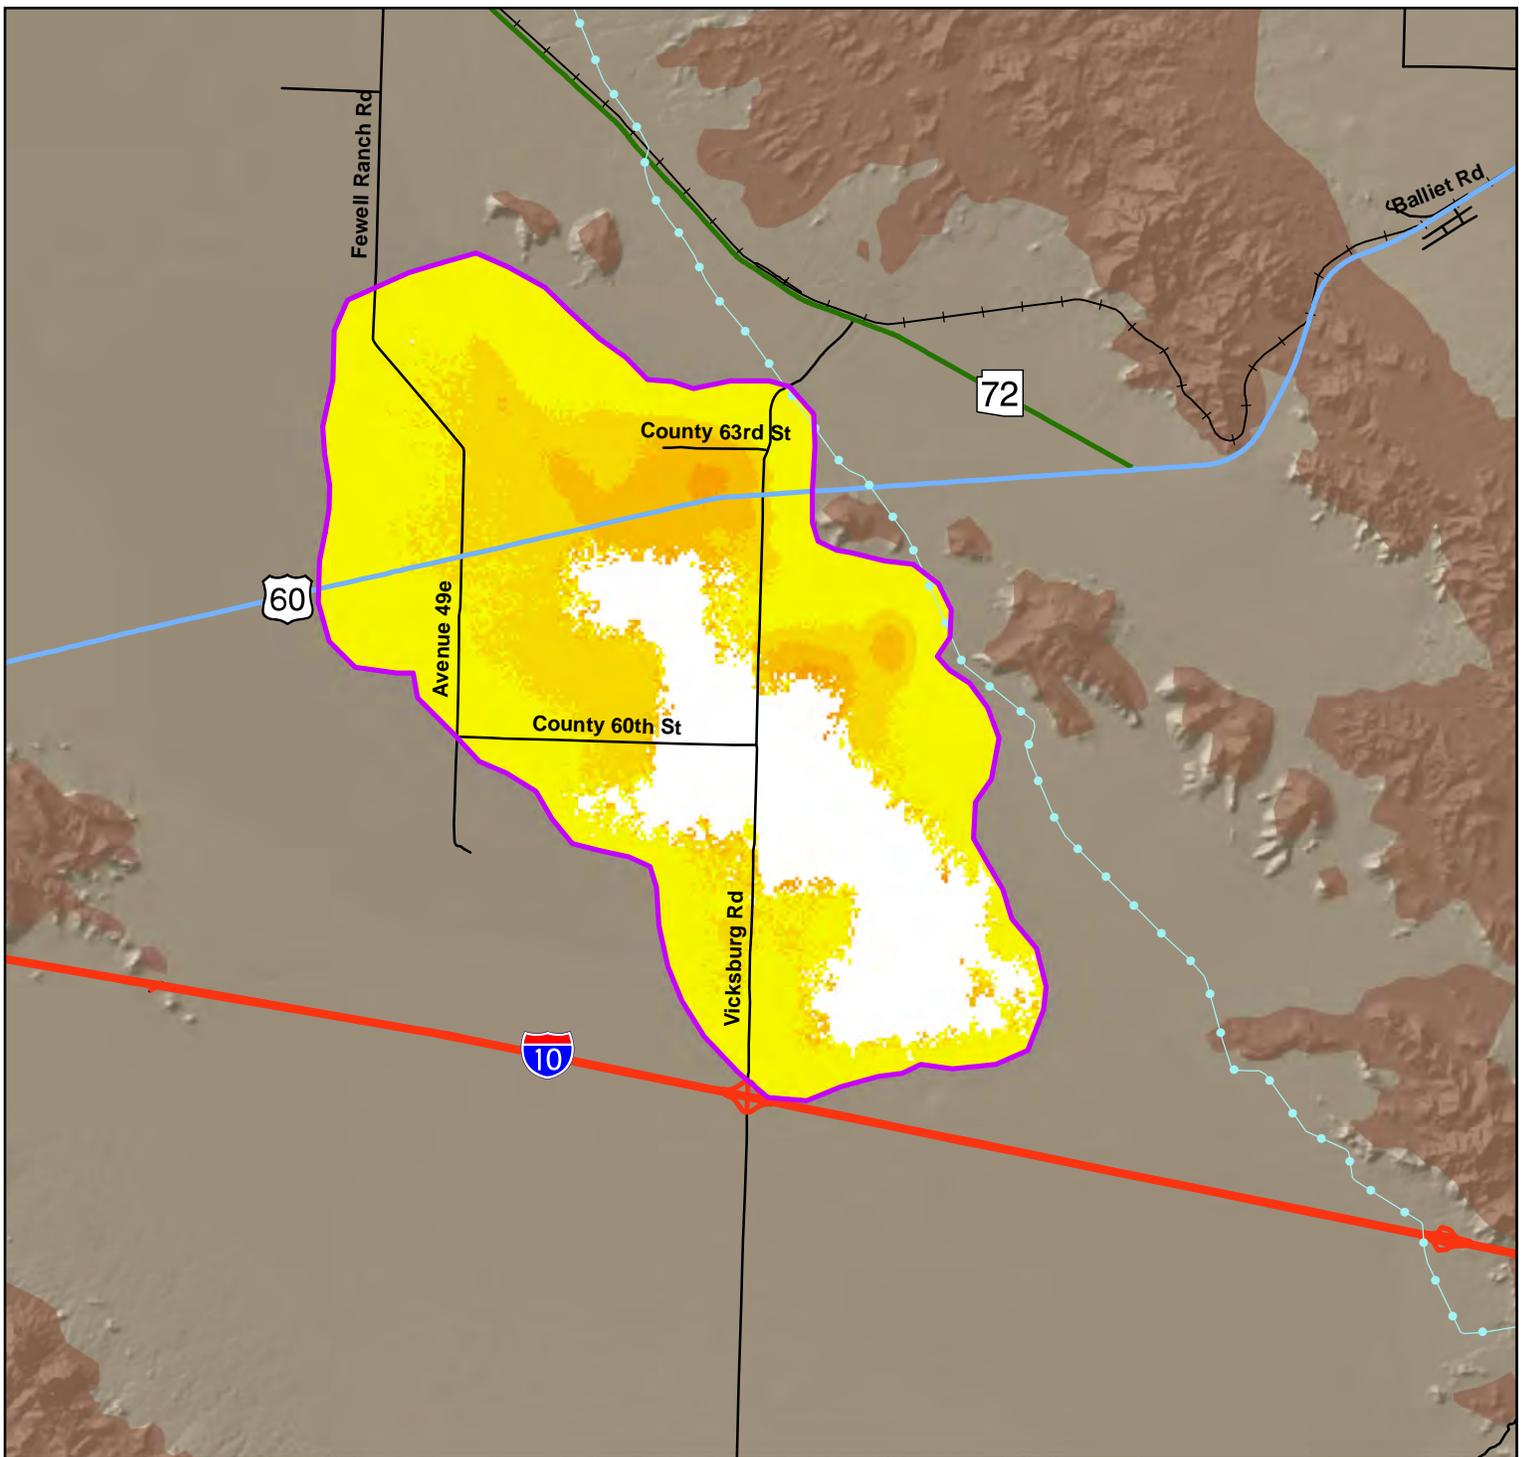
Figure 12 - Total Land Subsidence (cm) in the Ranegras Valley, La Paz County
 Based on Radarsat-2 Interferometric Synthetic Aperture Radar (InSAR) Data
 Time Period of Analysis: 3.9 Years 05/01/2010 To 03/17/2014

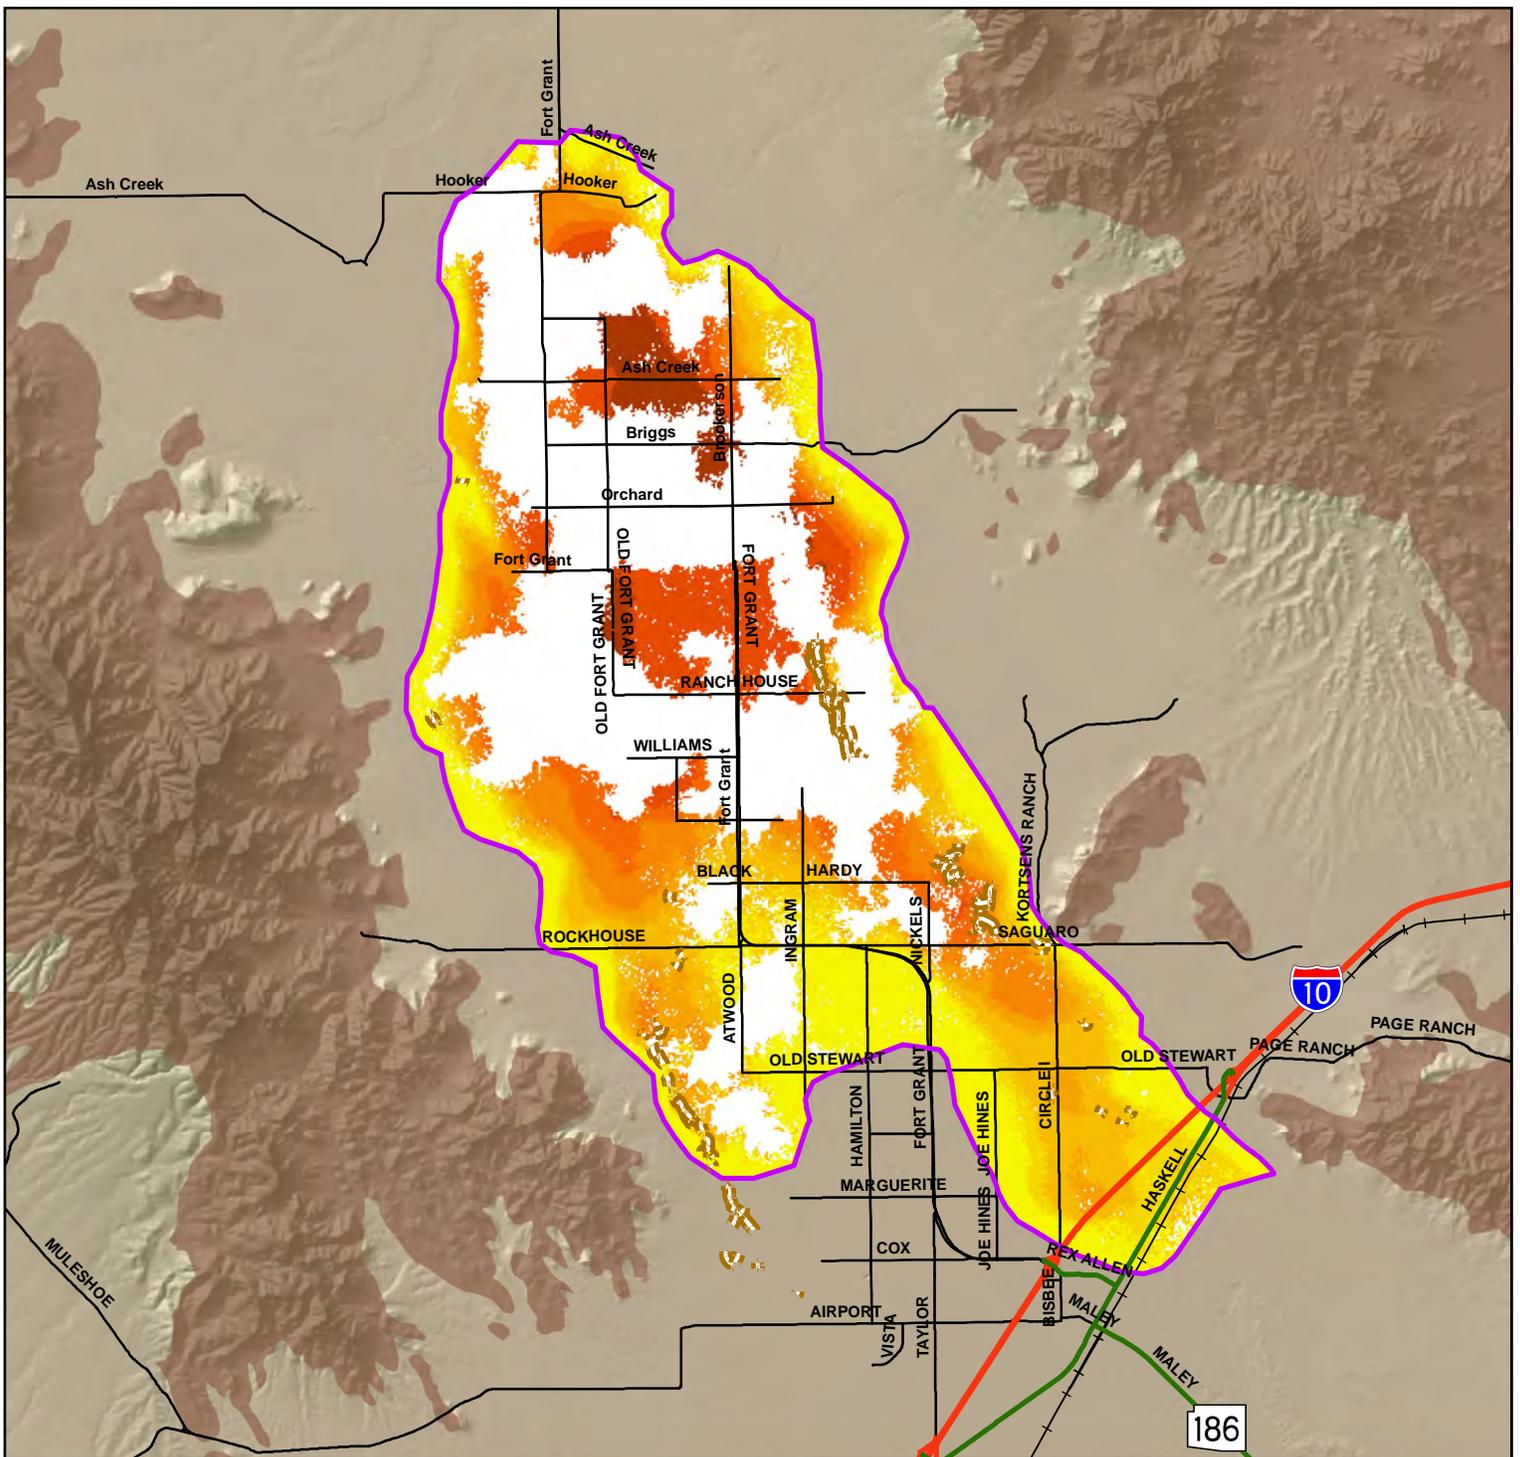
Figure 13 - Total Land Subsidence (cm) in the Fort Grant Road and Willcox Areas, Cochise County
Based on Radarsat-2 Interferometric Synthetic Aperture Radar (InSAR) Data

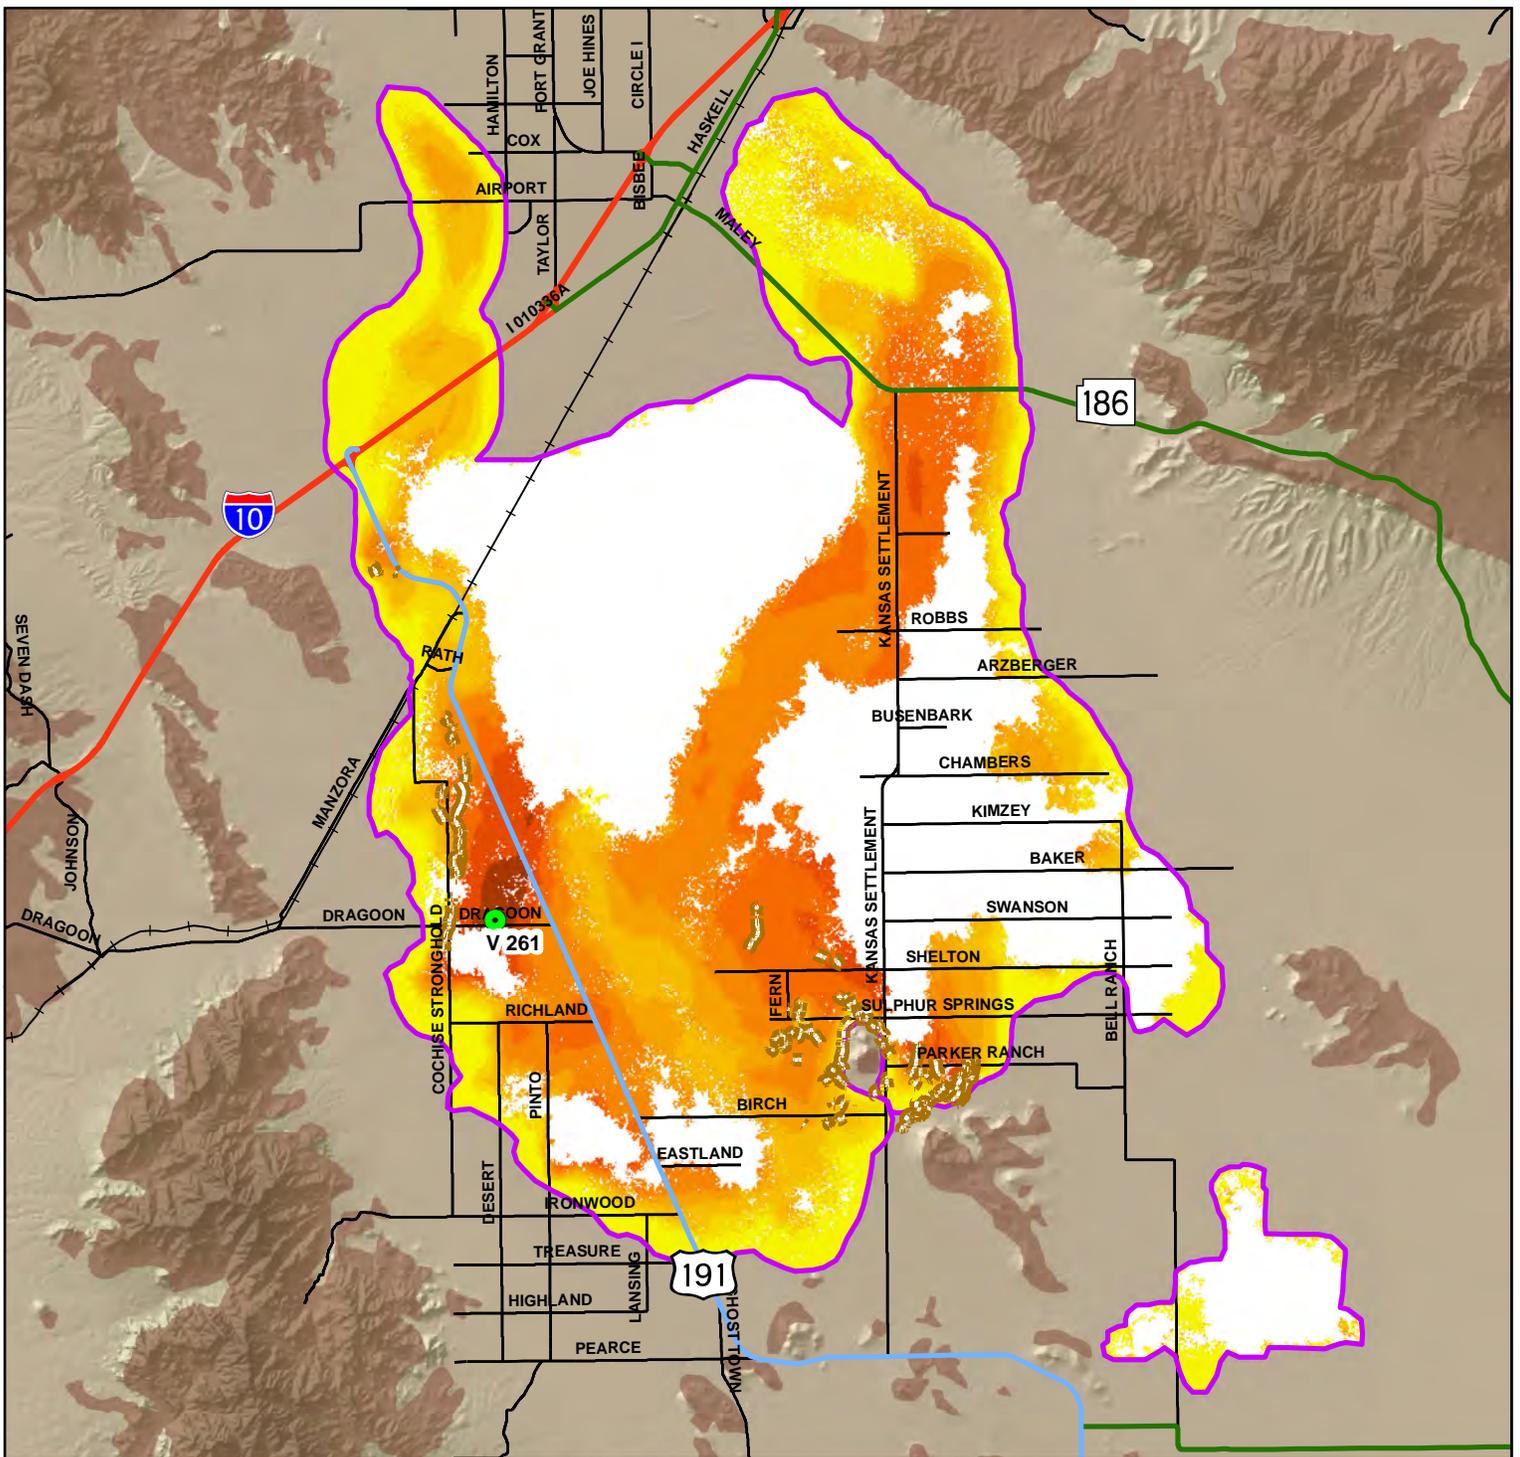
Figure 14 - Total Land Subsidence (cm) in the Willcox and Kansas Settlement Areas, Cochise County © MDA 2010 - 2014
 Based on Radarsat-2 Interferometric Synthetic Aperture Radar (InSAR) Data
 Time Period of Analysis: 3.9 Years 05/20/2010 To 03/21/2014

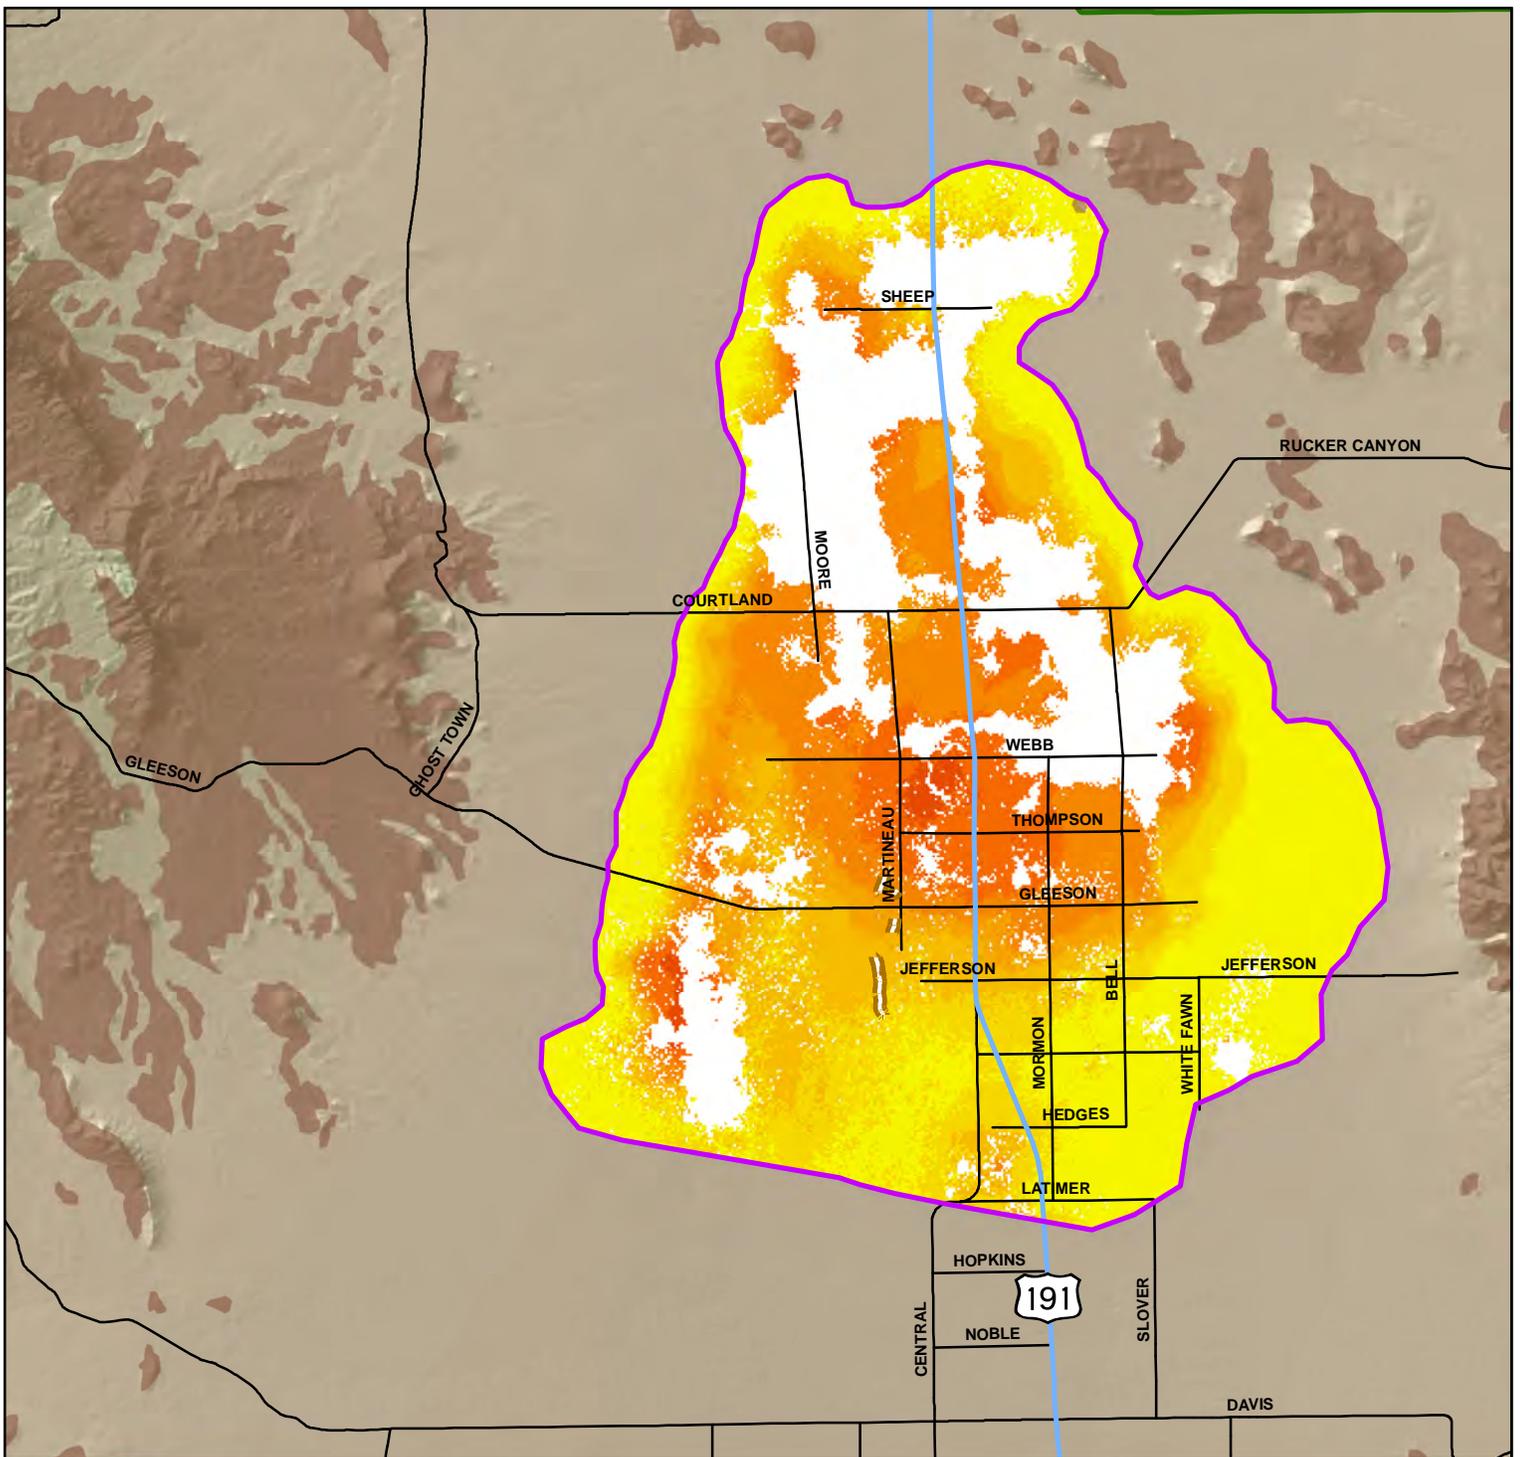
Figure 15 - Total Land Subsidence (cm) in the Elfrida Area, Cochise County
 Based on Radarsat-2 Interferometric Synthetic Aperture Radar (InSAR) Data
 Time Period of Analysis: 3.9 Years 05/05/2010 To 03/21/2014

Decorrelation (white areas) are areas where the phase of the received satellite signal changed between satellite passes, causing the data to be unusable. This occurs in areas where the land surface has been disturbed (i.e. bodies of water, snow, agriculture areas, areas of development, etc).

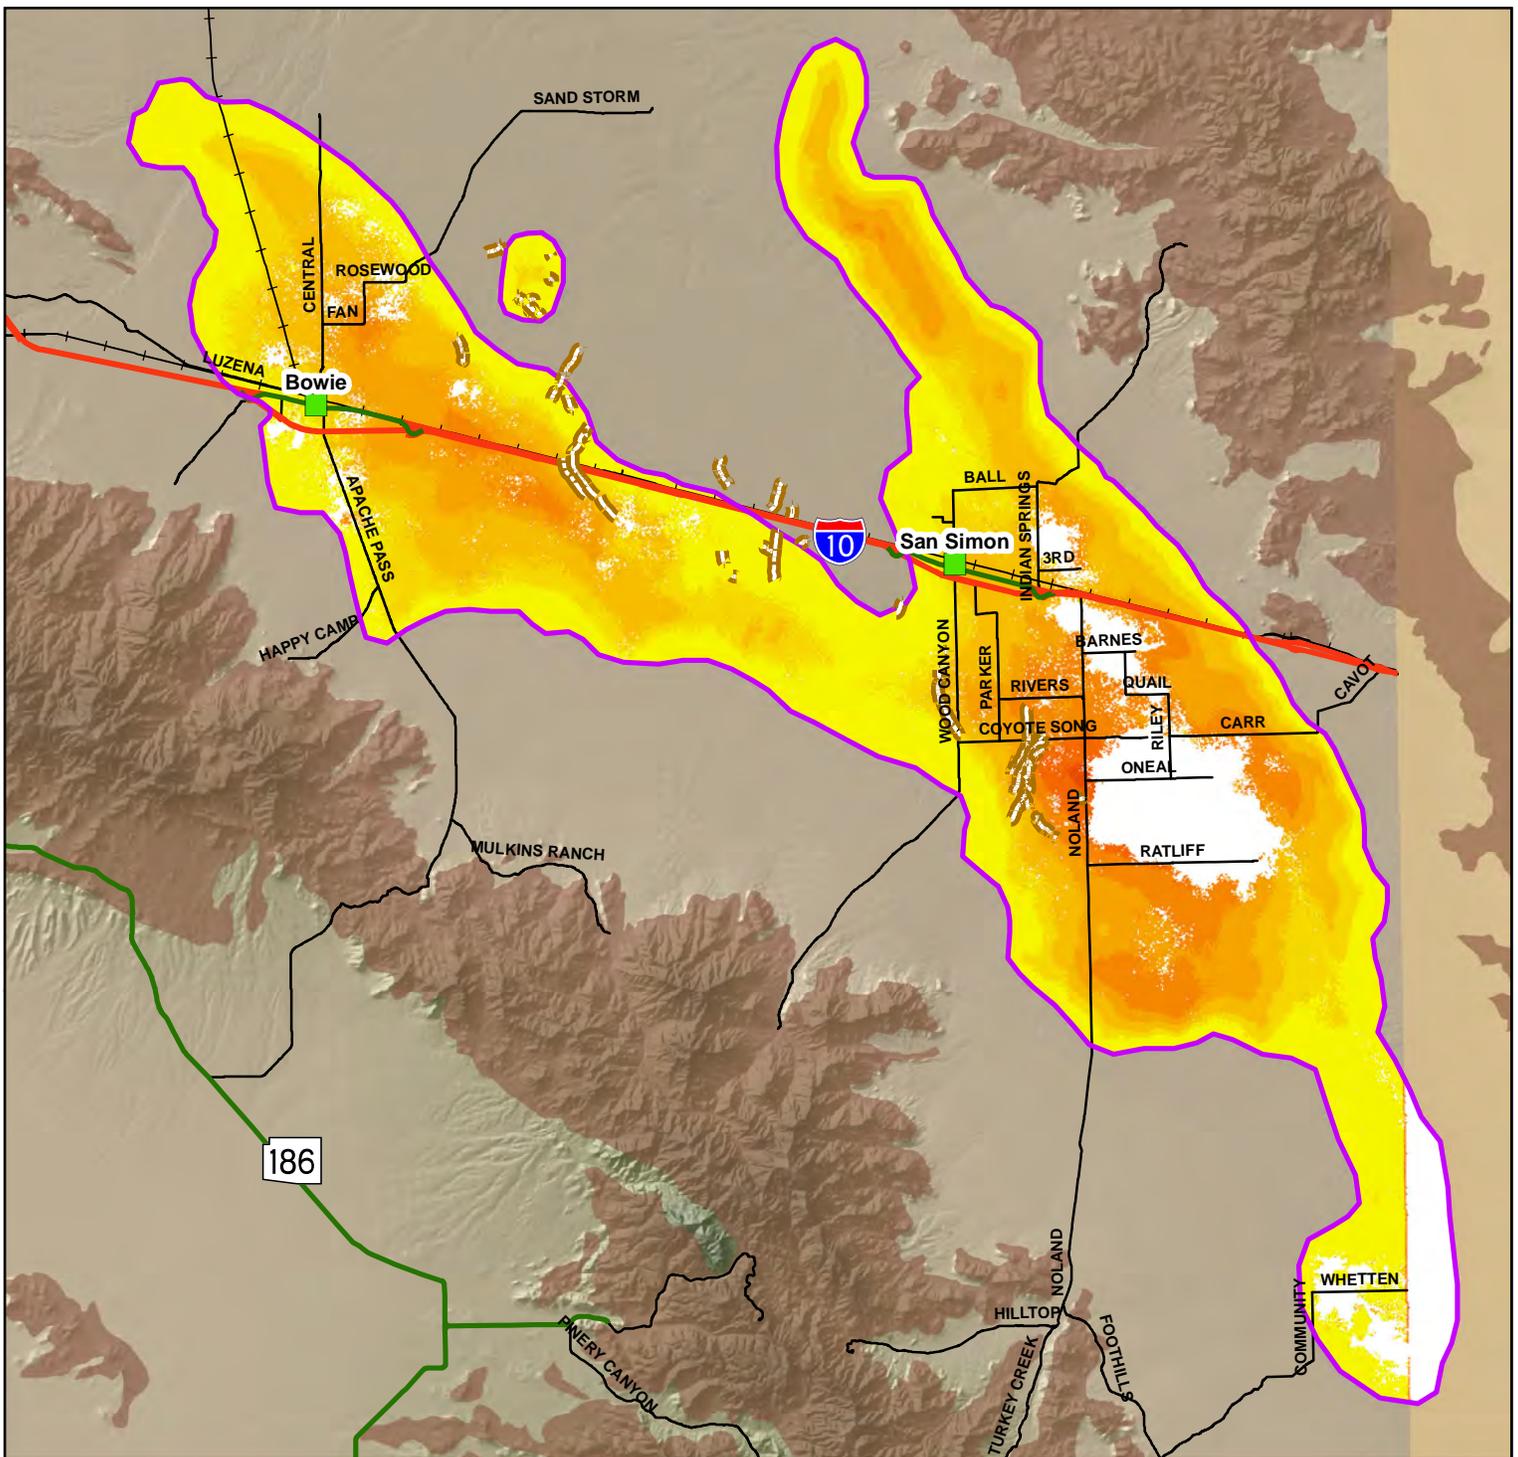
Figure 16 - Total Land Subsidence (cm) in the Bowie and San Simon Areas, Cochise County
 Based on Radarsat-2 Interferometric Synthetic Aperture Radar (InSAR) Data
 Time Period of Analysis: 3.9 Years 05/05/2010 To 03/21/2014

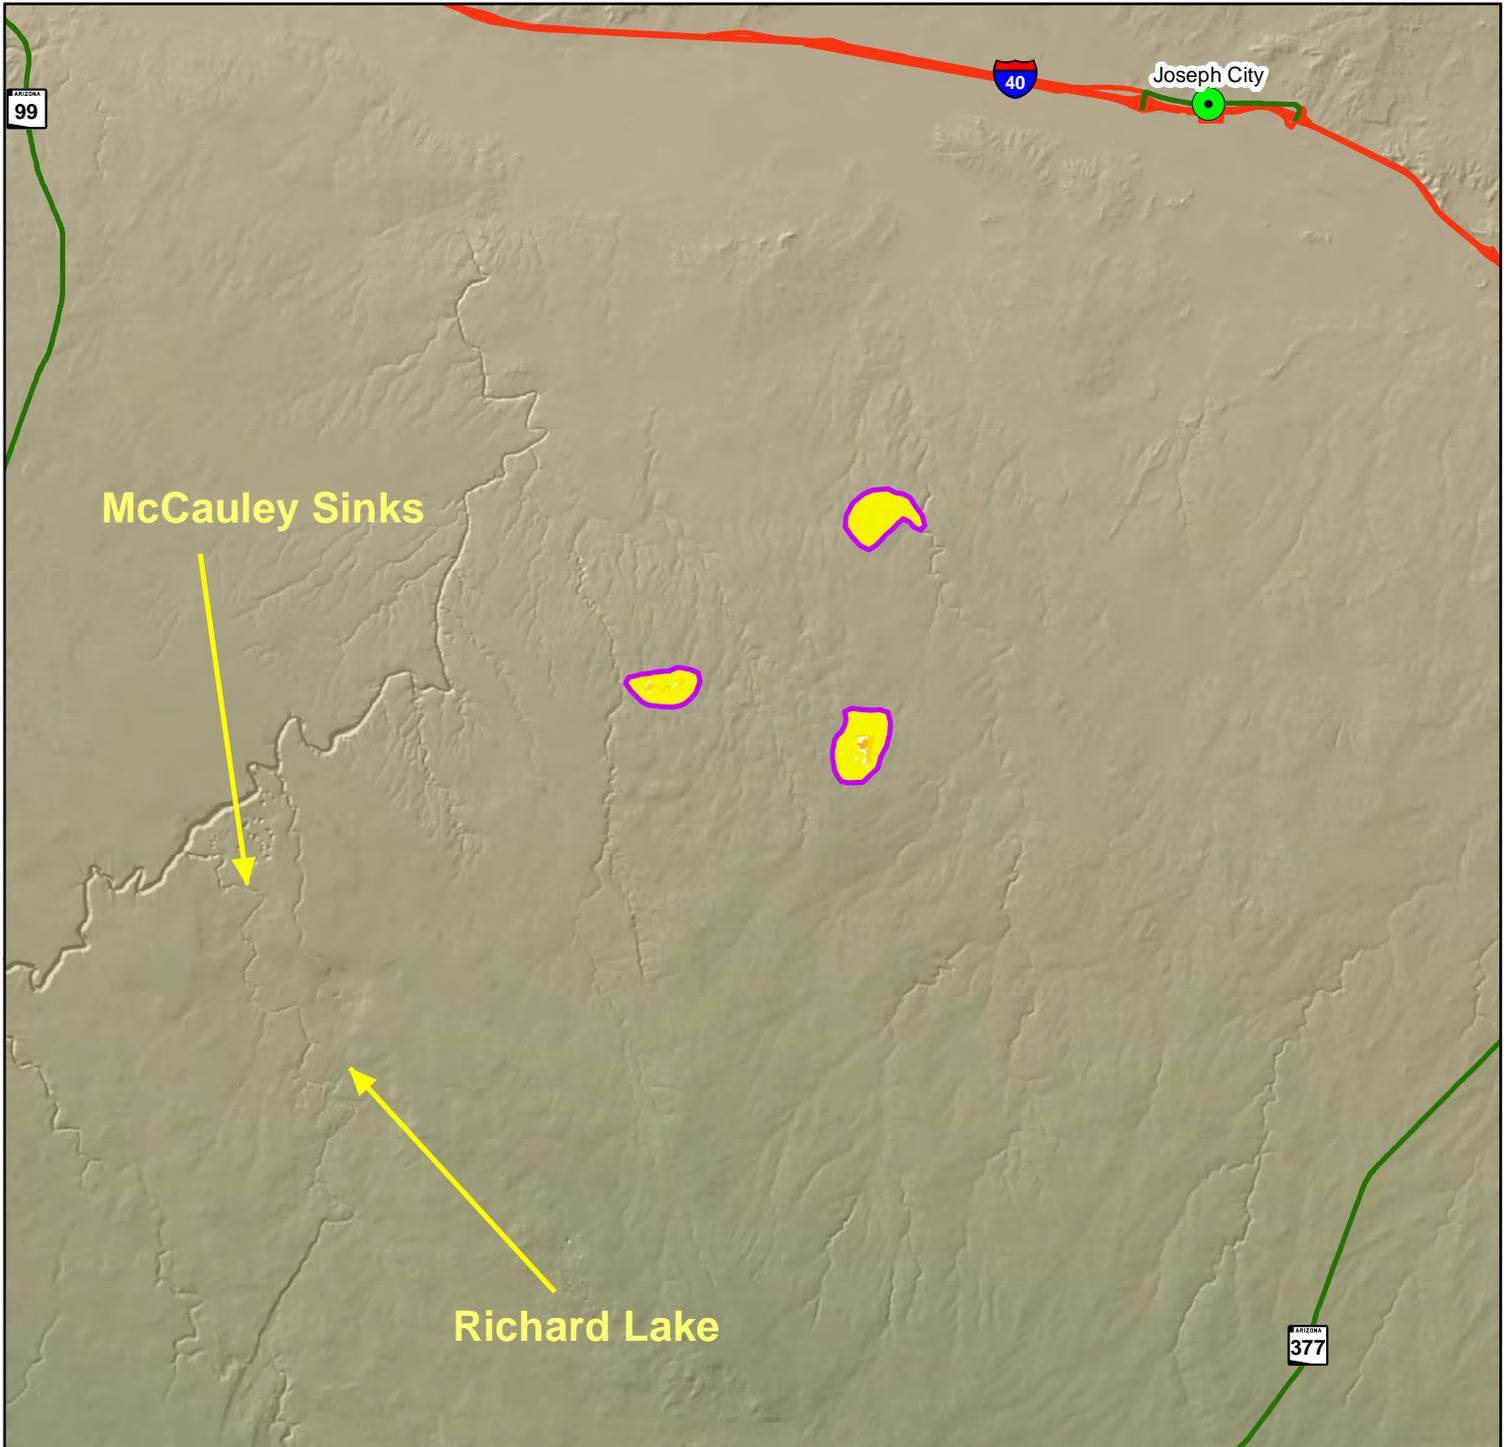
Figure 17 -- Total Land Subsidence (cm) in the Holbrook Basin, Navajo County
 Based on Radarsat-2 Interferometric Synthetic Aperture Radar (InSAR) Data
 Time Period of Analysis: 1.6 Years 10/16/2012 To 05/15/2014

InSAR data for the Holbrook Basin helped ADWR identify three land subsidence features in Navajo County. These features are known as the Holbrook Basin (Figure 17) land subsidence features and appear to be related to naturally occurring sinks and dissolution features. InSAR data is also being collected to establish a baseline for any existing land subsidence around the Petrified Forest National Park before planned underground potash mining activity begins in the area.
