Arizona Department of Water Resources

Land Subsidence Monitoring Report No. 2

August 2014

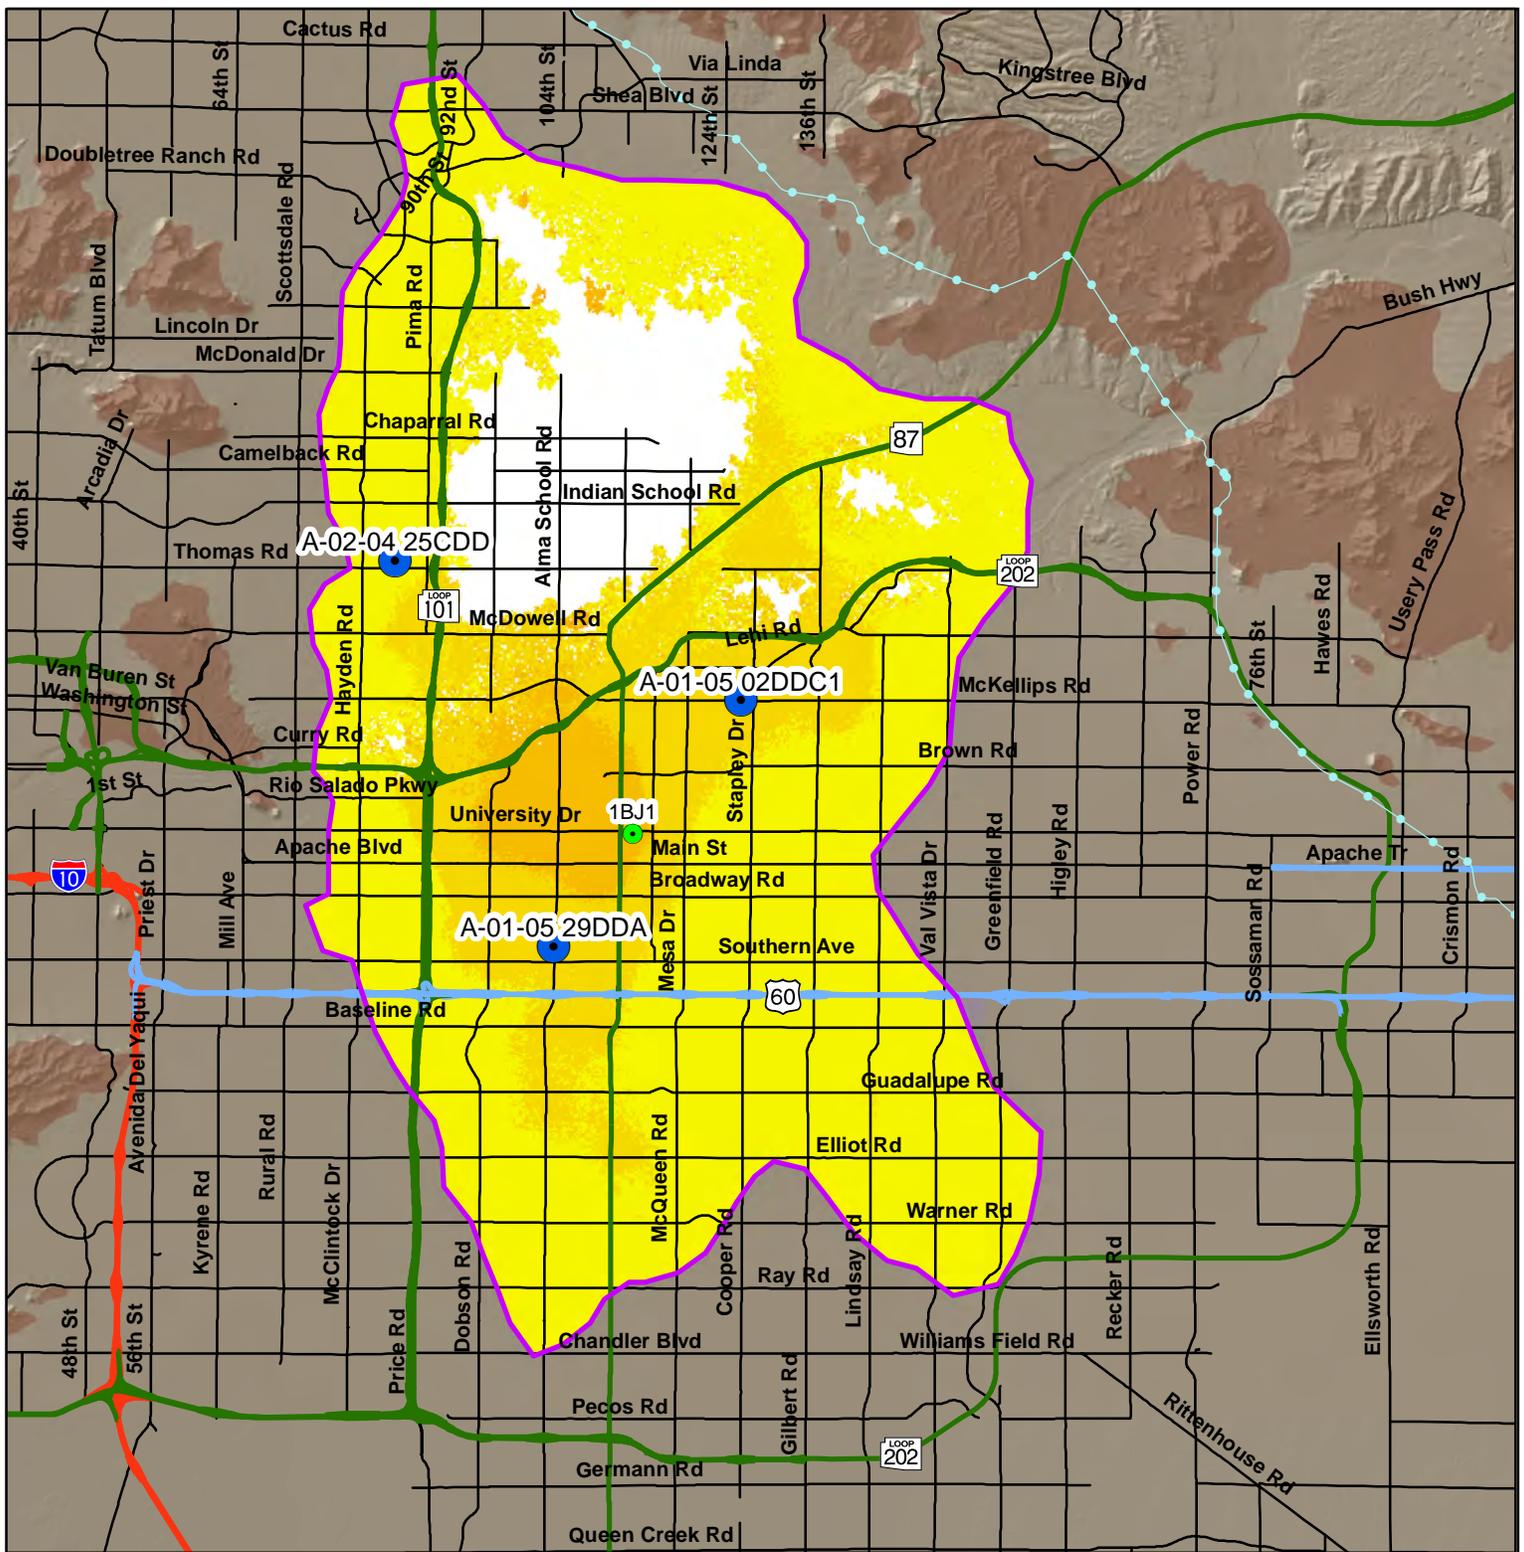
Figure 18 -- Total Land Subsidence (cm) in the Eastern Metropolitan Phoenix Area
 Based on Radarsat-2 Interferometric Synthetic Aperture Radar (InSAR) Data
 Time Period of Analysis: 2.5 Years 11/11/2011 To 04/17/2014

The most recent land subsidence feature identified with ADWR InSAR data is located in the eastern Metropolitan Phoenix area and is known as the East Valley Feature (Figure 18). This feature began to show deformation in late 2011. A review of ADWR automated groundwater monitoring site (transducers) hydrographs (Figure 19) in the area indicate that the land subsidence is a result of groundwater level declines due to increased groundwater pumping.

ADWR first detected new land subsidence in Eastern Metropolitan Phoenix, which includes portions of the Cities of Mesa, Chandler, and Scottsdale, in 2012 (Figure 18). After the land subsidence feature was detected in 2012, ADWR recovered a Maricopa County Department of Transportation survey monument, 1BJ1, which was established in 2000 in the East Valley (Photo 11). This monument will be used for on-going ground-truthing of the InSAR data and for land subsidence monitoring in the East Valley. The difference between the 2013 and 2014 GPS survey results indicate that the 1BJ1 monument has subsided 1.9 centimeters (0.75 inches) over a one-year period. As mentioned earlier, this new land subsidence feature is a result of declining groundwater levels (Figure 19) due to increased groundwater pumping in the area.

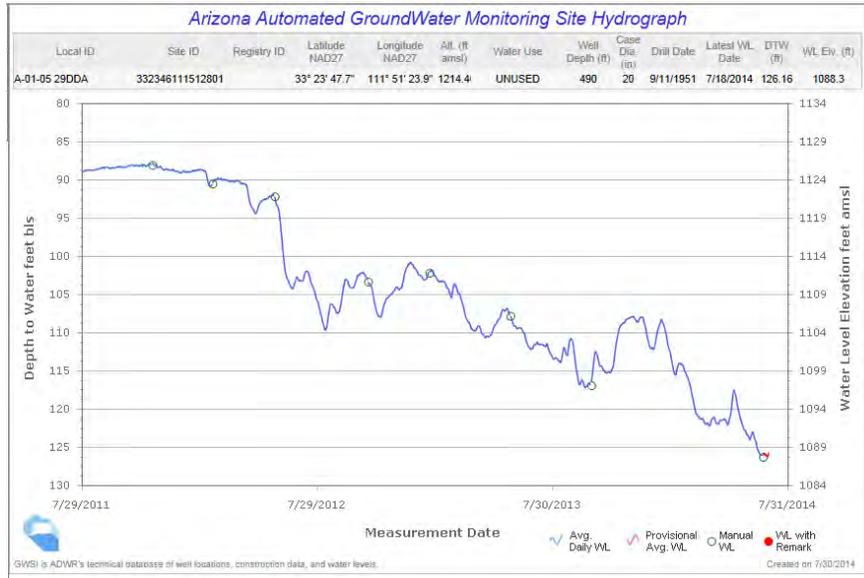
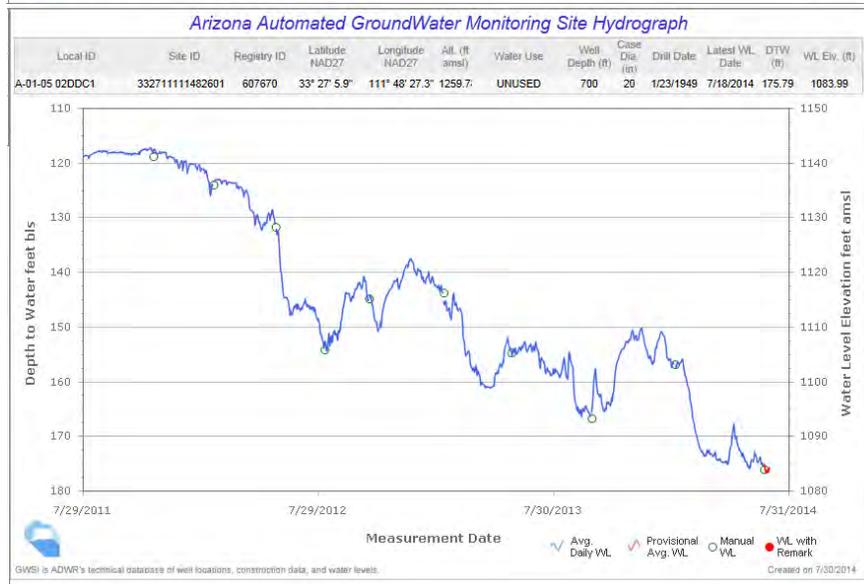
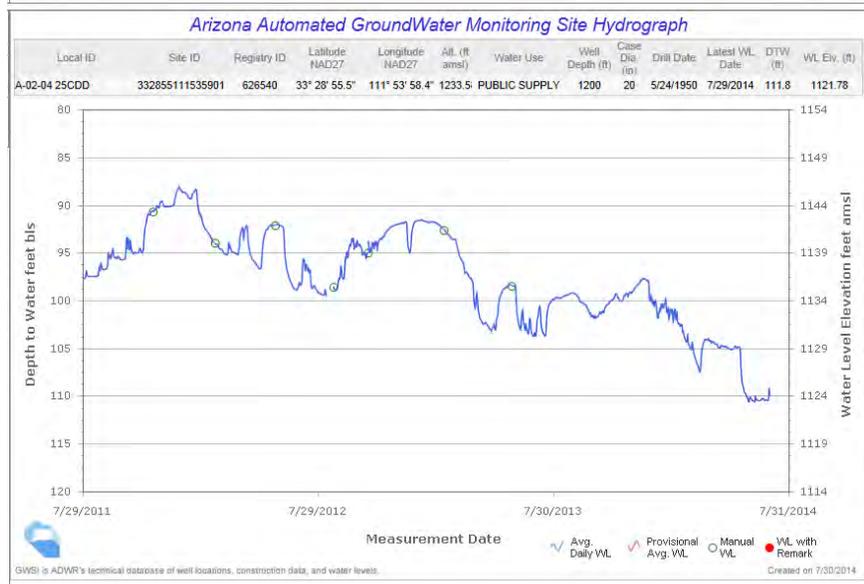
Figure 19 – Hydrographs documenting groundwater declines in the East Valley Land Subsidence Feature

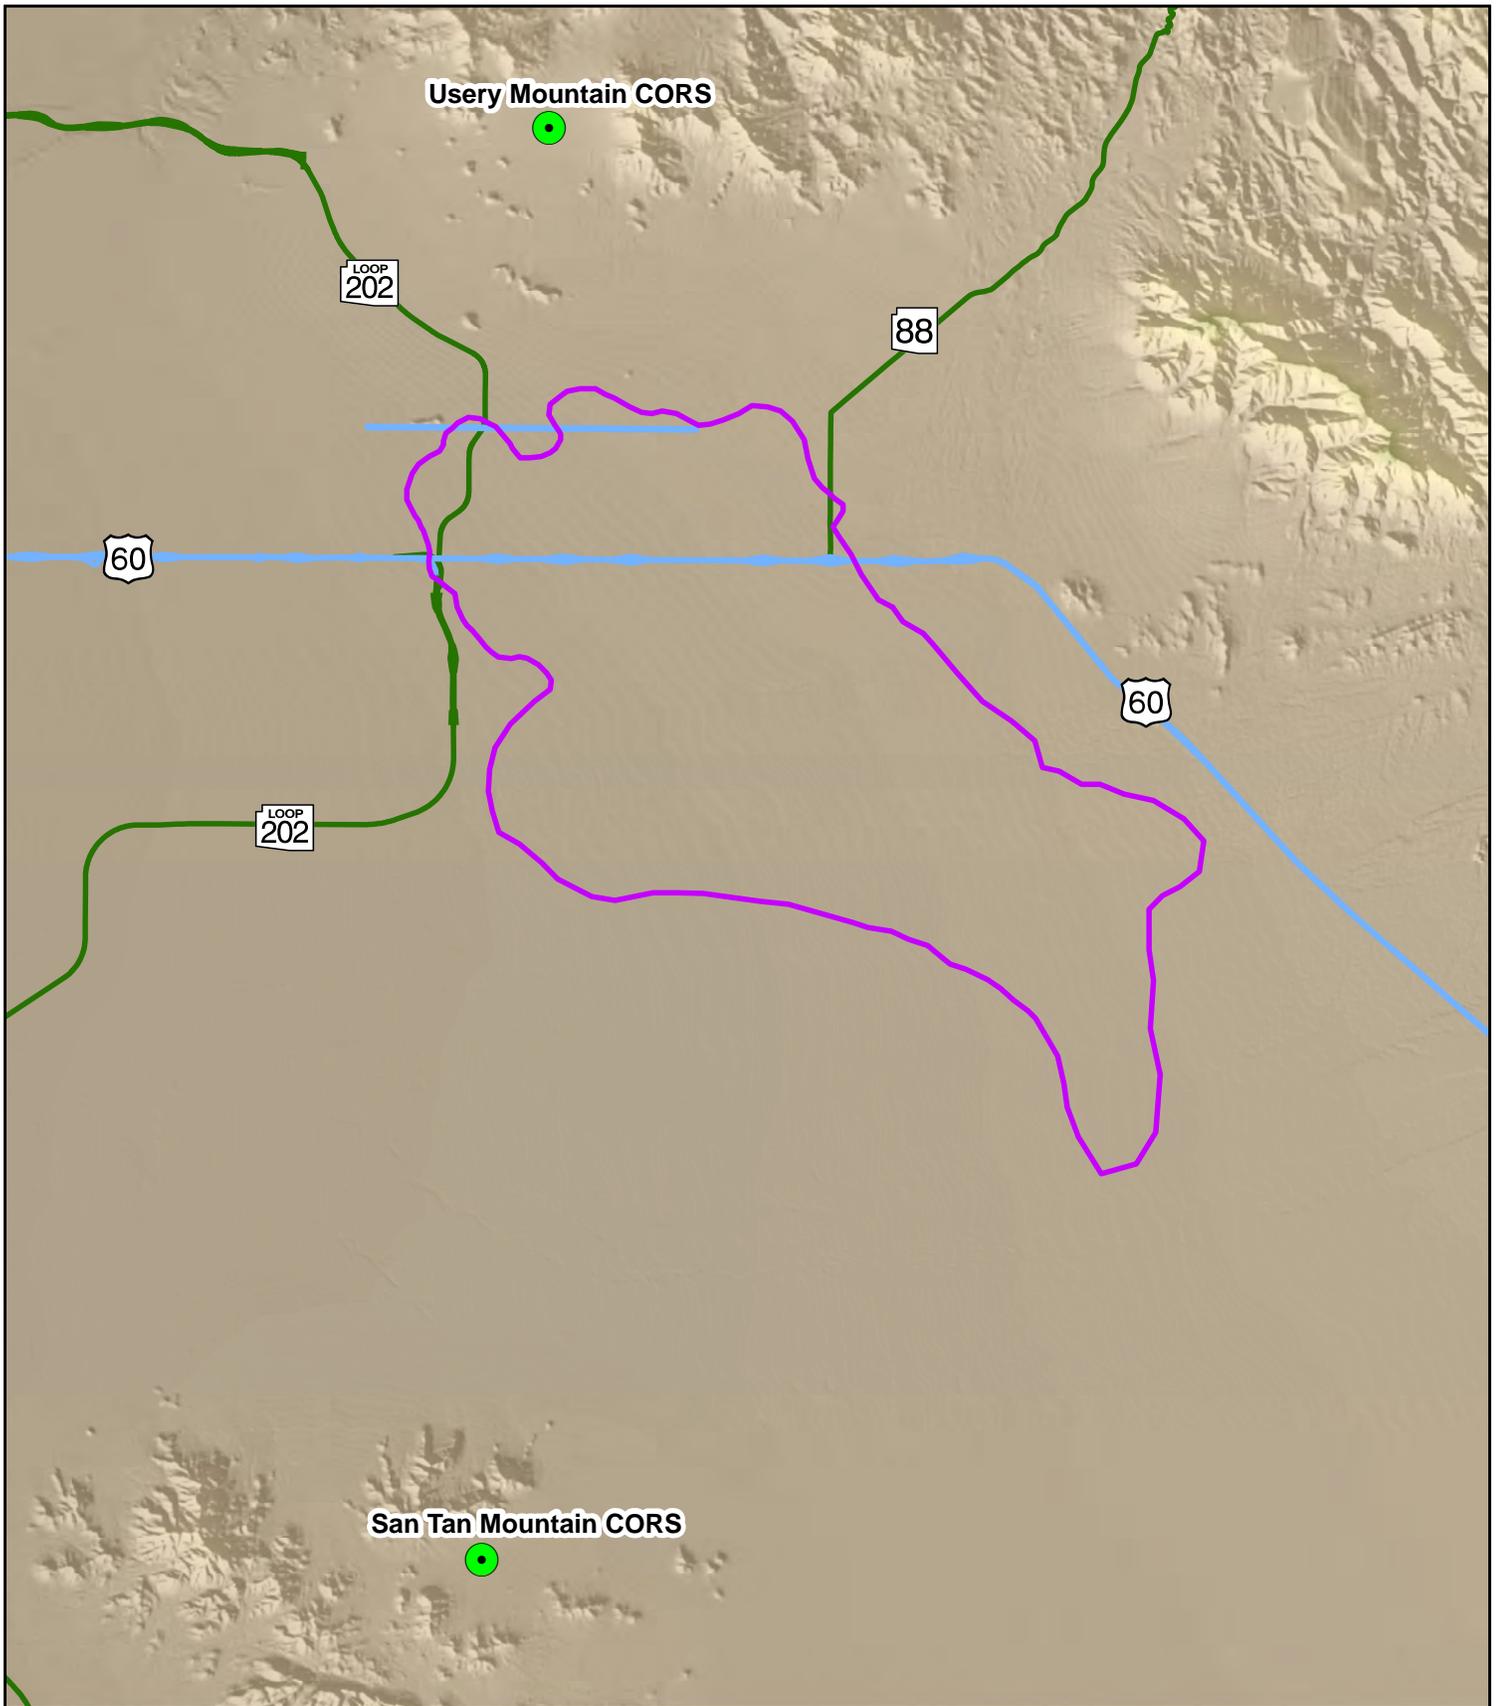
Figure 20 - Two New Bedrock CORS Sites

ADWR has worked with the ADOT, Central Arizona Project, Maricopa County Department of Transportation, and Maricopa County Parks to install two new stable CORS sites that are located on bedrock in Eastern Maricopa County at Usery Mountain and San Tan Mountain Parks (Photo 12). These sites will provide stable vertical control around the Hawk Rock land subsidence feature (Figure 20).

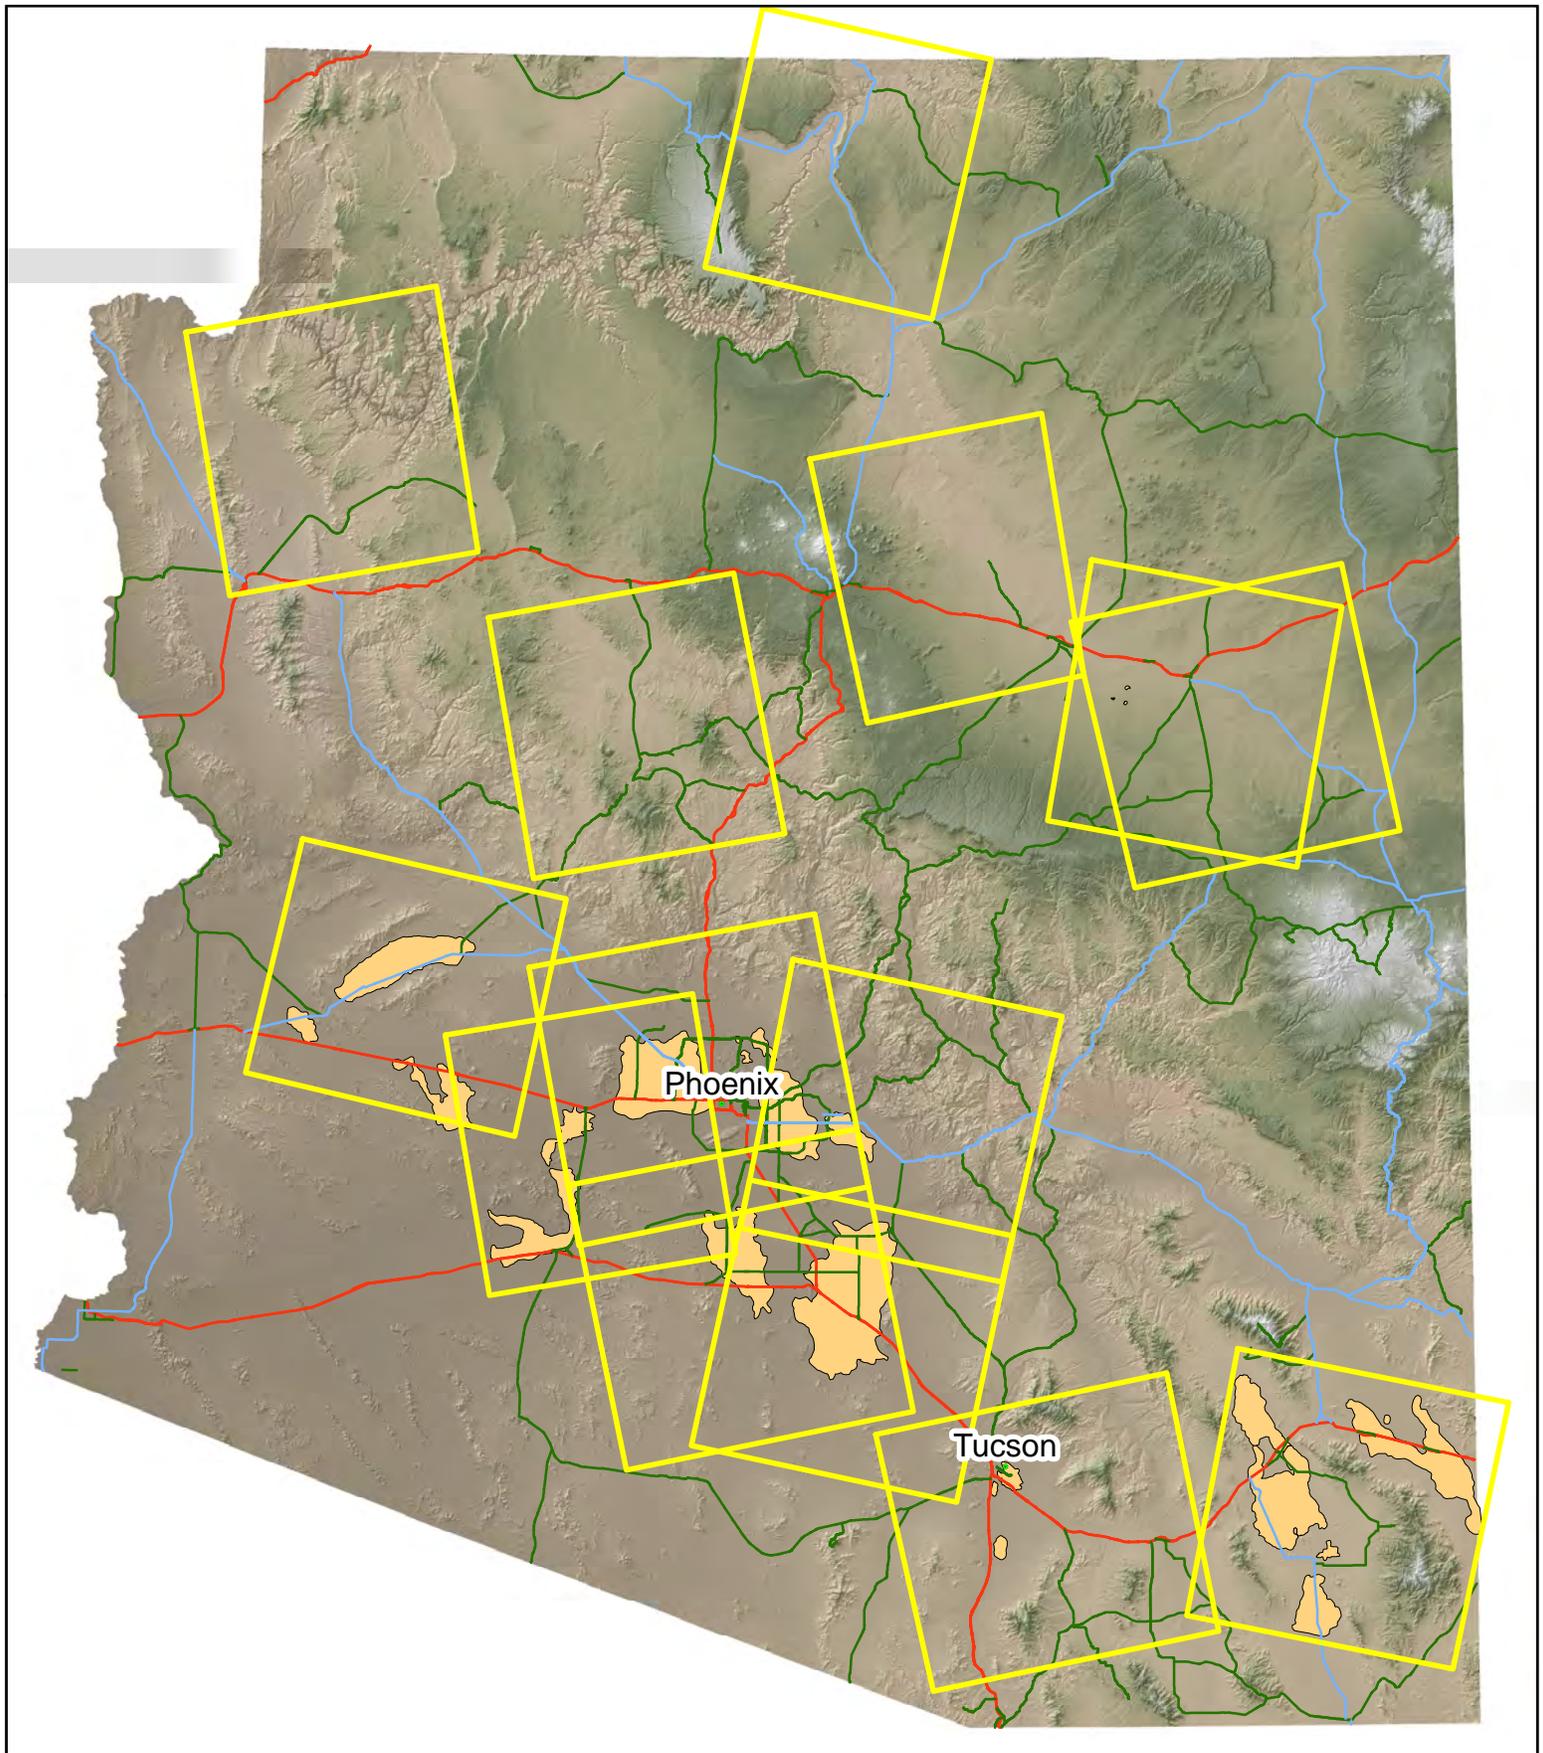
Figure 22 - Current Radarsat-2 Satellite Frames Used to Collect InSAR Data in Arizona
 InSAR Data is Collected, Processed, and Analyzed
 by the Geophysics/Surveying Unit of the ADWR Hydrology Division

ADWR will continue to collect InSAR data around the State at the existing data collection frequency and spatial distribution of more than 50,000 square miles (Figure 22). If needed, ADWR will begin to collect InSAR data in areas where increasing groundwater demands and declining groundwater level may be occurring or starting to occur. ADWR will also continue to update land subsidence maps on an annual basis, making the maps available on the Department's website.
