2510 Watershed Surveys and Plans

December 23, 1983

Storm Damage on Deer Creek Allotment

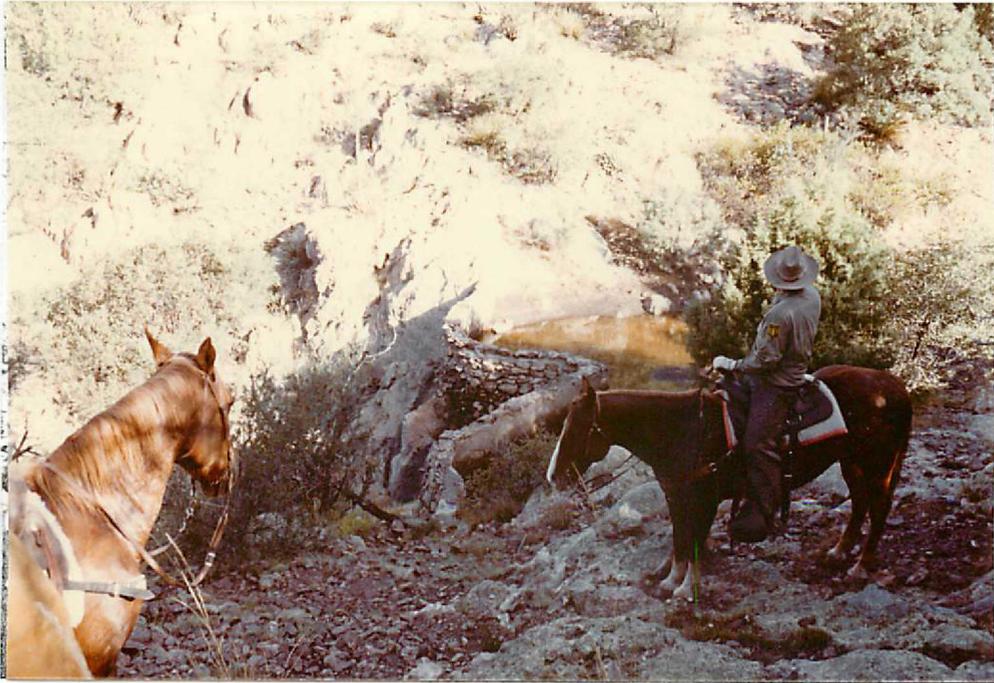
Crooked Dam - 11/1/83

We observed many water developments during the five days. The rock dams, such as Crooked Dam, Middle Pipestem, Upper Pipestem, Sonoran Basin Dam, and Kielberg Dam were not structurally damaged by high water. The storage behind the dams, however, is minimal because of debris deposited behind every one of them. Several of the rock dams we observed had no working means of piping water from behind the dam to a drinker. Alternatives for making these dams more useful were discussed. They included dredging, installing a perforated pipe into the face of the dam to tap water trapped in the debris, drilling a well into the deposit behind the dam, and raising the dam. All these alternatives have drawbacks as well as good points. Dredging is a problem because the tanks are remote, and there is an abundance of fresh material poised and waiting to roll in behind the dredged dam. Dredging would supply a lot of water storage area, and if we put a sediment trap above the reservoir, we could keep the storage capacity high for a longer time. Evaporation off the surface would be a problem. Installing perforated pipe in either of the face of the dam or vertically into the deposit would work fine if we could keep the perforations open. Apparently there are ways to keep a pipe open and we should try them.

My recommendation is to build a sediment trap upstream and make sure there is a pipe in the face of the dam that we can keep open. This combination should be effective.

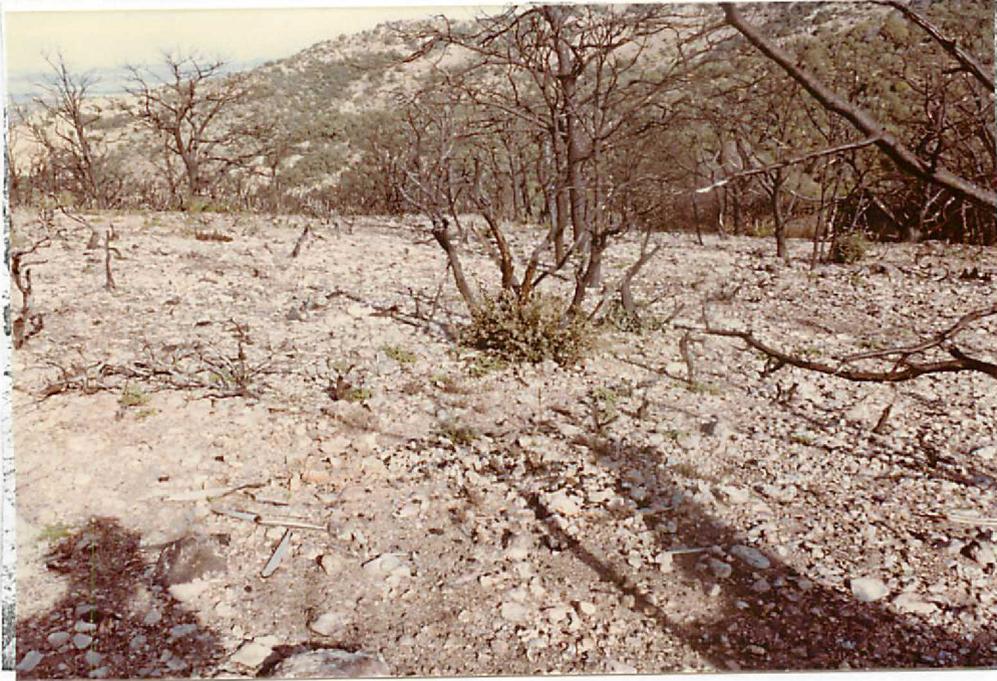
Cienega Fire - 11/1/83

Our brief look at the Cienega Fire left me with the impression that the slopes are fairly well revegetated. The top of the fire, however, is not doing as well. The attached photographs of the fire only represent the upper portion, and are not an example of what appeared to be the majority of the fire.

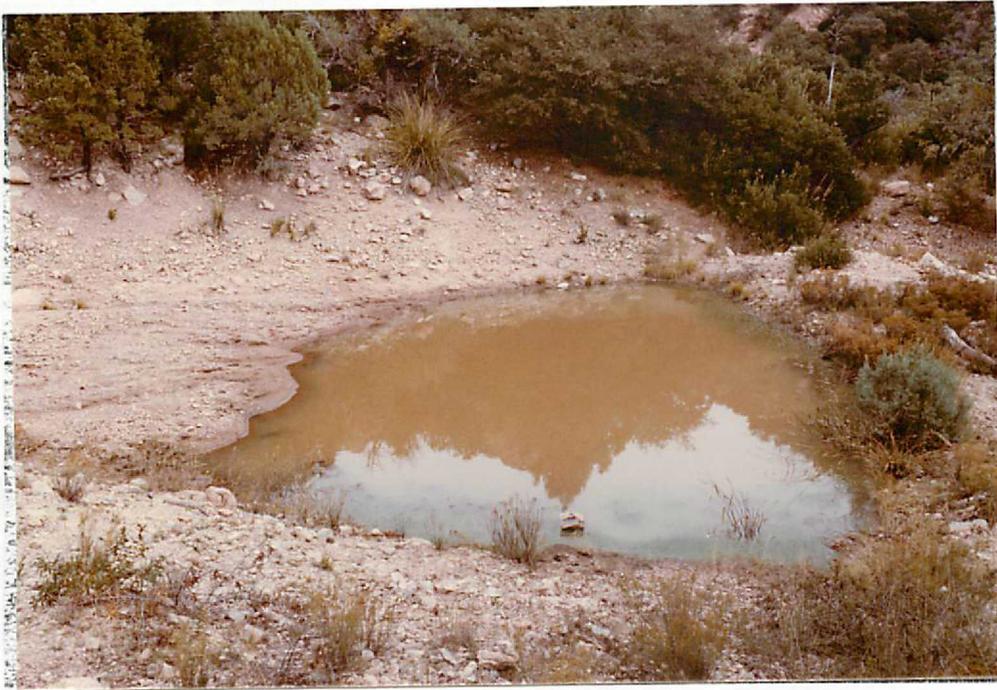
Unnamed Tank in Kielberg Canyon
near Powers Mine

All of the water developments we observed have proper water rights with the exception the small dirt tank adjacent to the road near Powers Mine. This tank is unnamed and is not on the Allotment Improvements list that I referred to.

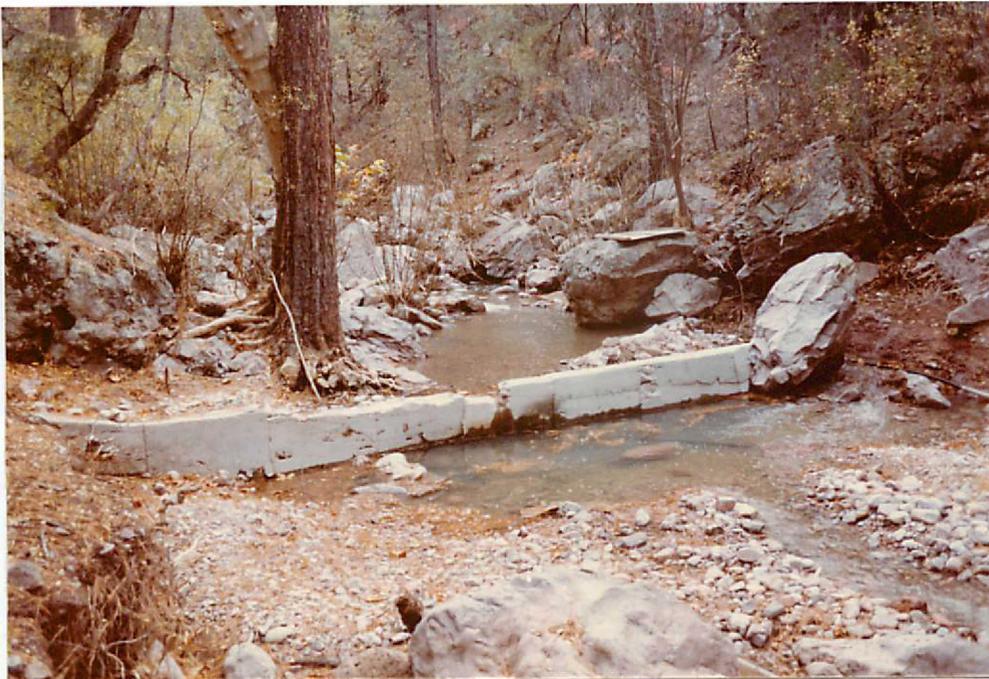
Powers Garden Water Works 11/2/83

Just a note about the Powers Garden water system. The pick-up point was damaged in the October storm, and a makeshift pick-up apparatus was functioning when I saw it. Every effort should be made to reconstruct the pick-up point so it picks up the water from the gravel, not the surface flow.

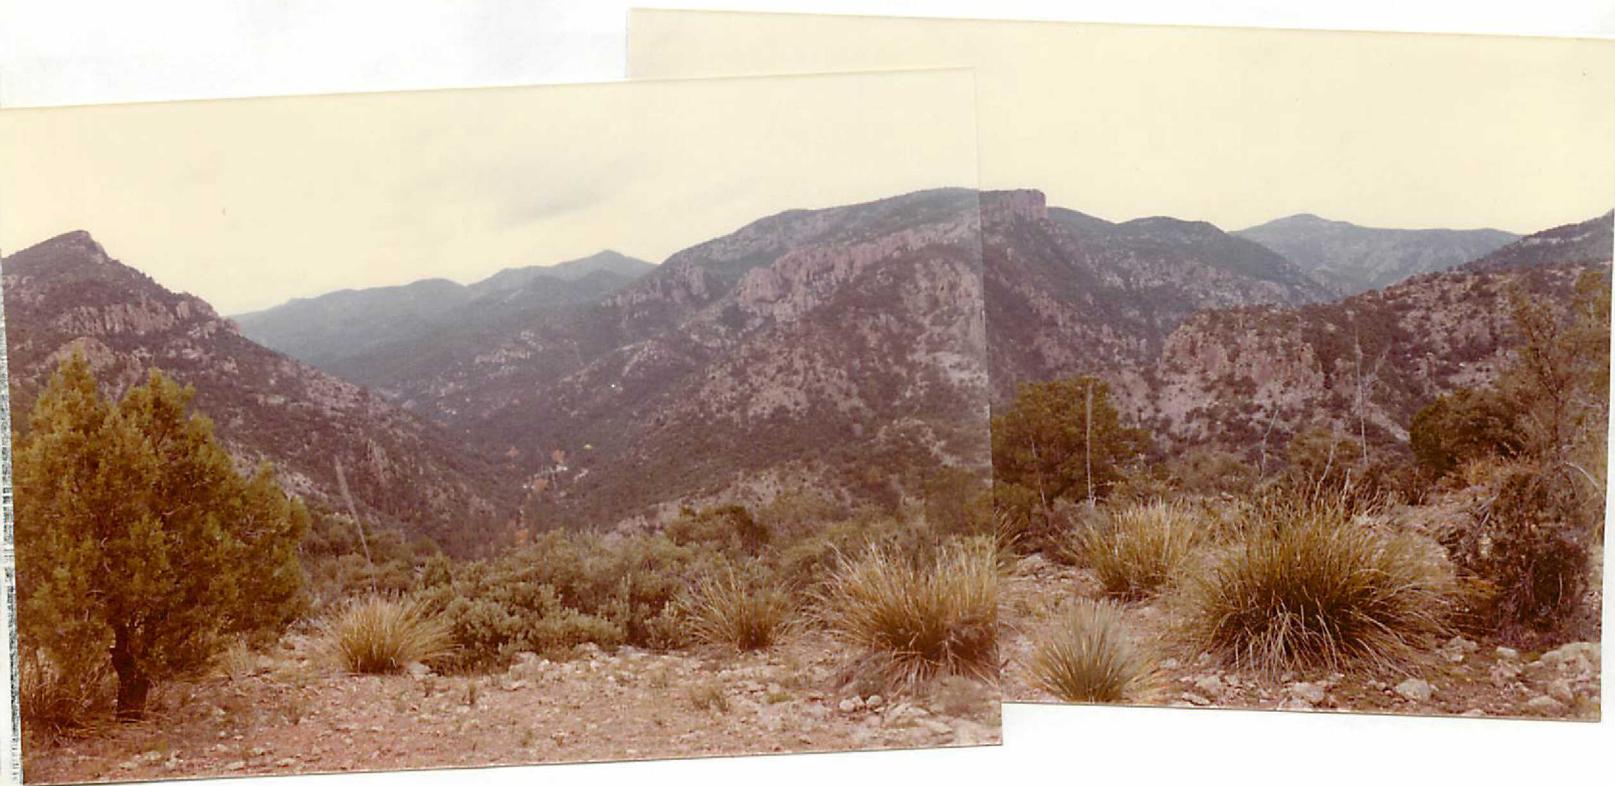
Rattlesnake Canyon - 11/3/83

The main channel of Rattlesnake Canyon sustained some very large flows and a great deal of rearranging occurred within the floodplain. A number of mature Ponderosa Pine and Sycamore trees were lost due to undermining and battering by water and floating debris. A surprising number of young trees remain. This is encouraging and leads me to believe that the vegetation in the riparian area will recover rapidly. The channel itself may not really stabilize for some time. Tremendous quantities of rock, gravel, and sand as well as limbs and logs from downed trees are in the channel. These will move a lot in future runoff events, making the channel unstable. The trail along the bottom is unrecognizable in some reaches, and will probably be difficult to establish in the near future because of the numerous channel crossings and close proximity to the channel throughout its length.
