Total Land Subsidence in the Harquahala Valley, Maricopa County
Based on Envisat Satellite Interferometric Synthetic Aperture Radar (InSAR) Data
Time Period of Analysis: 2.0 Years 02/14/2007 To 02/18/2009

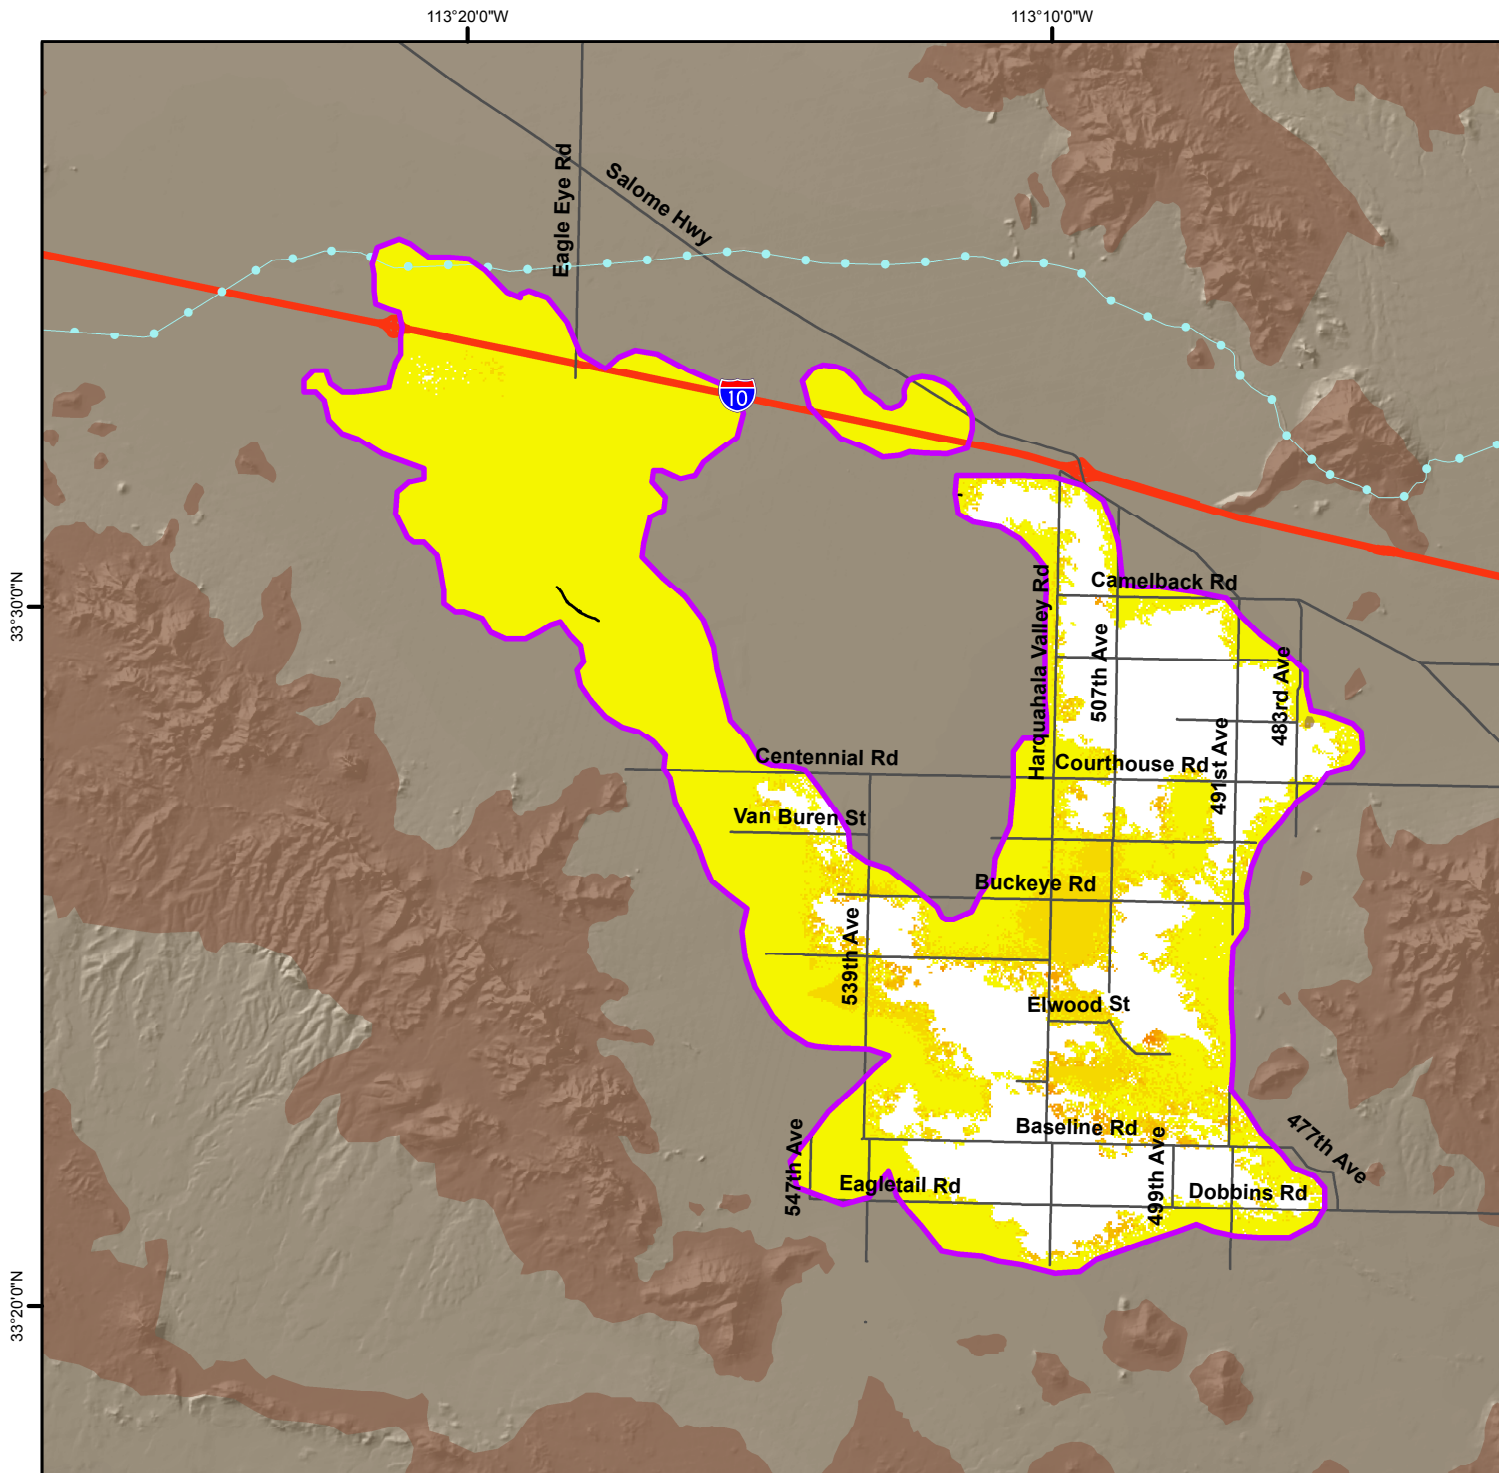
Decorrelation (white areas) are areas where the phase of the received satellite signal changed between satellite passes, causing the data to be unusable. This occurs in areas where the land surface has been disturbed (i.e. bodies of water, snow, agriculture areas, areas of development, etc).

Earth fissures were mapped by the Arizona Geological Survey.
 For information on earth fissures visit: www.azgs.gov/EFC
