Groundwater Recharge on Working Lands by Local Youth to Enhance

Ecosystem Services - Final Report

Report Date: 11/17/25

Report Period: 1/29/2021 - 11/30/25

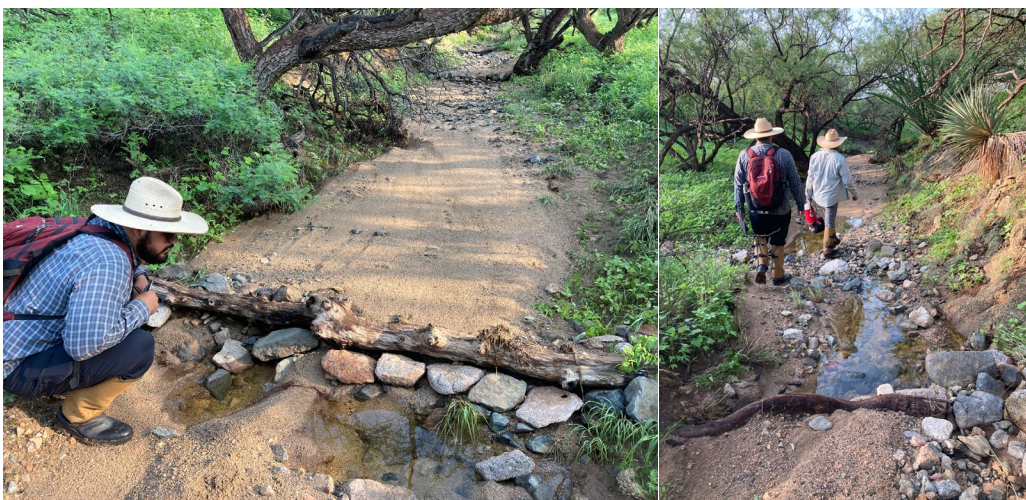
Figures 1 & 2. Erosion control structures, filled in with sediment after recent rains.

Task 1: A total number of 699 ECS were installed at T4 Ranch by spring 2023 throughout 12 drainages, surpassing the deliverable of 500 (400 + 100 from youth restoration engagement). In some drainages, ECS filled in with sediment after multiple monsoons swept water downstream and dropped the sediment as the structure slowed the water flow. Additional ECS were built on top of these structures to continue raising the channel bed where it had been incised, and to further stabilize the banks. GPS points were taken for each structure and compiled into a shapefile.

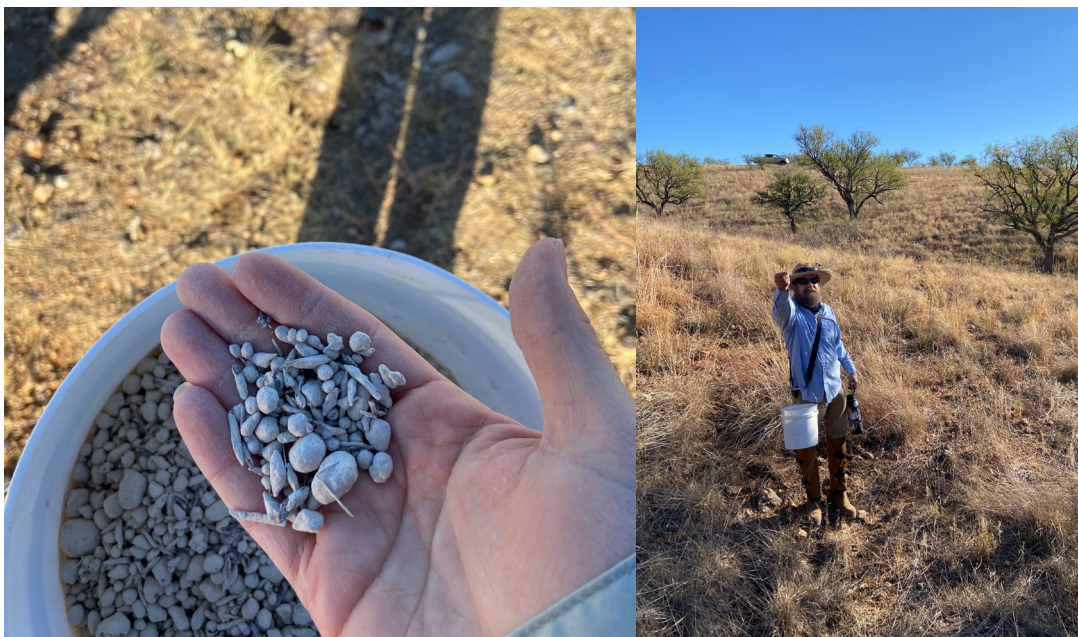
Figures 4 & 5: Seed Pellets being spread throughout the project site.

Task 2: Mulching activities were halted in summer 2022 because of a lack of materials and feasibility. Funding for mulching was reallocated to building additional erosion control structures (Task 1). Wild seed was collected and seed was purchased to create 1,440 pounds of native seed pellets, which were spread throughout the ECS after installation. Species included grasses like Sideoats grama (*Bouteloua curtipendula*) and shrubs like rubber rabbitbrush (*Ericameria nauseosa*) that thrive in arid climates.
