Total Land Subsidence in the Butler Valley Area, La Paz County
 Based on Sentinel-1 Satellite Interferometric Synthetic Aperture Radar (InSAR) Data
 Time Period of Analysis: 9.0 Years 03/06/2017 To 04/24/2026

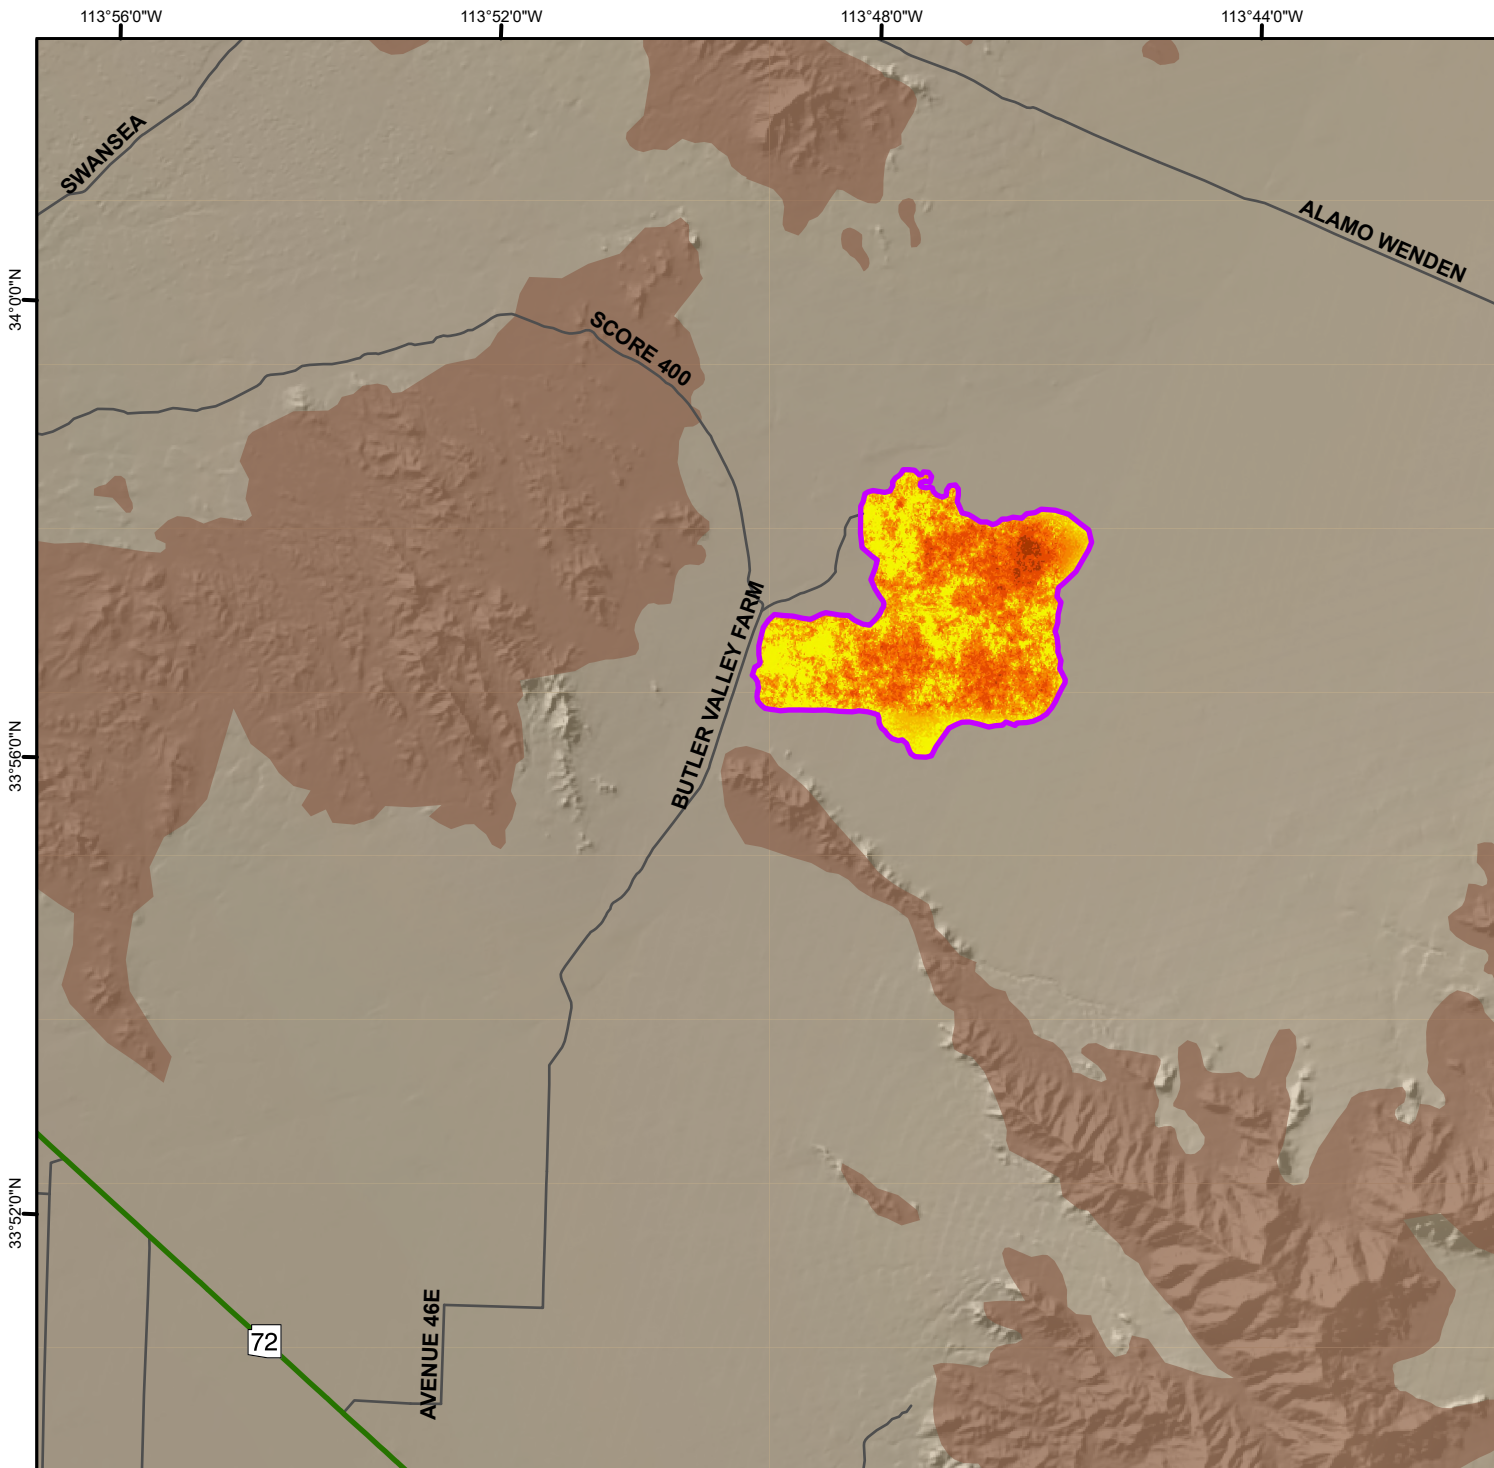
Decorrelation (white areas) are areas where the phase of the received satellite signal changed between satellite passes, causing the data to be unusable. This occurs in areas where the land surface has been disturbed (i.e. bodies of water, snow, agriculture areas, areas of development, etc).
