**Total Land Subsidence in the Elfrida Area, Cochise County**  
 Based on Sentinel-1 Satellite Interferometric Synthetic Aperture Radar (InSAR) Data  
**Time Period of Analysis: 9.1 Years 02/24/2017 To 05/08/2026**

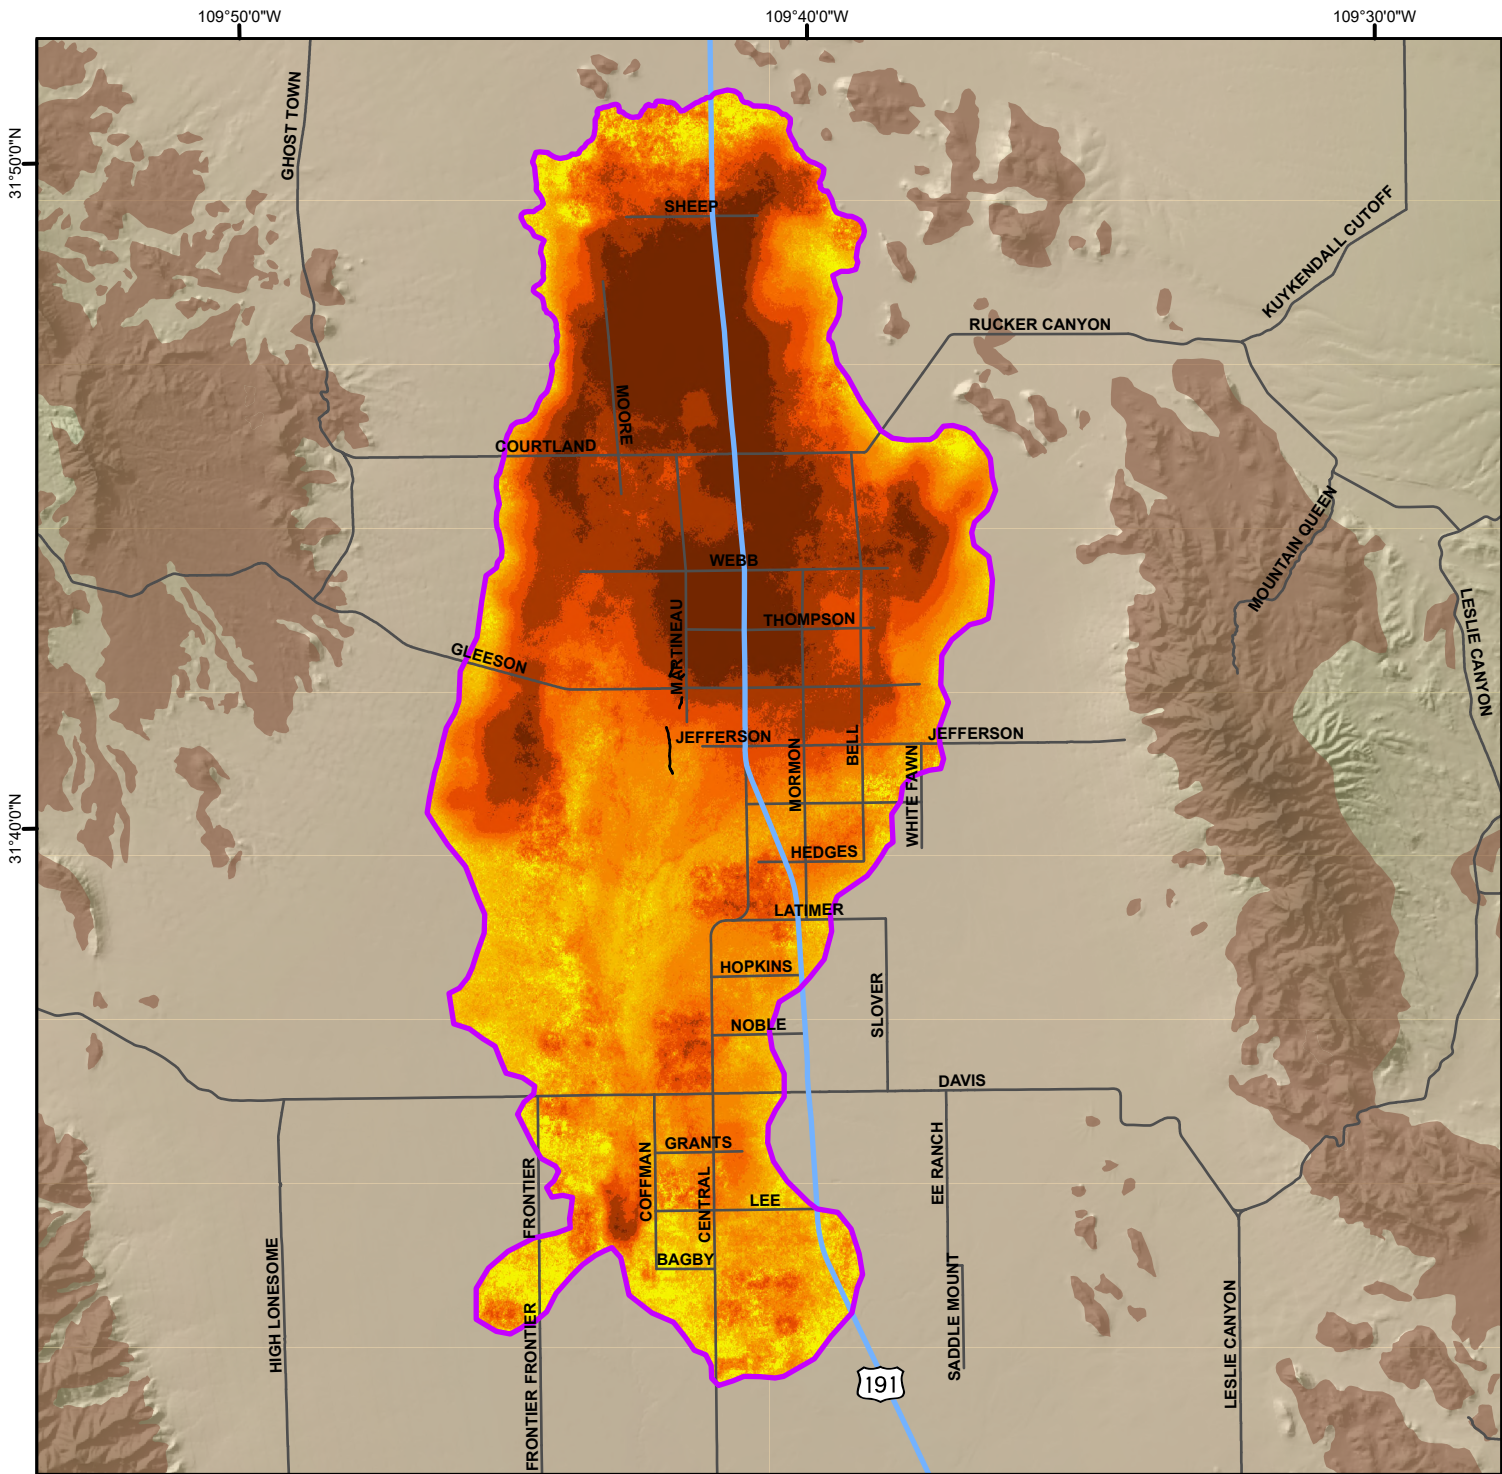
Decorrelation (white areas) are areas where the phase of the received satellite signal changed between satellite passes, causing the data to be unusable. This occurs in areas where the land surface has been disturbed (i.e. bodies of water, snow, agriculture areas, areas of development, etc).

Earth fissures were mapped by the Arizona Geological Survey. For information on earth fissures visit: [www.azgs.gov/EFC](http://www.azgs.gov/EFC)
