Total Land Subsidence in the Elfrida Area, Cochise County
 Based on Sentinel-1 Satellite Interferometric Synthetic Aperture Radar (InSAR) Data
Time Period of Analysis: 1.0 Years 05/13/2025 To 05/08/2026

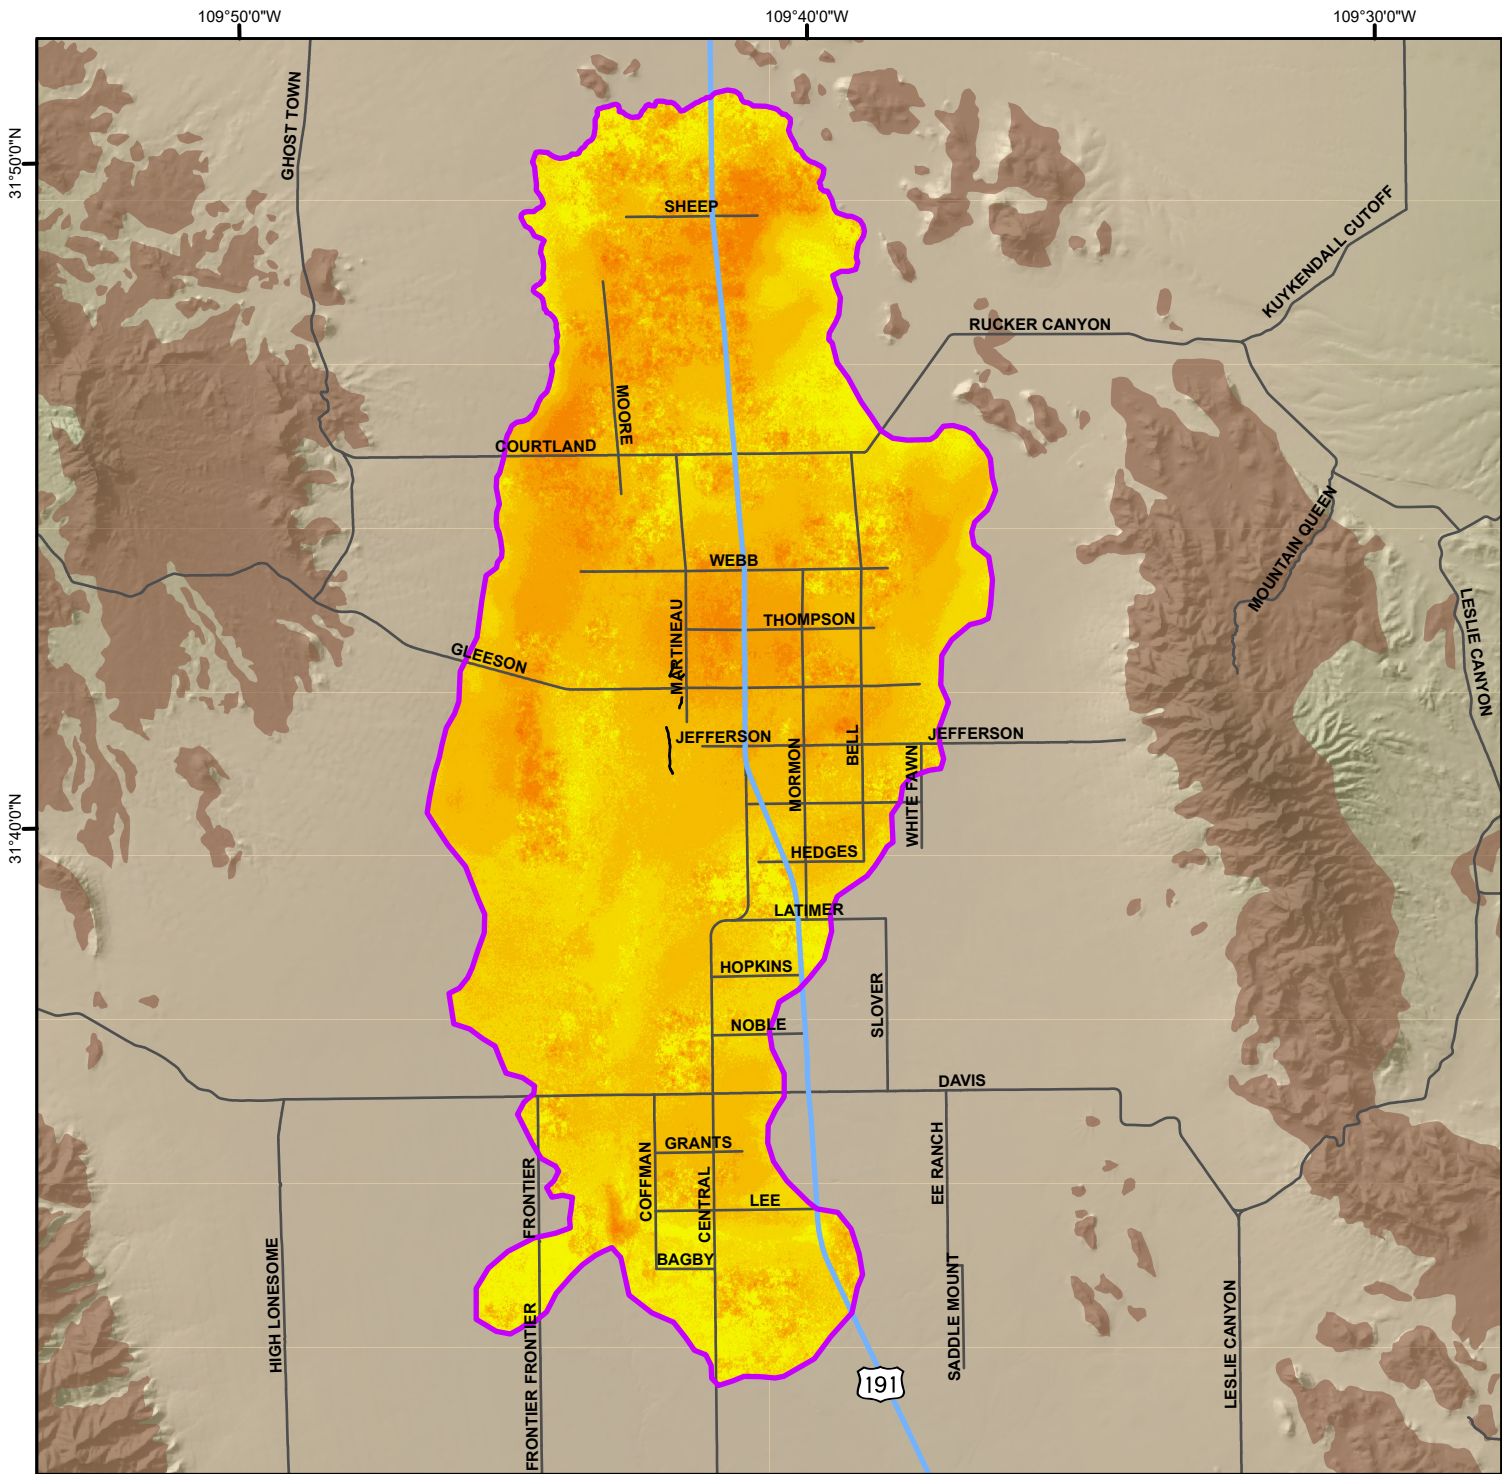
Decorrelation (white areas) are areas where the phase of the received satellite signal changed between satellite passes, causing the data to be unusable. This occurs in areas where the land surface has been disturbed (i.e. bodies of water, snow, agriculture areas, areas of development, etc).
