Land Subsidence Rate in the Elfrida Area, Cochise County
 Based on Sentinel-1 Satellite Interferometric Synthetic Aperture Radar (InSAR) Data
 Time Period of Analysis: 1.0 Years 05/13/2025 To 05/08/2026

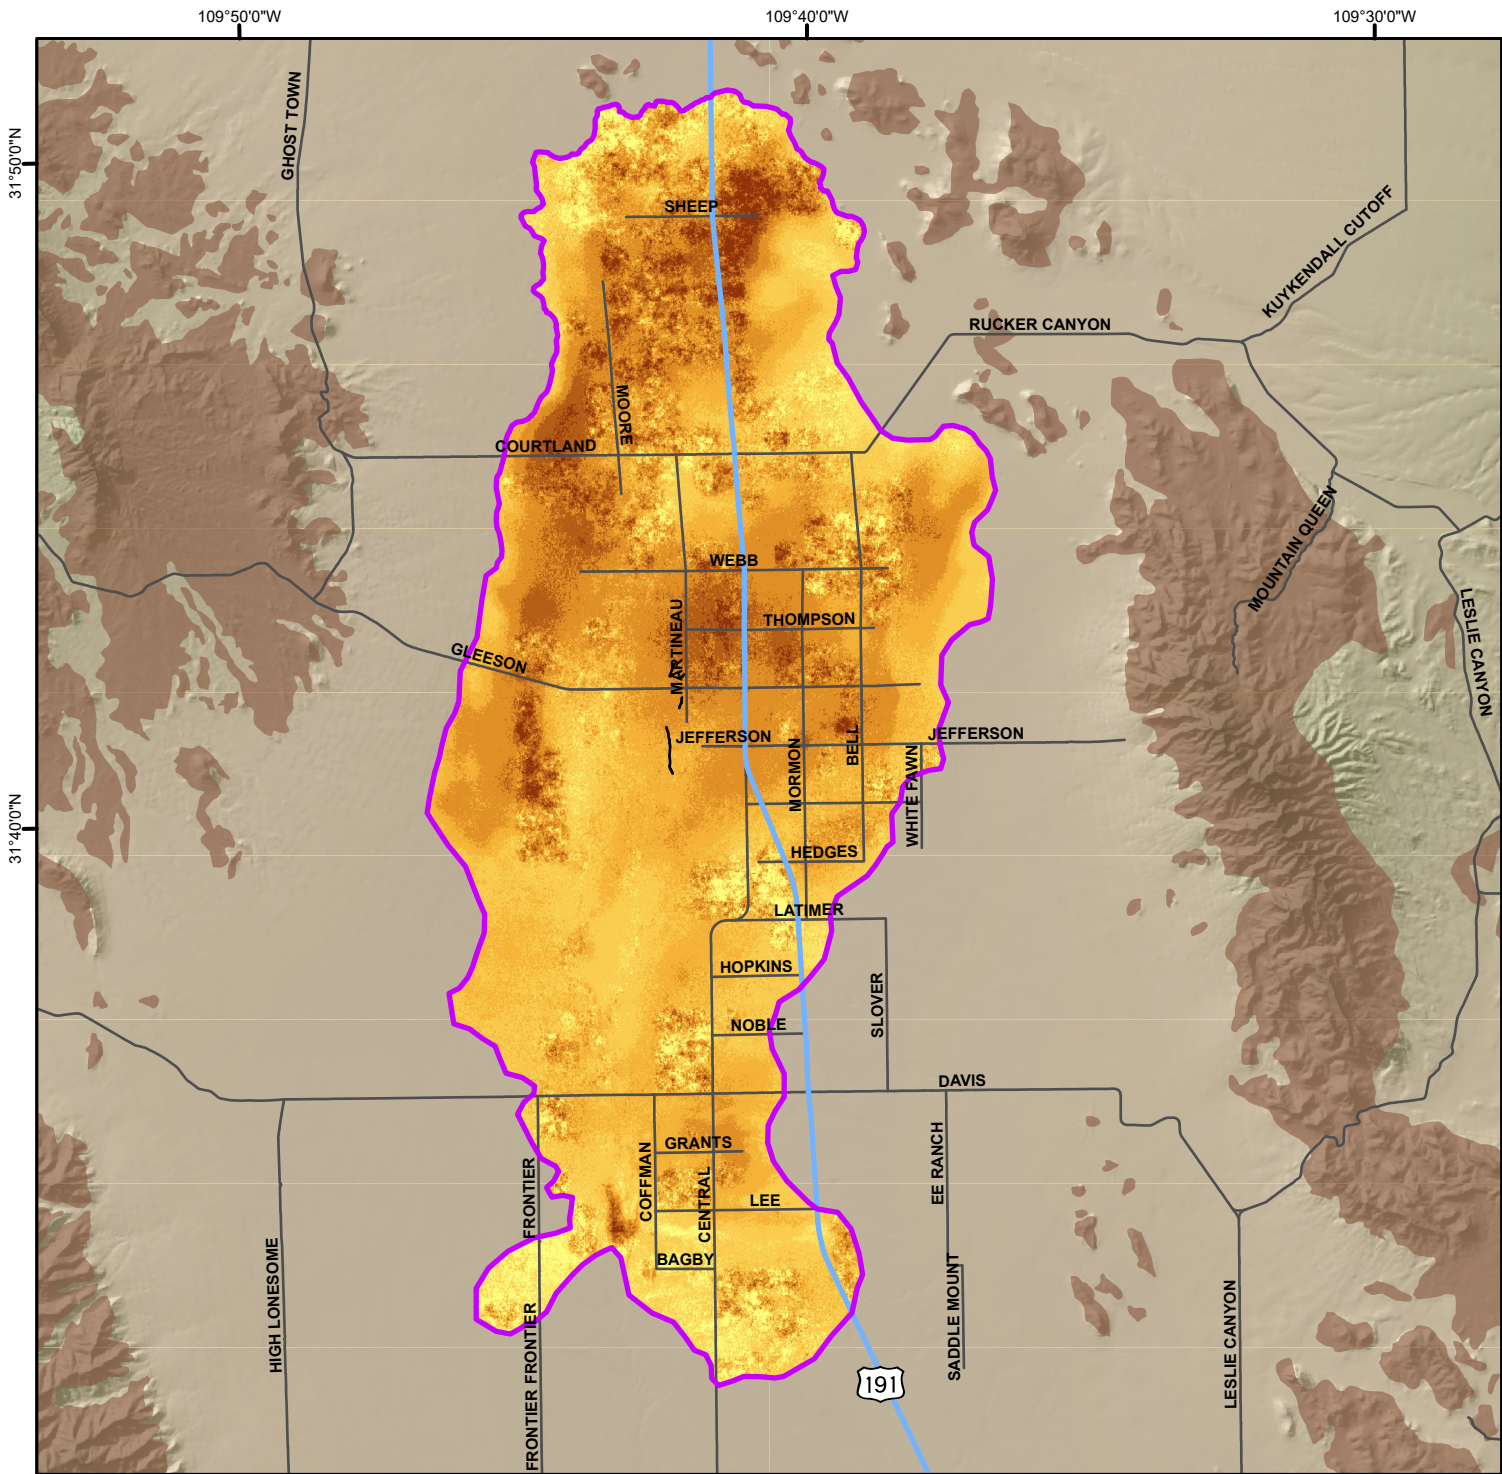
Decorrelation (white areas) are areas where the phase of the received satellite signal changed between satellite passes, causing the data to be unusable. This occurs in areas where the land surface has been disturbed (i.e. bodies of water, snow, agriculture areas, areas of development, etc).

Earth fissures were mapped by the Arizona Geological Survey. For information on earth fissures visit: www.azgs.gov/EFC
