Total Land Subsidence in the Sahuarita and Green Valley Areas, Pima County
 Based on Radarsat-2 Satellite Interferometric Synthetic Aperture Radar (InSAR) Data
Time Period of Analysis: 16.0 Years 05/15/2010 To 04/09/2026

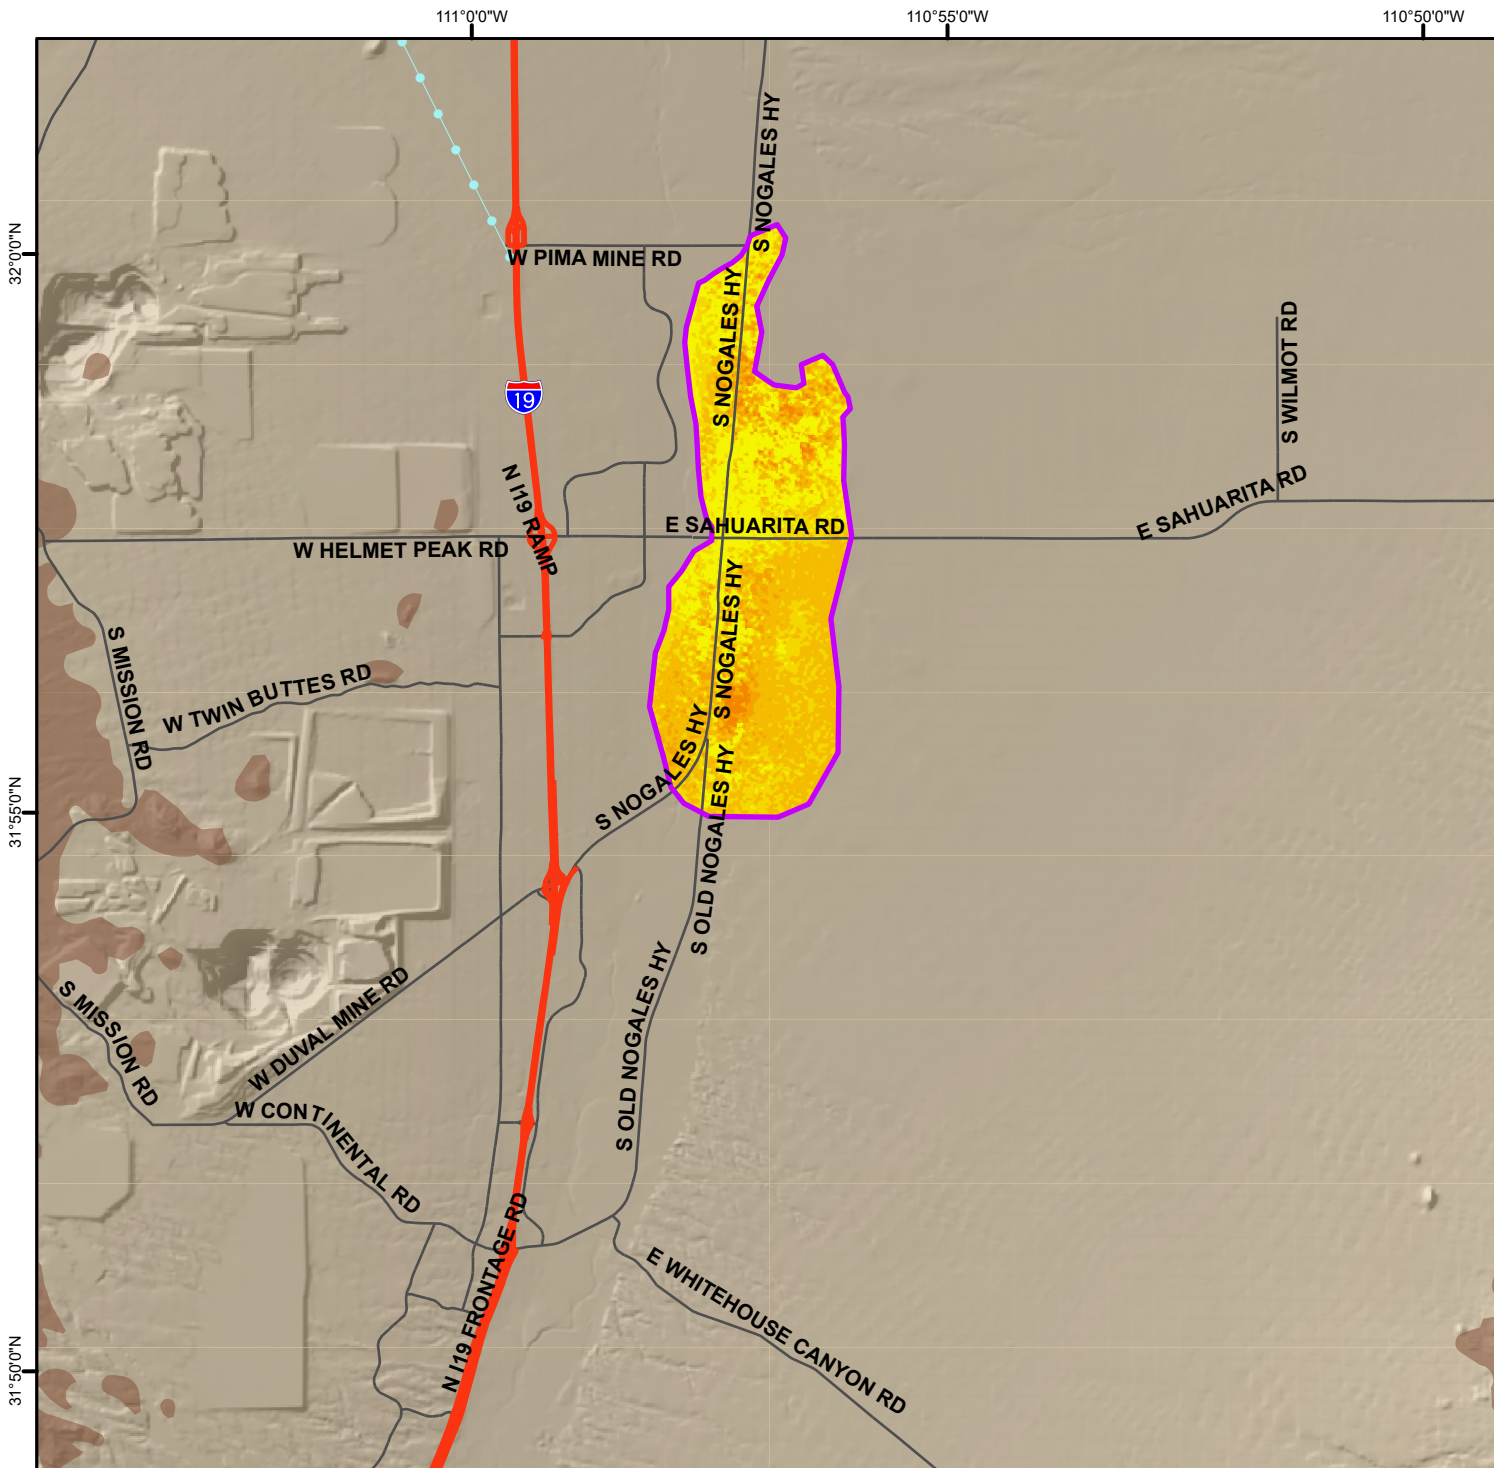
Decorrelation/No Data
Greater 40 cm (15.7 in)
25 - 40 cm (9.8 - 15.7 in)
15 - 25 cm (5.9 - 9.8 in)
10 - 15 cm (3.9 - 5.9 in)
6 - 10 cm (2.4 - 3.9 in)
4 - 6 cm (1.6 - 2.4 in)
2 - 4 cm (0.8 - 1.6 in)
1 - 2 cm (0.4 - 0.8 in)
0 - 1 cm (0 - 0.4 in)

Decorrelation (white areas) are areas where the phase of the received satellite signal changed between satellite passes, causing the data to be unusable. This occurs in areas where the land surface has been disturbed (i.e. bodies of water, snow, agriculture areas, areas of development, etc).
