Total Land Subsidence in the Harquahala Valley, Maricopa County
 Based on Sentinel-1 Satellite Interferometric Synthetic Aperture Radar (InSAR) Data
 Time Period of Analysis: 9.0 Years 03/06/2017 To 04/24/2026

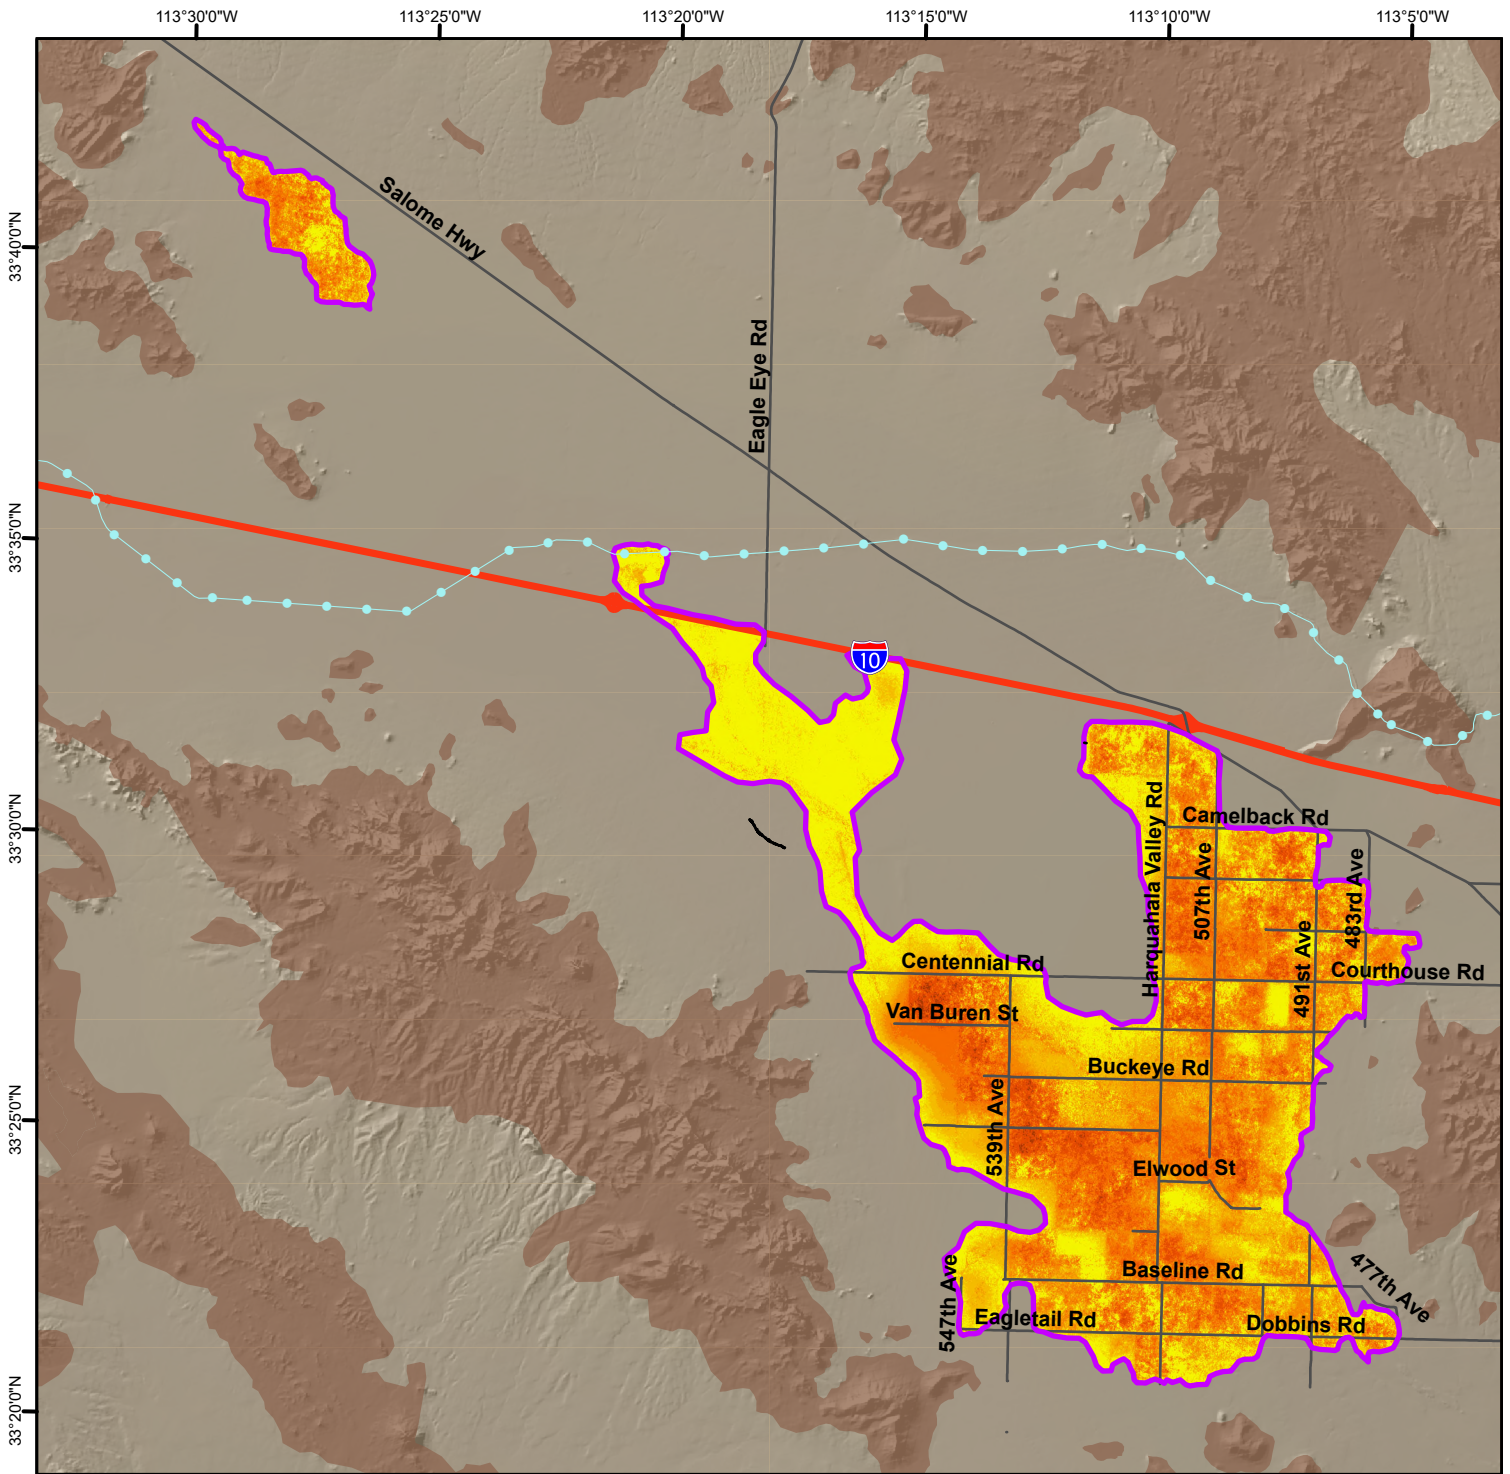
Decorrelation (white areas) are areas where the phase of the received satellite signal changed between satellite passes, causing the data to be unusable. This occurs in areas where the land surface has been disturbed (i.e. bodies of water, snow, agriculture areas, areas of development, etc).

Earth fissures were mapped by the Arizona Geological Survey. For information on earth fissures visit: www.azgs.gov/EFC
