Total Land Subsidence in the Hawk Rock Area, Maricopa and Pinal Counties
 Based on Radarsat-2 Satellite Interferometric Synthetic Aperture Radar (InSAR) Data
 Time Period of Analysis: 16.0 Years 05/15/2010 To 03/16/2026

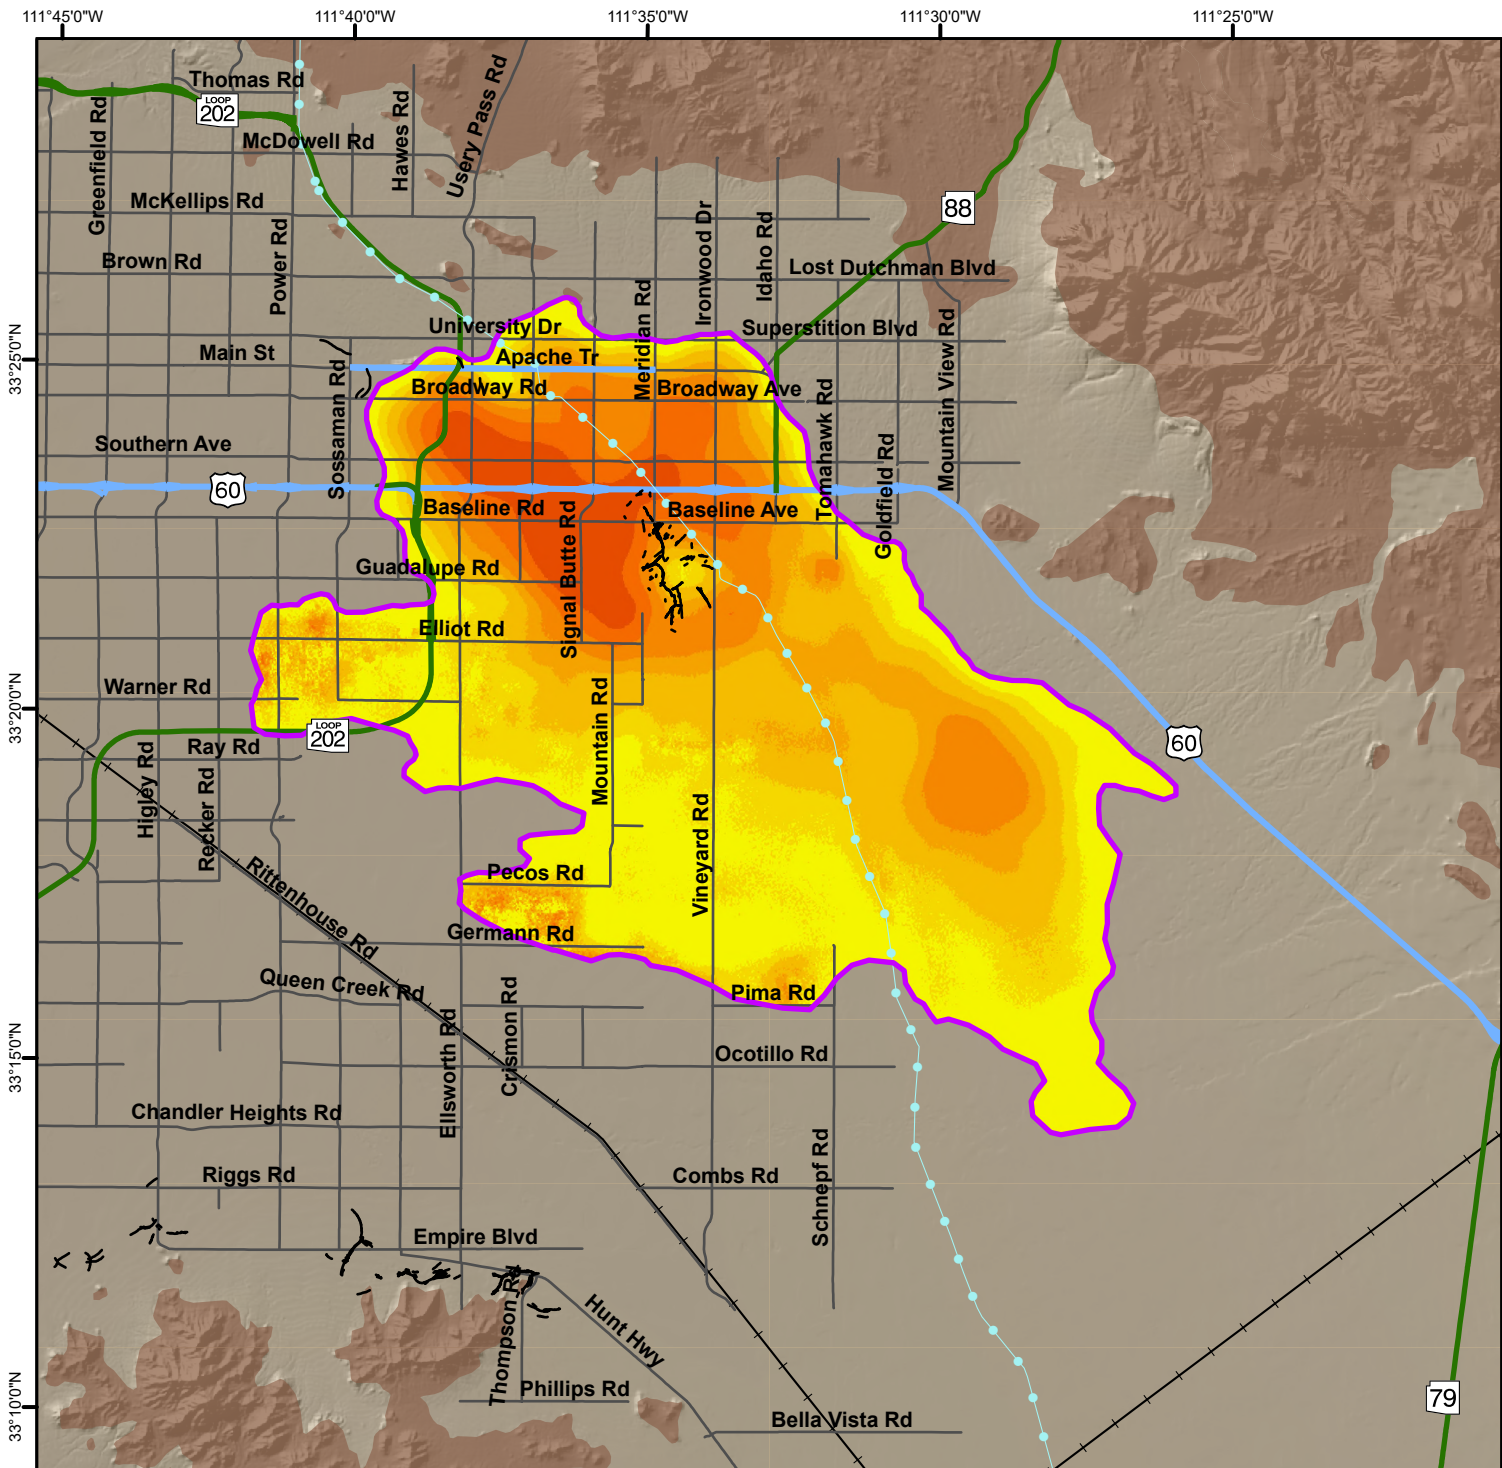
Decorrelation (white areas) are areas where the phase of the received satellite signal changed between satellite passes, causing the data to be unusable. This occurs in areas where the land surface has been disturbed (i.e. bodies of water, snow, agriculture areas, areas of development, etc).
