# **Hydrology and Water Use Data of the San Simon Valley Sub-Basin**

**Presented by Frank Corkhill, Chief Hydrologist**

**Arizona Department of Water Resources  
Hydrology Division**

**May 16, 2015**

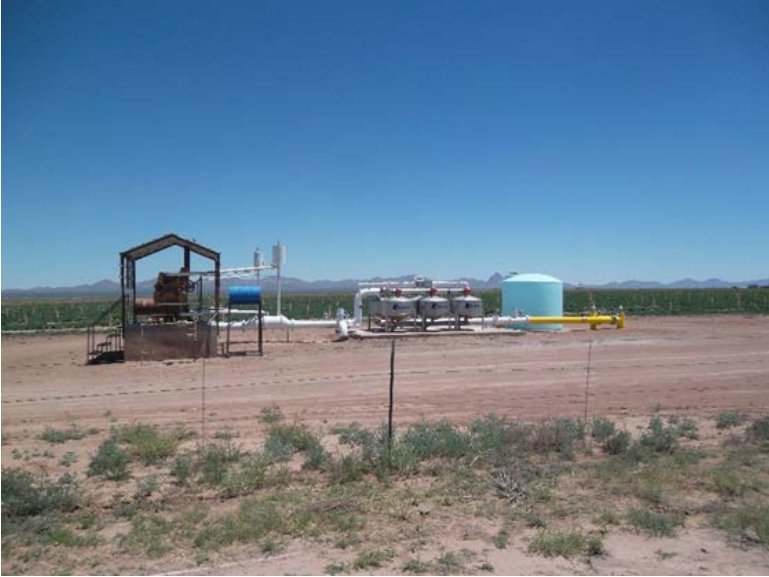
New Orchard South of San Simon  
(Drip Irrigation)

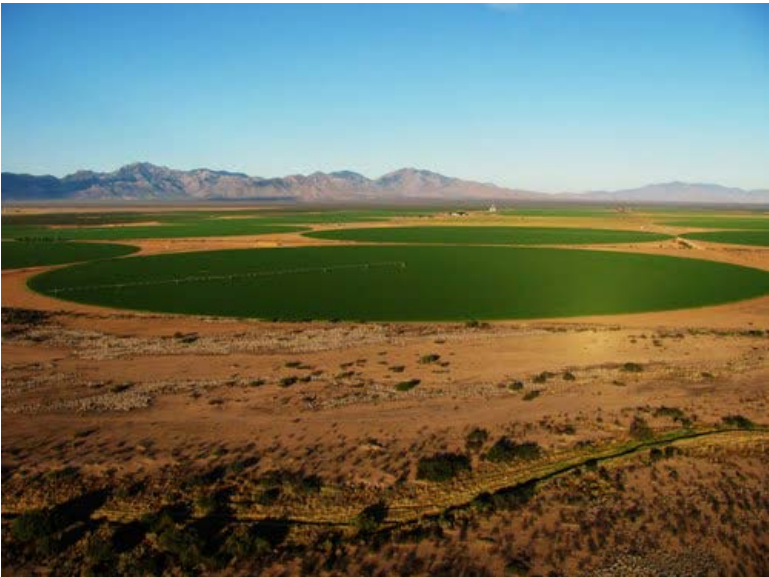
Alfalfa South of San Simon  
(Center Pivot Irrigation)

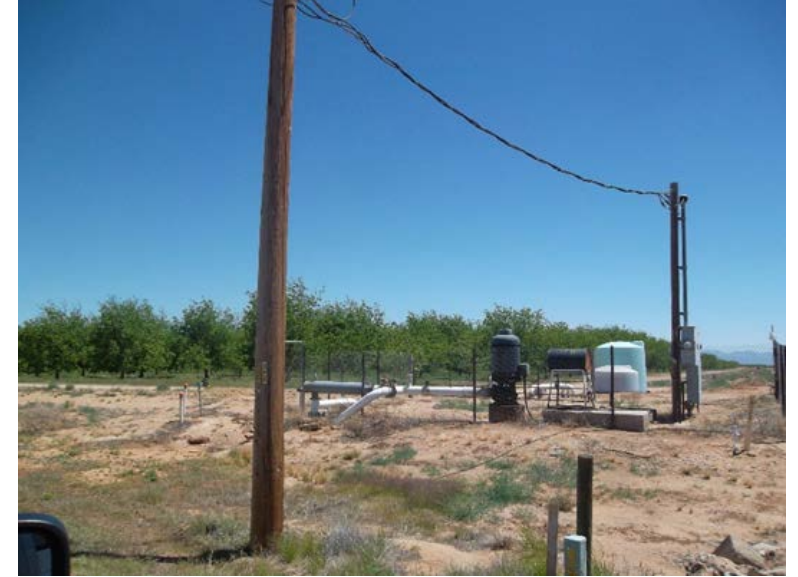
Older Pecans North of Bowie  
(Drip Irrigation)

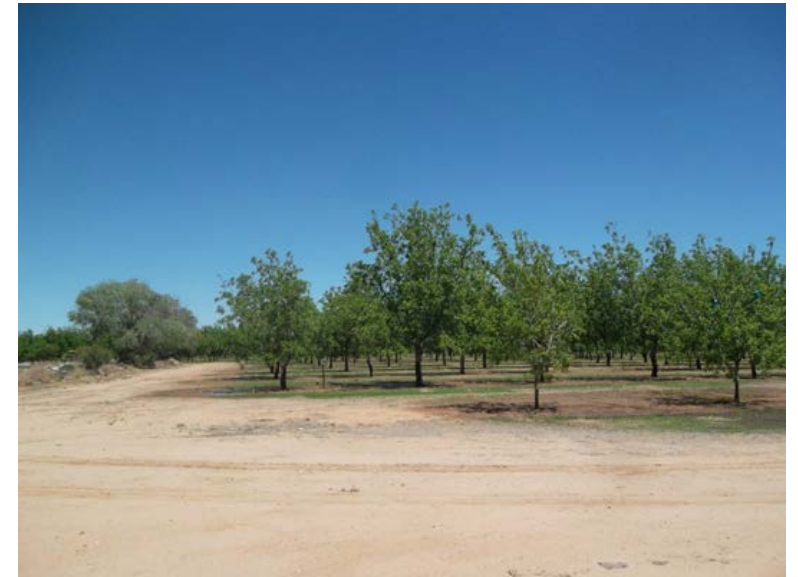
Older Pecans North of Bowie  
(Drip Irrigation In Progress)
