Subject: **Tucson Water & ADWR Task 4 Report**

TUCSON WATER – ADWR TASK 4 REPORT
June – December 2023
October 19, 2023

This Report consists of the findings and recommendations resulting from continuing leak detection project with Tucson Water (TW) and Contractors. Tucson Waters goal is to reduce our non-revenue water loss to 4%. The Condition Assessment Program (formerly Infrastructure Reliability & Infrastructure Systems - IRIS) is utilizing technology as a tool to locate leaks within our water distribution mains, water service meters, and other water assets. The report is divided into three sections which include the Executive Summary, Detailed Leak Detection Technology reporting, and Tucson Water Asset Management follow up system.

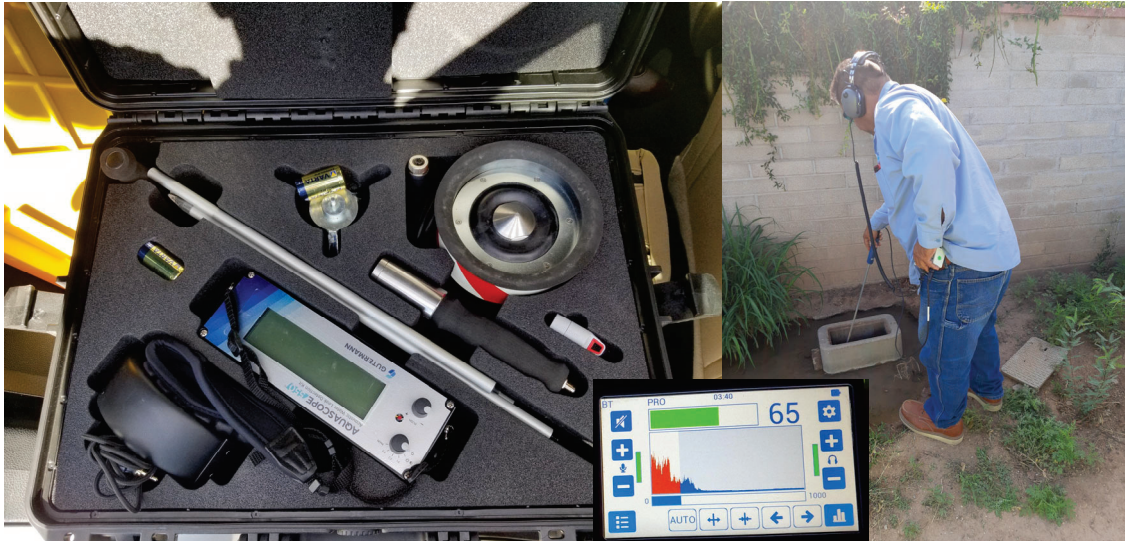
During the pilot test, Tucson Water had the opportunity to pilot the FCS correlating system to better locate leaks. The correlating equipment has significantly increased our leak detection methods with success. FCS equipment was \$26,000. Tucson Water service area is divided up into four areas consisting of North, East, Central, and West. Crews from each area occasionally call on the Condition Assessment team to perform a finite leak detection test to pinpoint the location. Note: at times water does not always surface and make the location immediately known. This tool and testing method save from over excavation and saves on maintenance costs. All work is trackable with our Asset Management program.
