Subject: **Tucson Water & Arizona Department of Water Resources (ADWR)
Leak Detection Program – 2023 Final Monitoring Report Deliverable**

2023
Final Report

WATER MANAGEMENT
ASSISTANCE PROGRAM

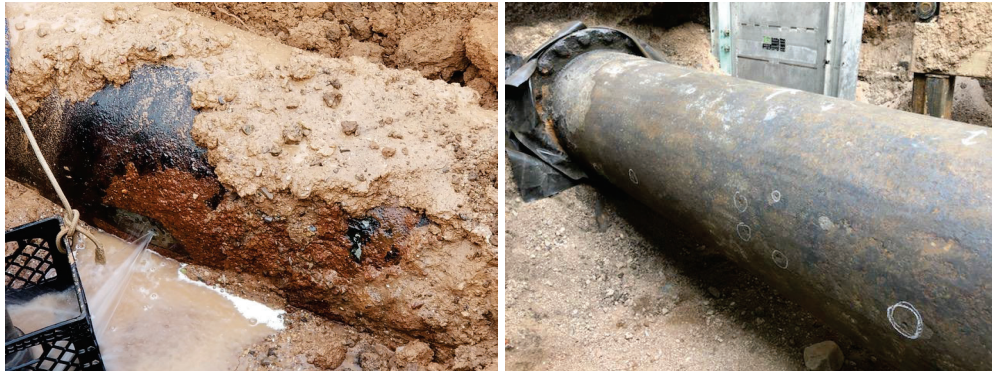
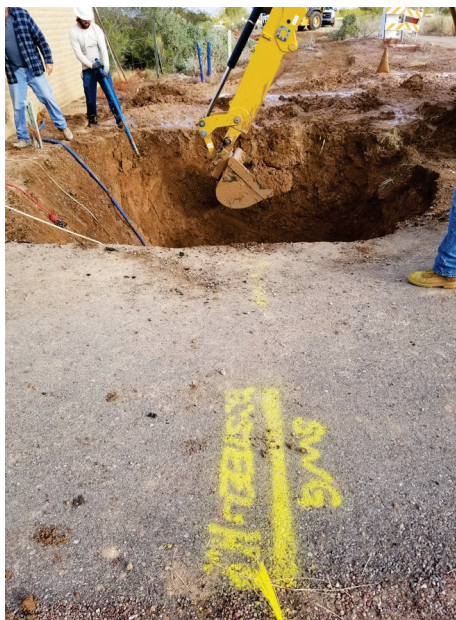
Site two – remedial measure: existing 30” welded steel pipeline was excavated, and forensics identified severe pitting on the pipeline from outside in and one through wall penetration causing a severe leak. The pipe was repaired by new welded collar straps, a new coating installed, and a new sacrificial cathodic protection system was designed, and electrically wired for the cp system, new 32lb. high potential magnesium anodes were installed and wired into an above ground junction box with a new corrosion test station.

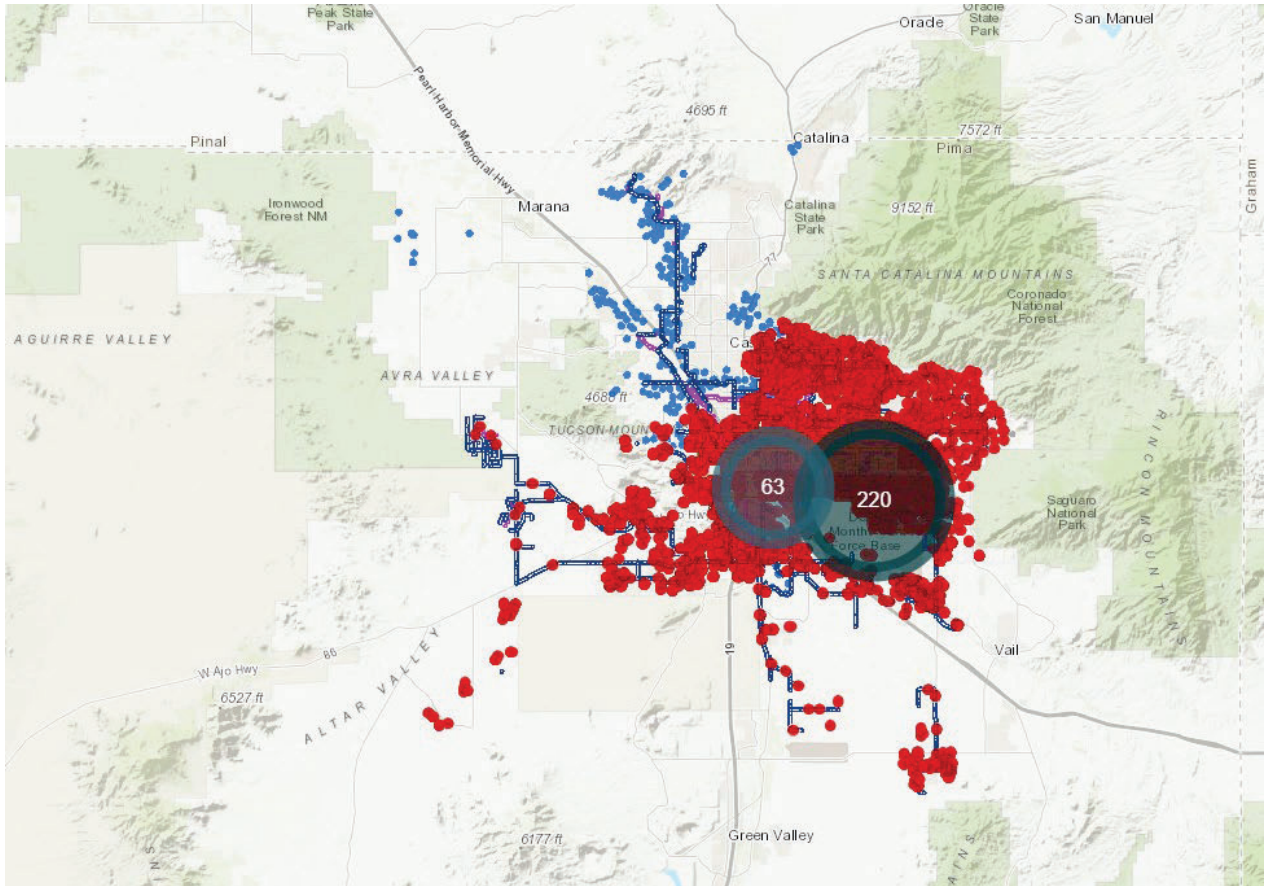
Overview – City of Tucson Water Infrastructure (Project Tracker).
