Upon arriving at Tuba, Arizona, to investigate the reconstruction of the dam in the Moencopi Wash, we found a temporary earth embankment had been built on that portion of the old dam yet remaining. This bank diverted the water from the Wash into the ditch that irrigates the school farm and Indian lands below. We were told it was the fourth time this season the bank had been replaced, at a considerable cost and with much delay to farming operations.

DAM IN INDIAN WASH
TUBA ARIZONA

DAM IN MOUNGOPIE WASH

TUBA ARIZONA

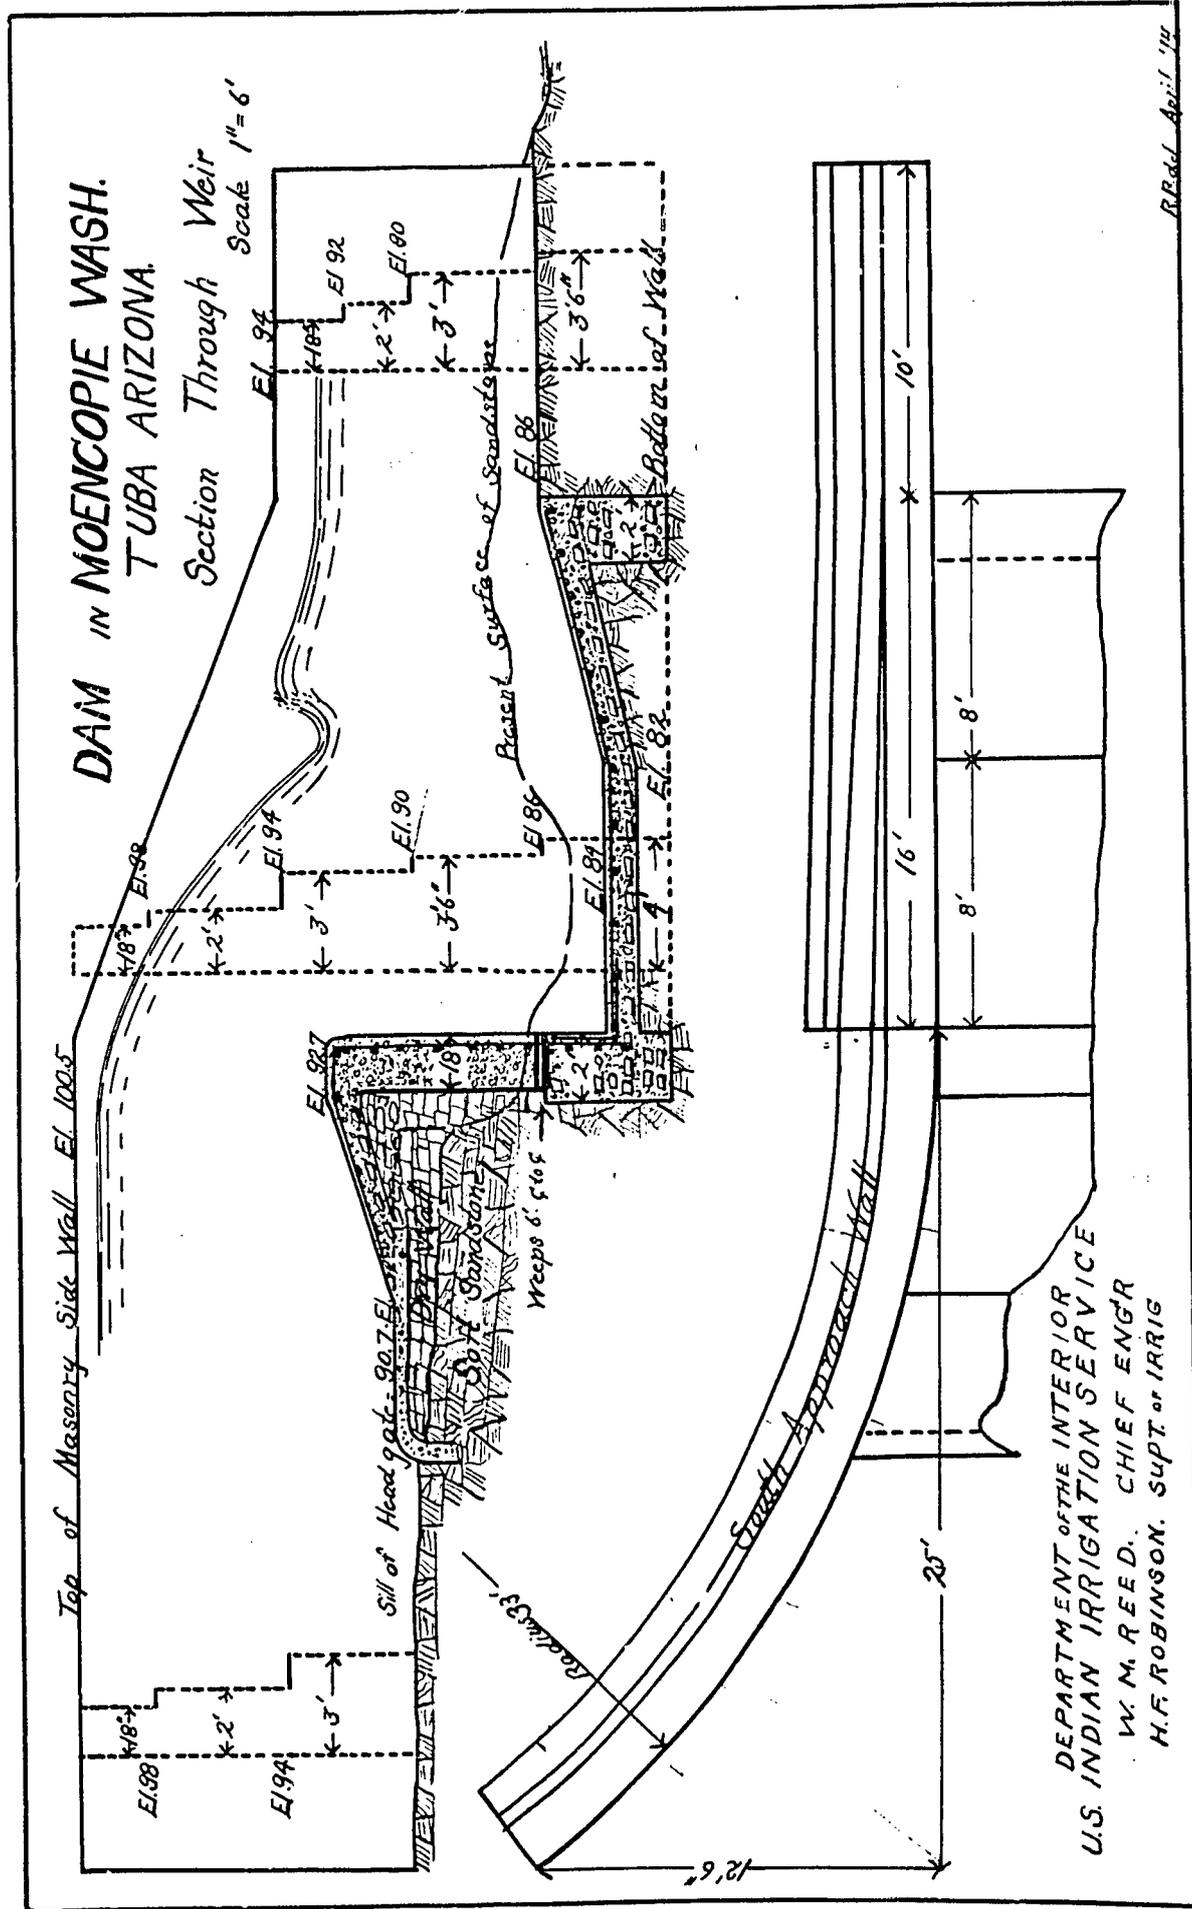
DAM IN MOENCOPIE WASH. TUBA ARIZONA.

Section Through Weir
Scale 1"=6'

The construction of the weir in panels was adopted for several reasons: To simplify form work and save lumber for forms, to avoid shrinkage cracks or rather to confine same to panel points where the steel will tie the panels together, and as the concrete must be all hand mixed, to have separate units and avoid the stopping of the day's work at any but the completed units as shown.
