REVIEW OF THE  
GEOLOGY AND HYDROLOGY  
OF LITTLE SYCAMORE CREEK  
YAVAPAI COUNTY, ARIZONA

for  
Cyprus Bagdad Copper Company

by  
Paul A. Manera, P.E.

April 24, 1975

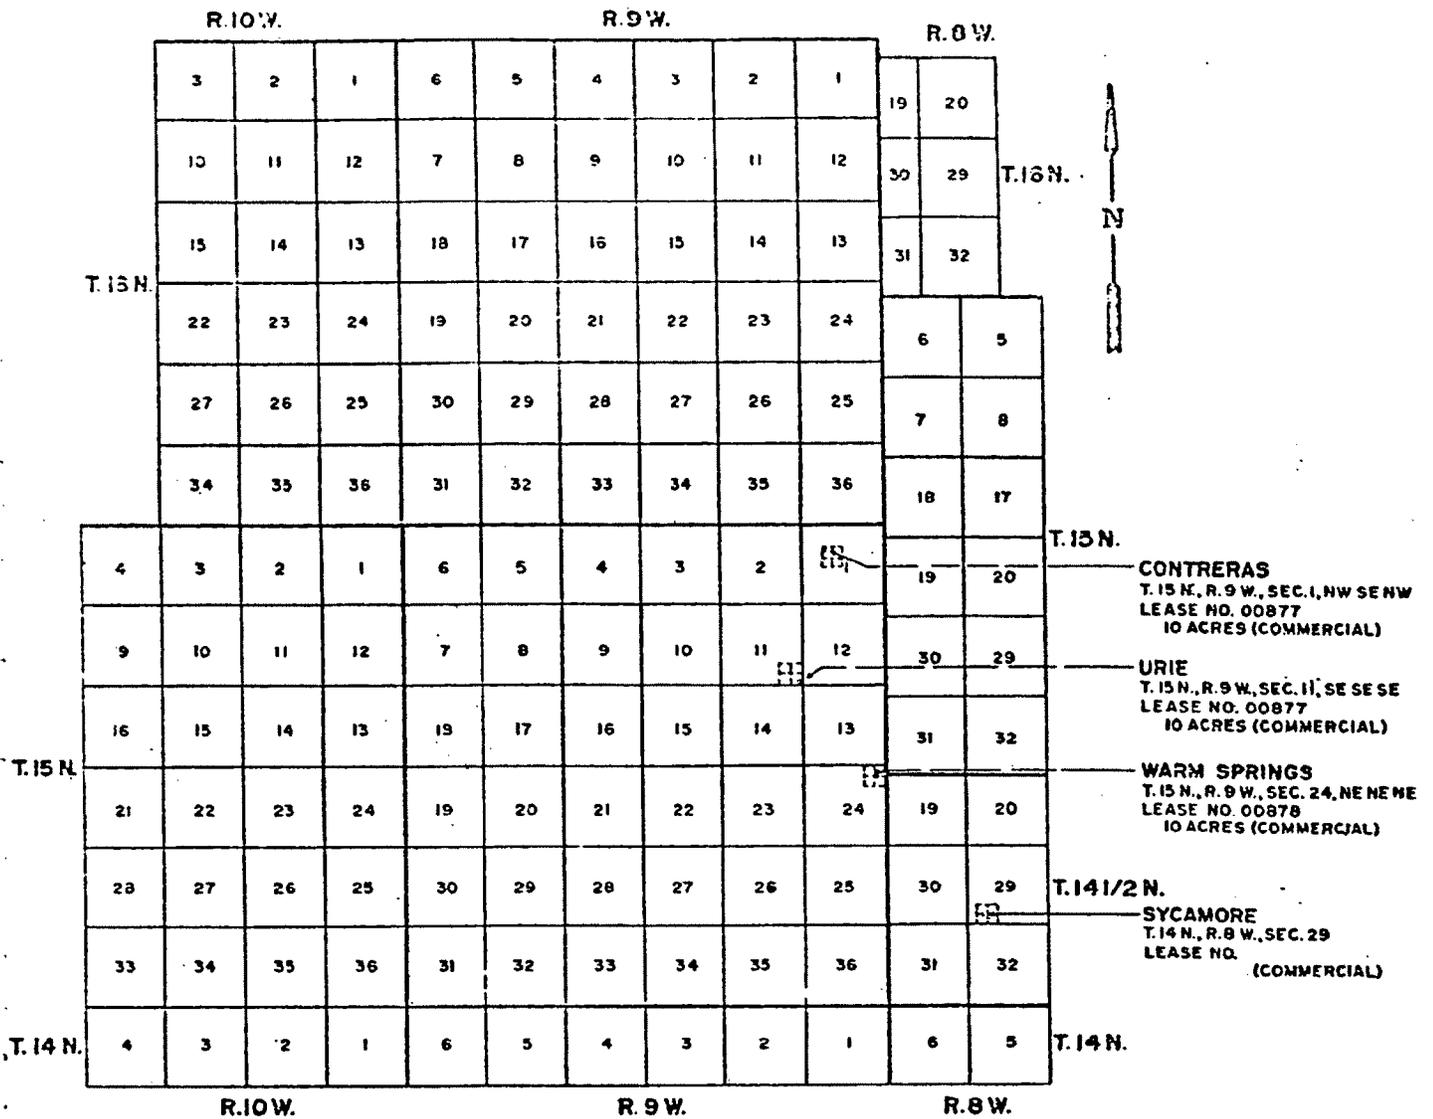
FIGURE 1

CYPRUS - BAGDAD COPPER COMPANY  
WATER WELL SITES

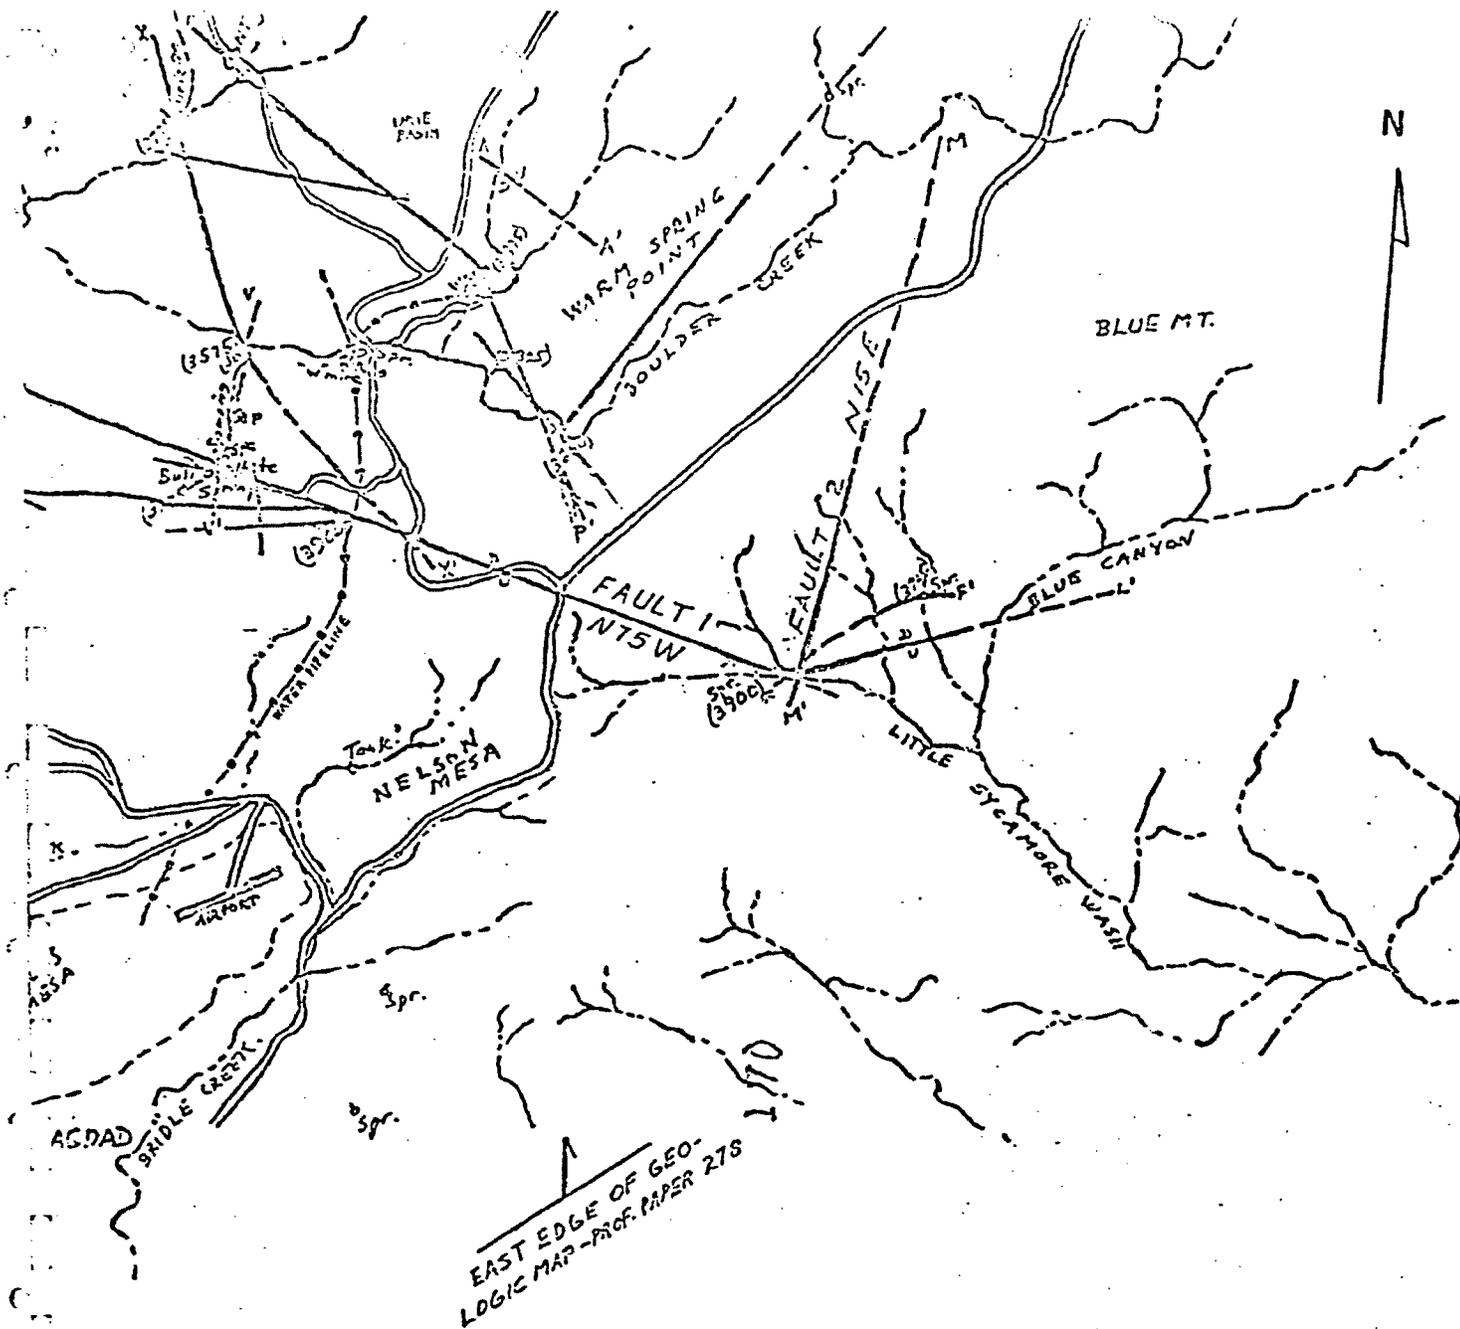
CYPRUS BAGDAD COPPER CO.  
 SKETCH MAP FROM AERIAL  
 PHOTOGRAPHS SHOWING THE  
 FAULT INTERSECTION AT  
 SYCAMORE CREEK

DATA FROM TURNER & ASSOCIATES  
 SCALE 1/60,000 (APPROXIMATE)

The analysis of the aerial photographs indicated one major fault, one secondary fault and one or more minor faults intersecting in or near Little Sycamore Wash in Section 29, T. 14½ N., R. 8 W. The faulting, as determined from the aerial photographs, is shown on Figure 2. The upper Sycamore seep is located in a fine grained intrusive rock. The strike of the shear zone is N 72° W with a dip of 86° to the north. This correlates with the fault direction of N 75° W established by Turner in his earlier studies. The lower Sycamore seep is located in the shear zone of the secondary fault (Fault 2 on Figure 2). The strike of the shear zone was measured at N 20° E with vertical shearing compared to Turner's projection of N 15° E. The intersection of the two faults is slightly south of the present stream bed.
