Groundwater Conditions in Southeast Arizona

*Pearce Sunsites Community Meeting
September 23, 2014*

*Michael J. Lacey, Director
Arizona Department of Water Resources*

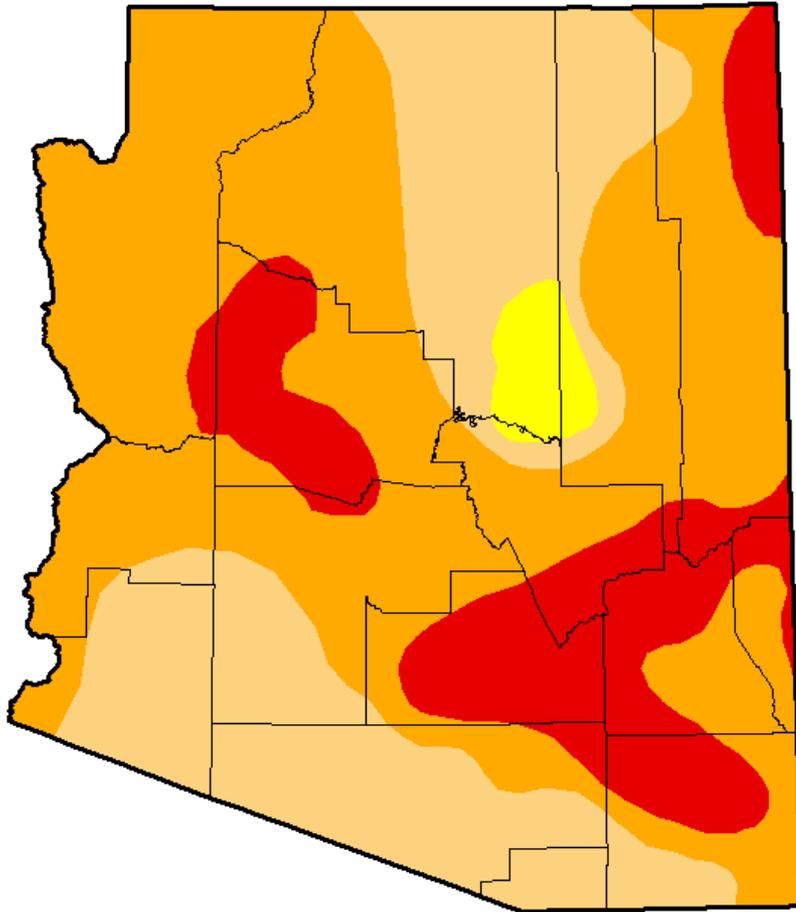
July 29, 2014

Short Term Drought Status Map

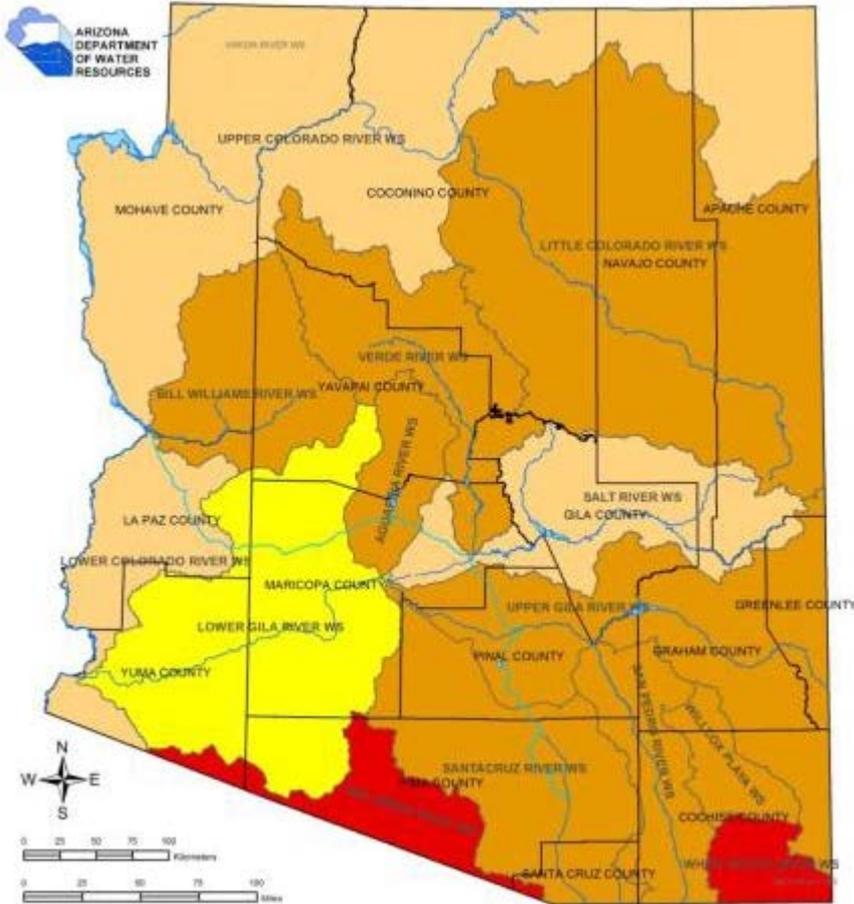
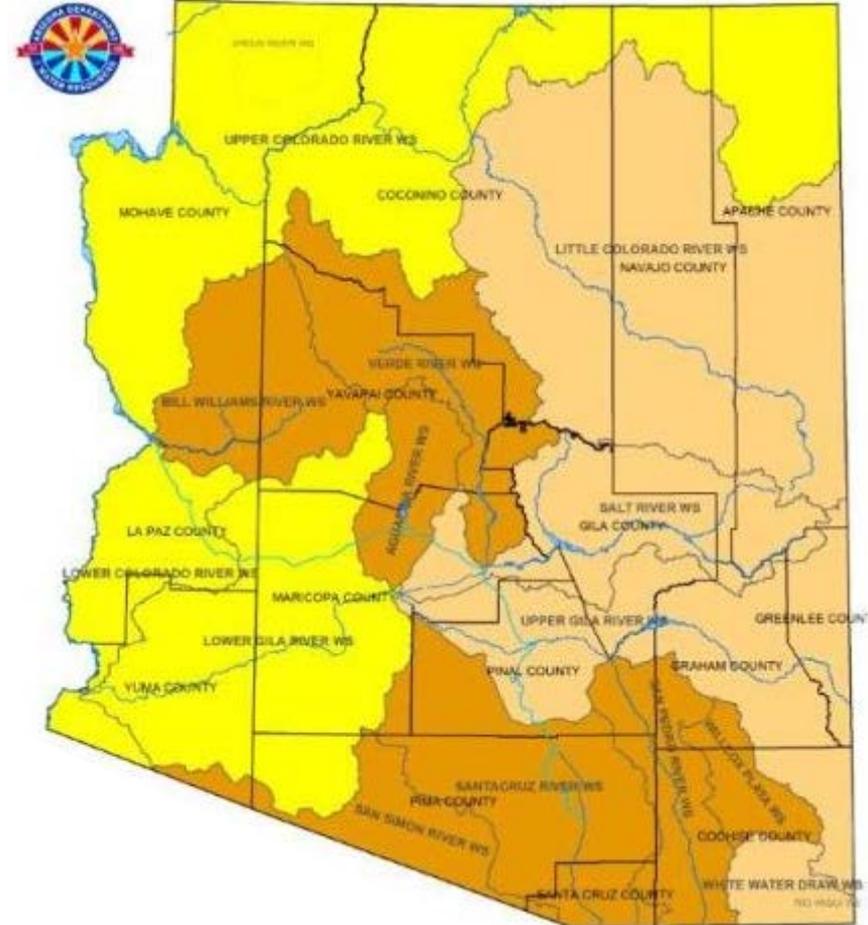
Long Term Drought Status Map

July 2013

July 2014

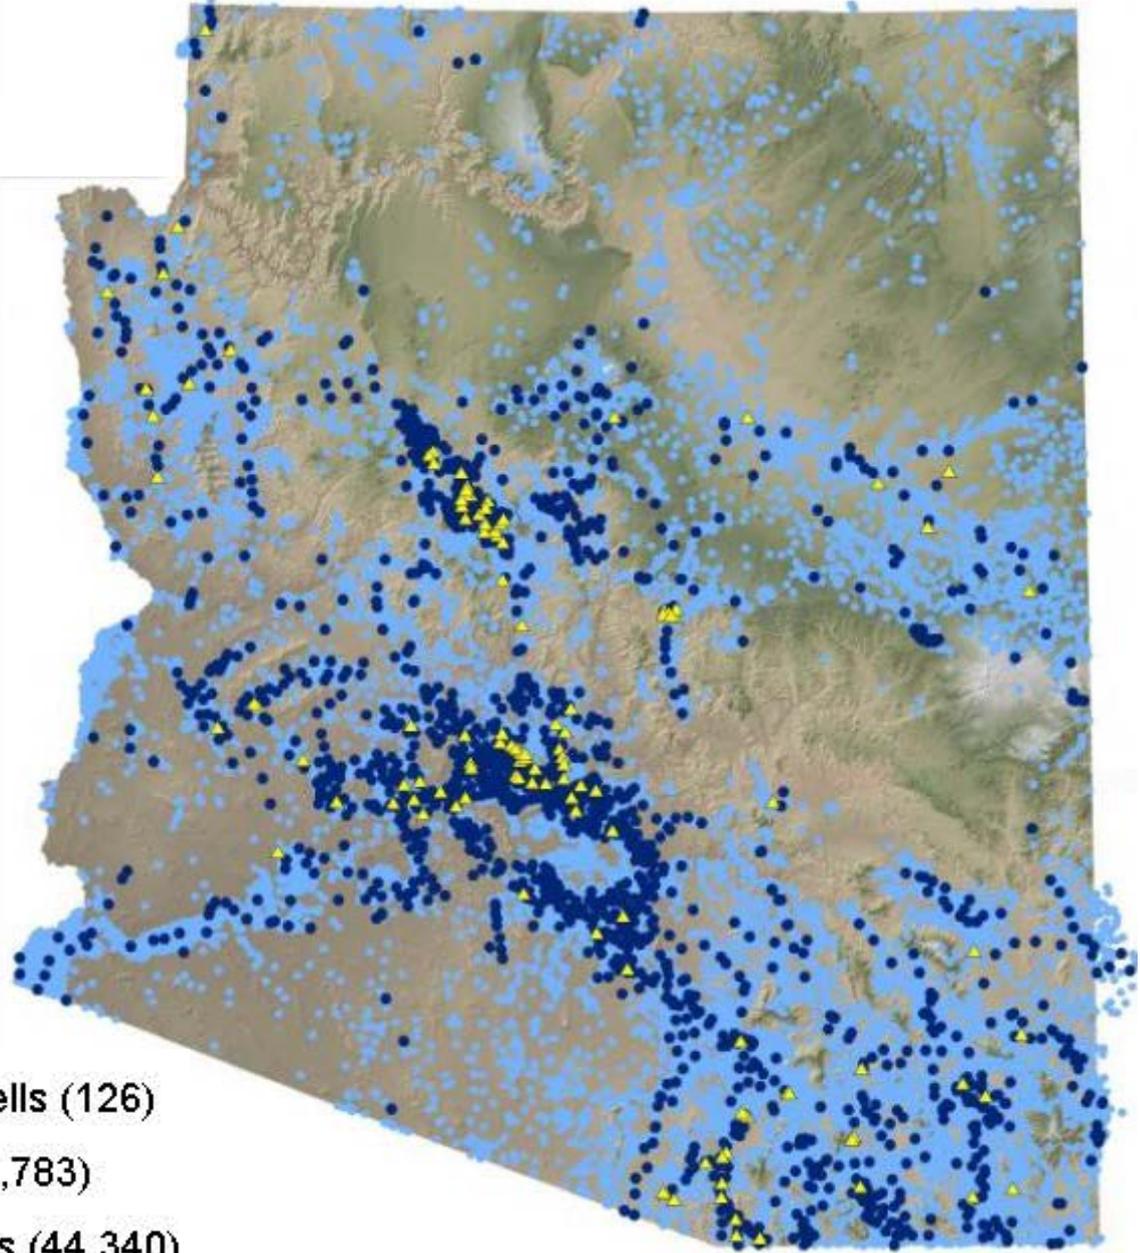
Groundwater Wells Used to Monitor Annual Changes in Groundwater Levels

- ▲ Automated Wells (126)
- Index Wells (1,783)
- All GWSI Wells (44,340)

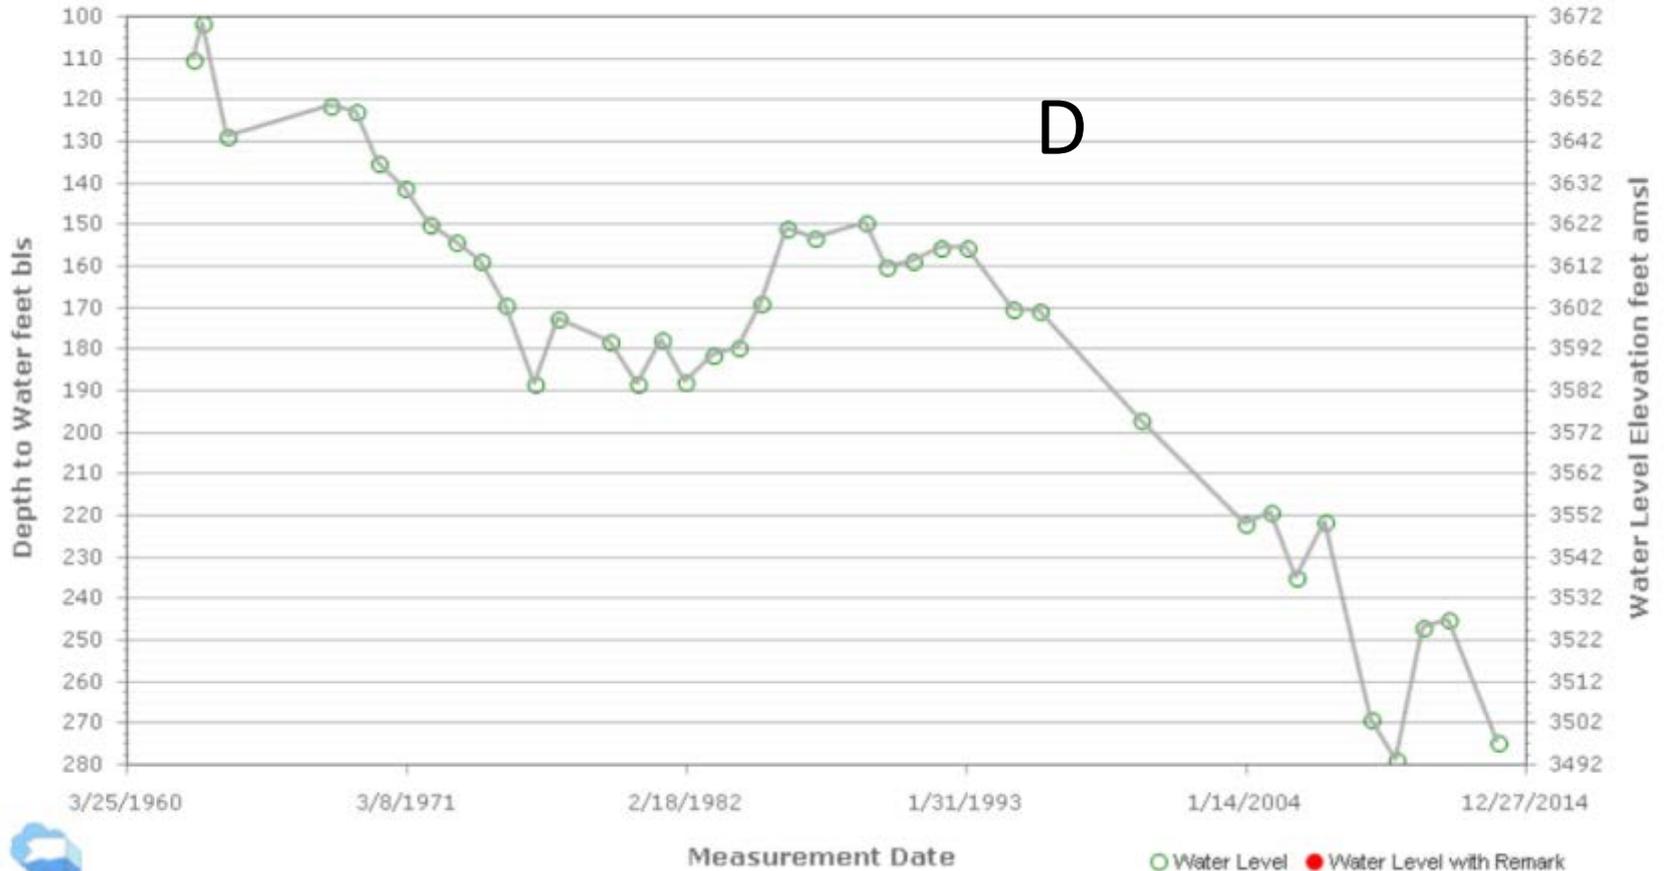
Hydrograph for Well near San Simon

Local ID	Site ID	Registry ID	Latitude NAD27	Longitude NAD27	Alt. (ft amsl)	Water Use	Well Depth (ft)	Case Dia. (in)	Drill Date	Latest WL Date	DTW (ft)	WL Elev. (ft)
D-14-31 35BCC	321016109094501		32° 10' 12.8"	109° 9' 27.5"	3772	IRRIGATION	800	16	12/24/1958	11/6/2013	274.6	3497.4

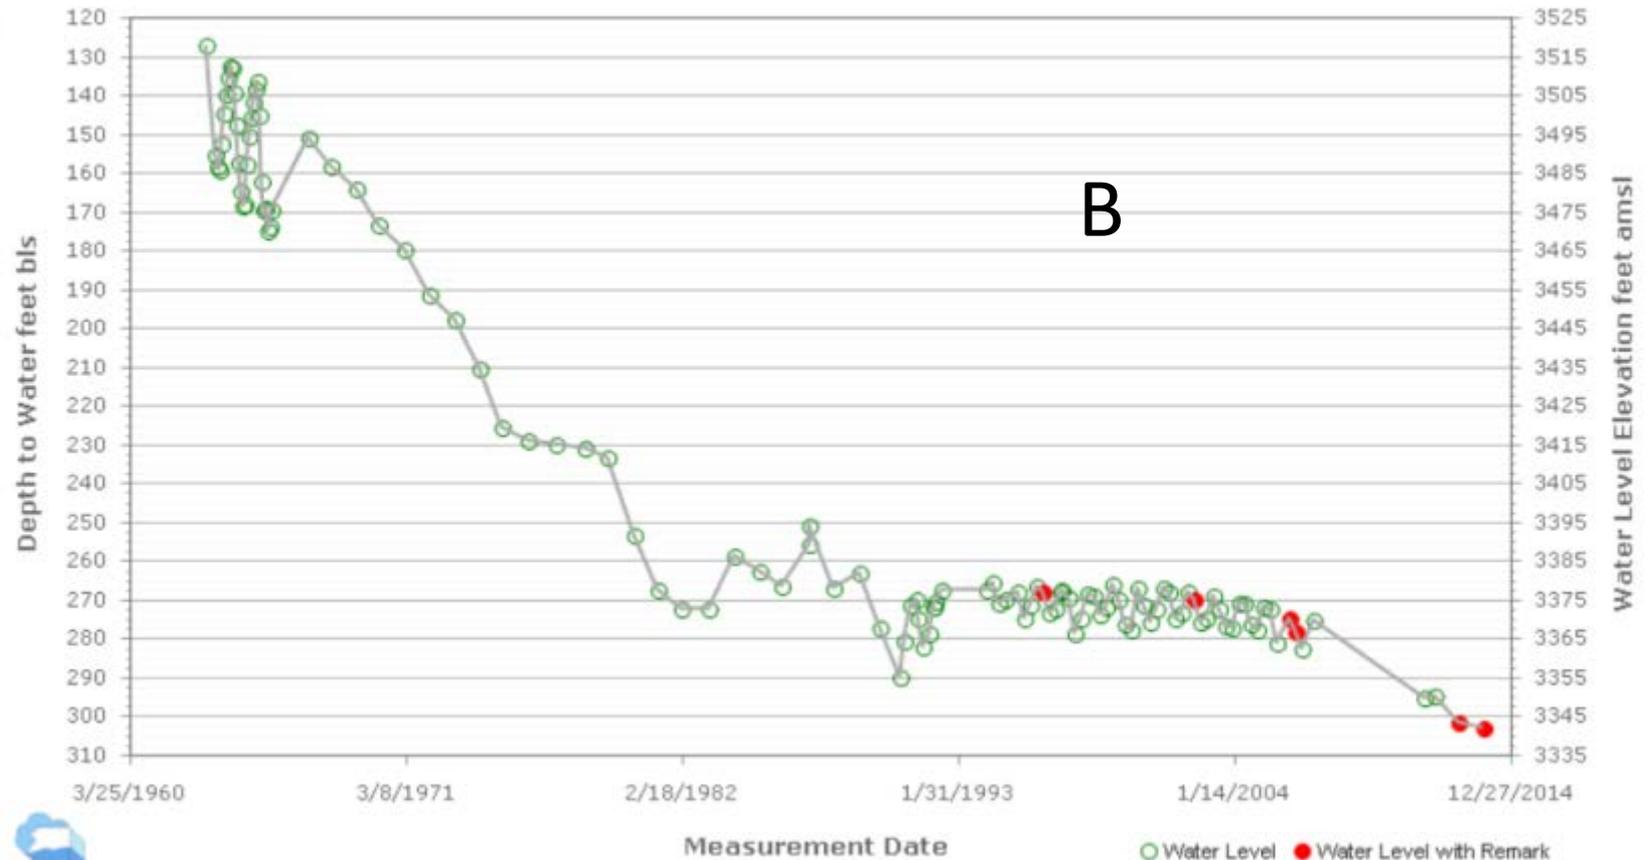
Hydrograph for Well near Bowie

Local ID	Site ID	Registry ID	Latitude NAD27	Longitude NAD27	Alt. (ft amsl)	Water Use	Well Depth (ft)	Case Dia. (in)	Drill Date	Latest WL Date	DTW (ft)	WL Elev. (ft)
D-12-28 25DCC	322116109262201		32° 21' 16.8"	109° 26' 24.3"	3645	UNUSED	1700	18	9/1/1955	11/29/2011	294.2	3350.8

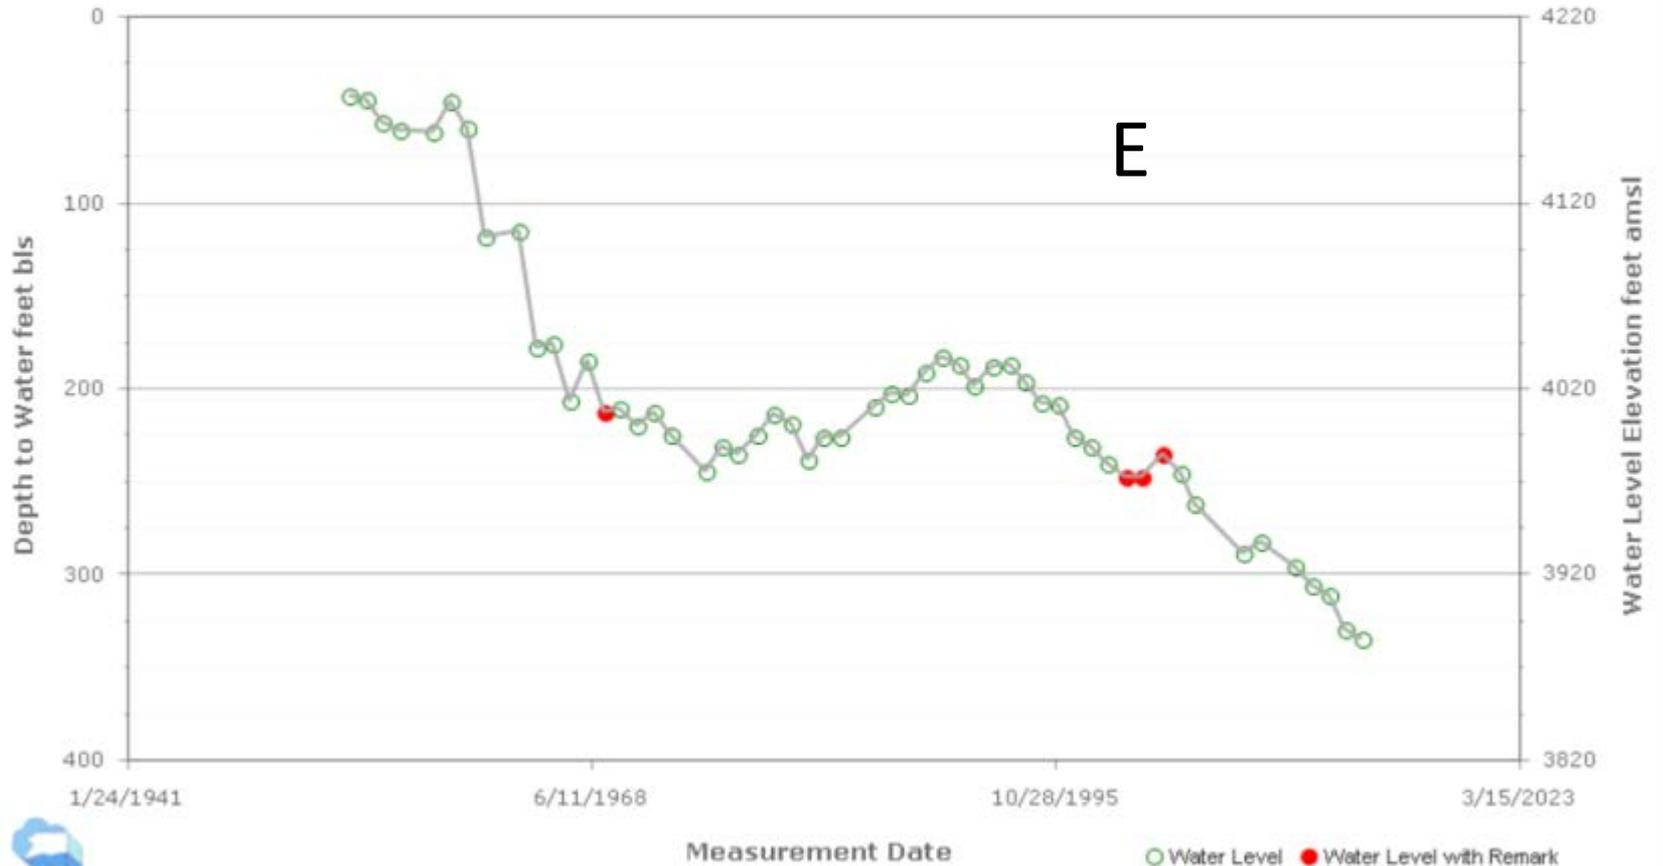
Hydrograph for Well in the Willcox Basin

Local ID	Site ID	Registry ID	Latitude NAD27	Longitude NAD27	Alt. (ft amsl)	Water Use	Well Depth (ft)	Case Dia. (in)	Drill Date	Latest WL Date	DTW (ft)	WL Elev. (ft)
D-15-25 25AAD	320614109442401	604416	32° 6' 17.6"	109° 44' 20.4"	4220	IRRIGATION	515	18	8/1/1953	11/6/2013	334.7	3885.3

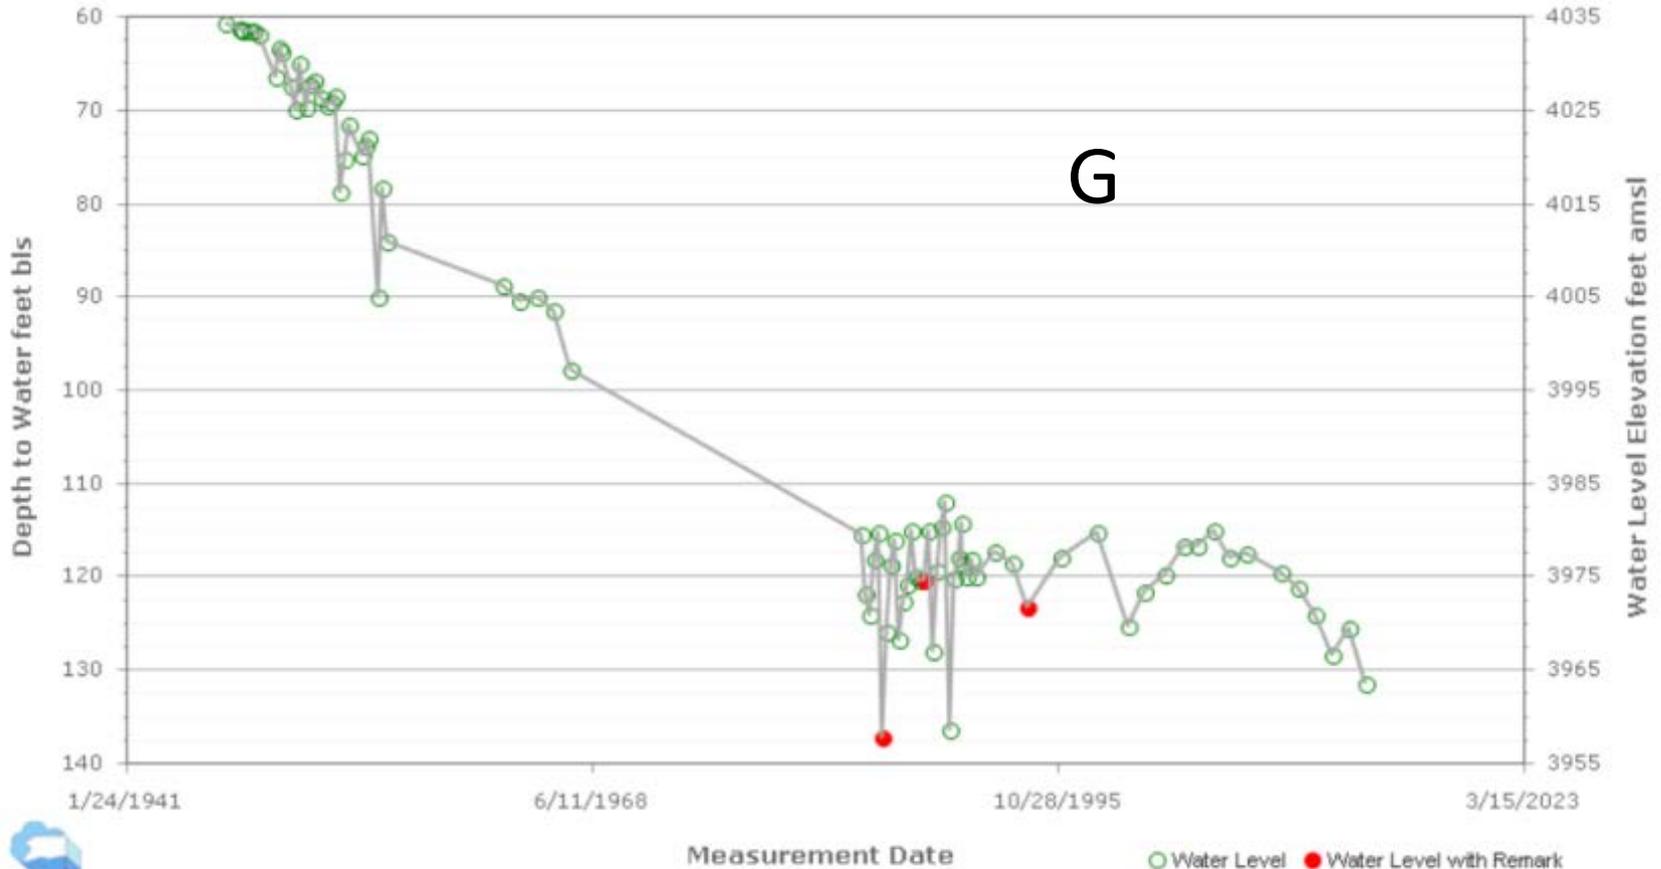
Hydrograph for Well in Douglas INA

Local ID	Site ID	Registry ID	Latitude NAD27	Longitude NAD27	Alt. (ft amsl)	Water Use	Well Depth (ft)	Case Dia. (in)	Drill Date	Latest WL Date	DTW (ft)	WL Elev. (ft)
D-22-26 04DAD	313242109415501		31° 32' 41.4"	109° 41' 52.8"	4095	DOMESTIC	275	12	5/1/1946	11/6/2013	131.3	3963.7

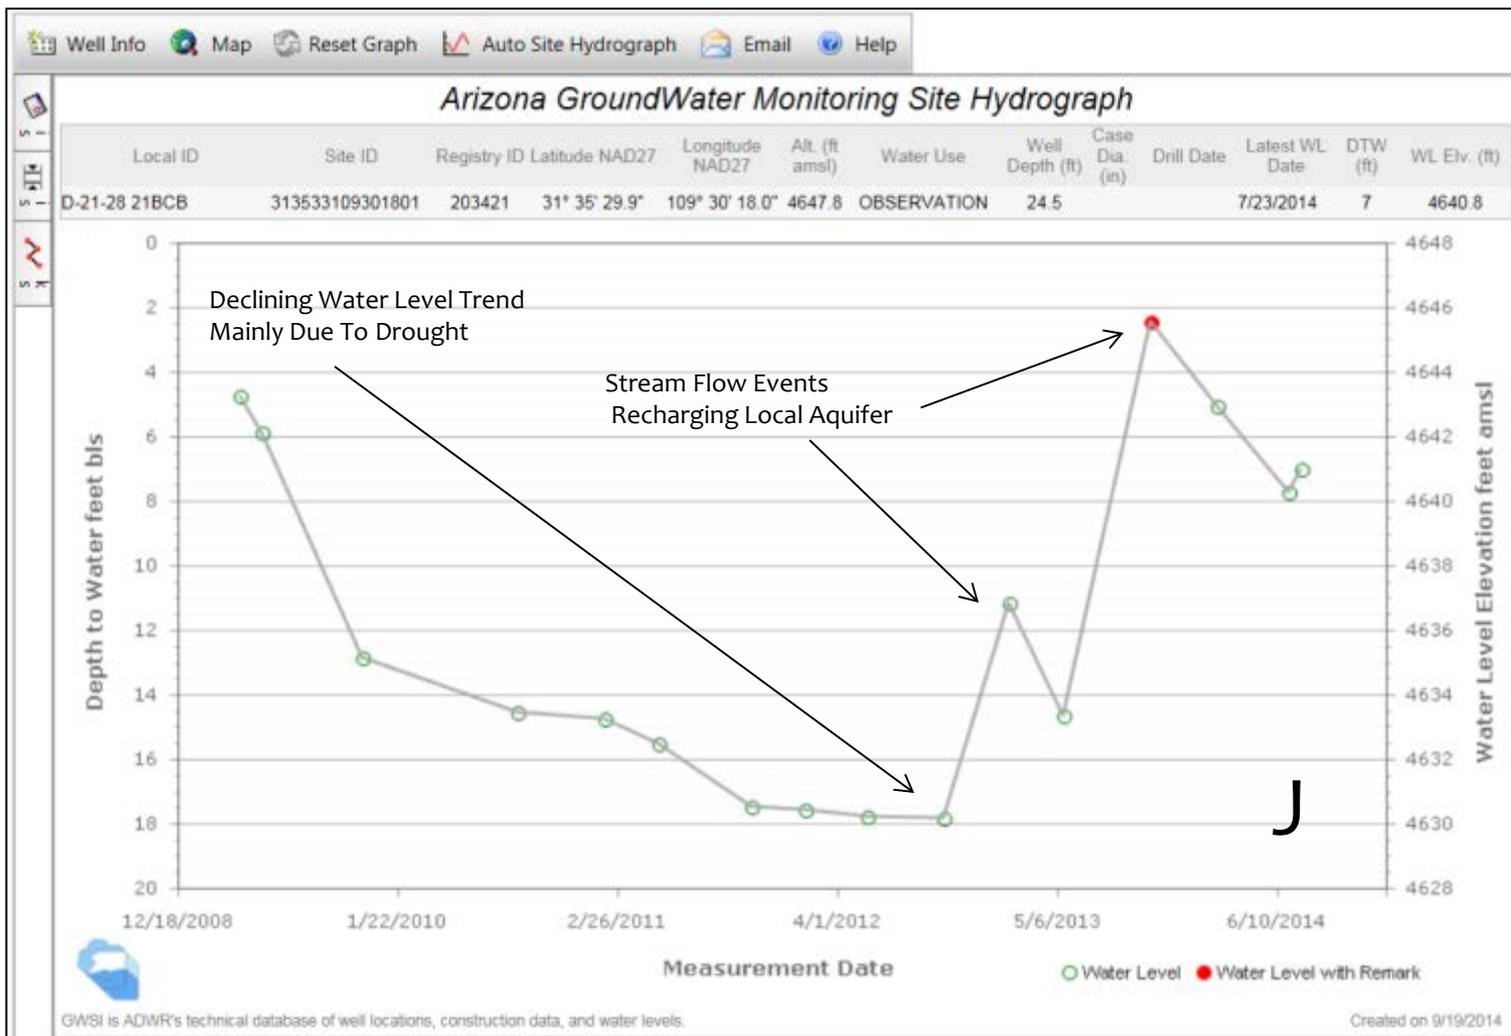
Hydrograph for Leslie Canyon Well (Located on the Southern Border of the Douglas INA)

Leslie Canyon well is a state drought index well that is remotely located in a bedrock area and essentially unaffected by regional groundwater pumping but sensitive to impacts of drought and recharge from stream flow in Leslie Canyon

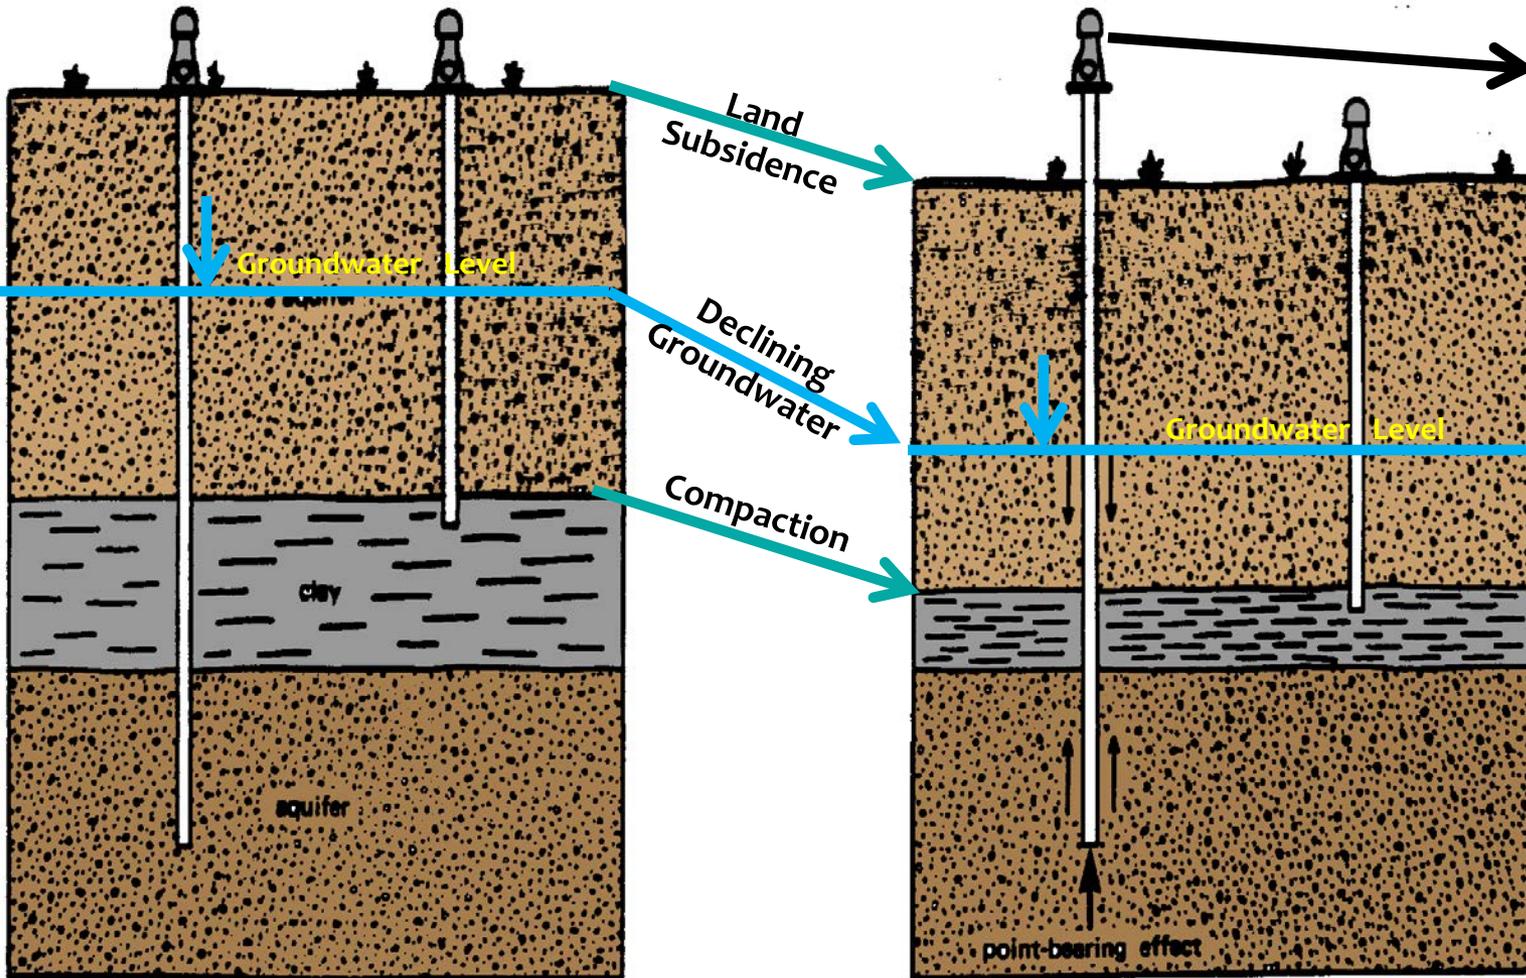
Land Subsidence and Groundwater Withdrawal

Displaced Well Example:
Located a mile northeast
of the Intersection of
Dragoon and Cochise
Stronghold Roads,
Cochise County, AZ

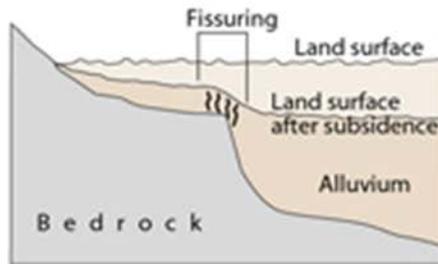
Earth Fissure Formation by Differential compaction

As the land surface subsides, alluvium stretches and eventually fails, generally in a region of abrupt change in alluvium thickness.

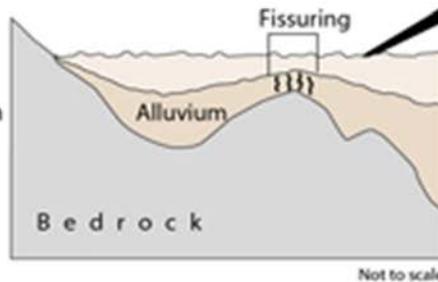
Fissures are concentrated in areas where the thickness of the alluvium changes, such as near the margin of basins or where bedrock is near the surface.

Lateral stresses induce tension cracking.

Surface water infiltrates, dissolving the natural cement bonding the soil, connecting hairline cracks, and further eroding and enlarging the fissure.

Fissure progressively enlarges, capturing surface runoff, sediment, and debris. Eventually vegetation establishes itself, creating a line of vegetation along the trace of the fissure.

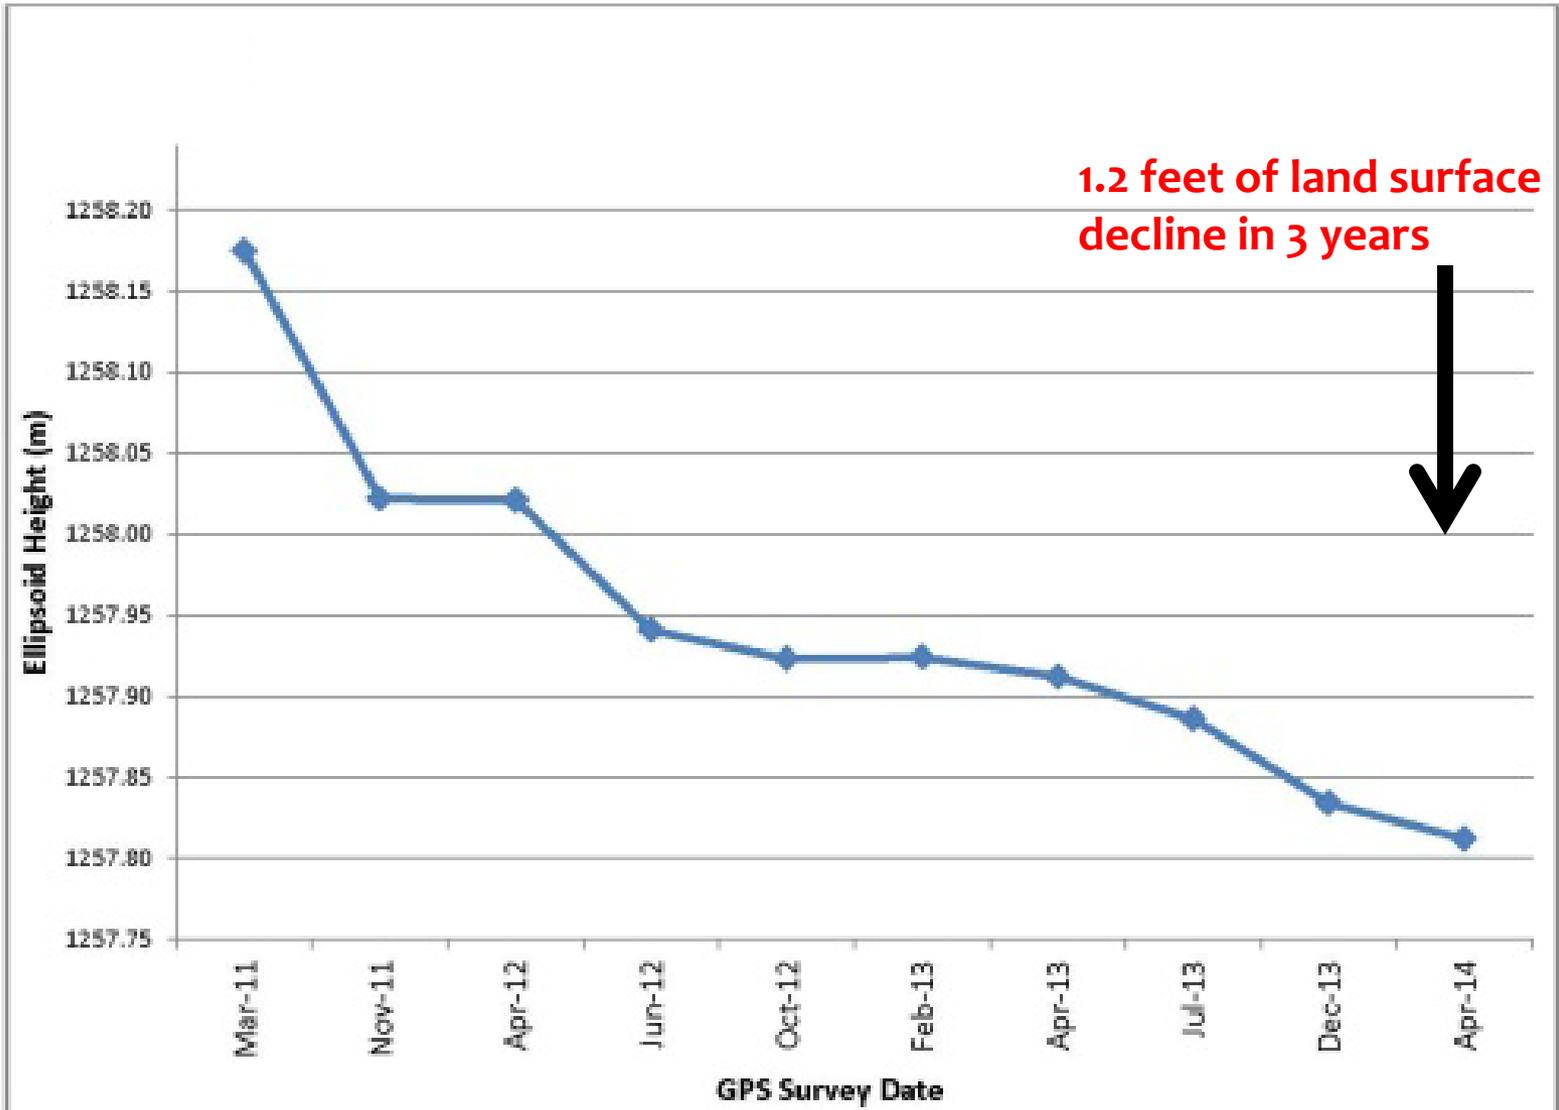
Cochise County GPS Survey for Land Subsidence Monitoring and InSAR Support (March 2011 through April 2014)

Graph 2 – GPS Survey data for land subsidence along Dragoon Rd in the Kansas Settlement Land Subsidence Feature

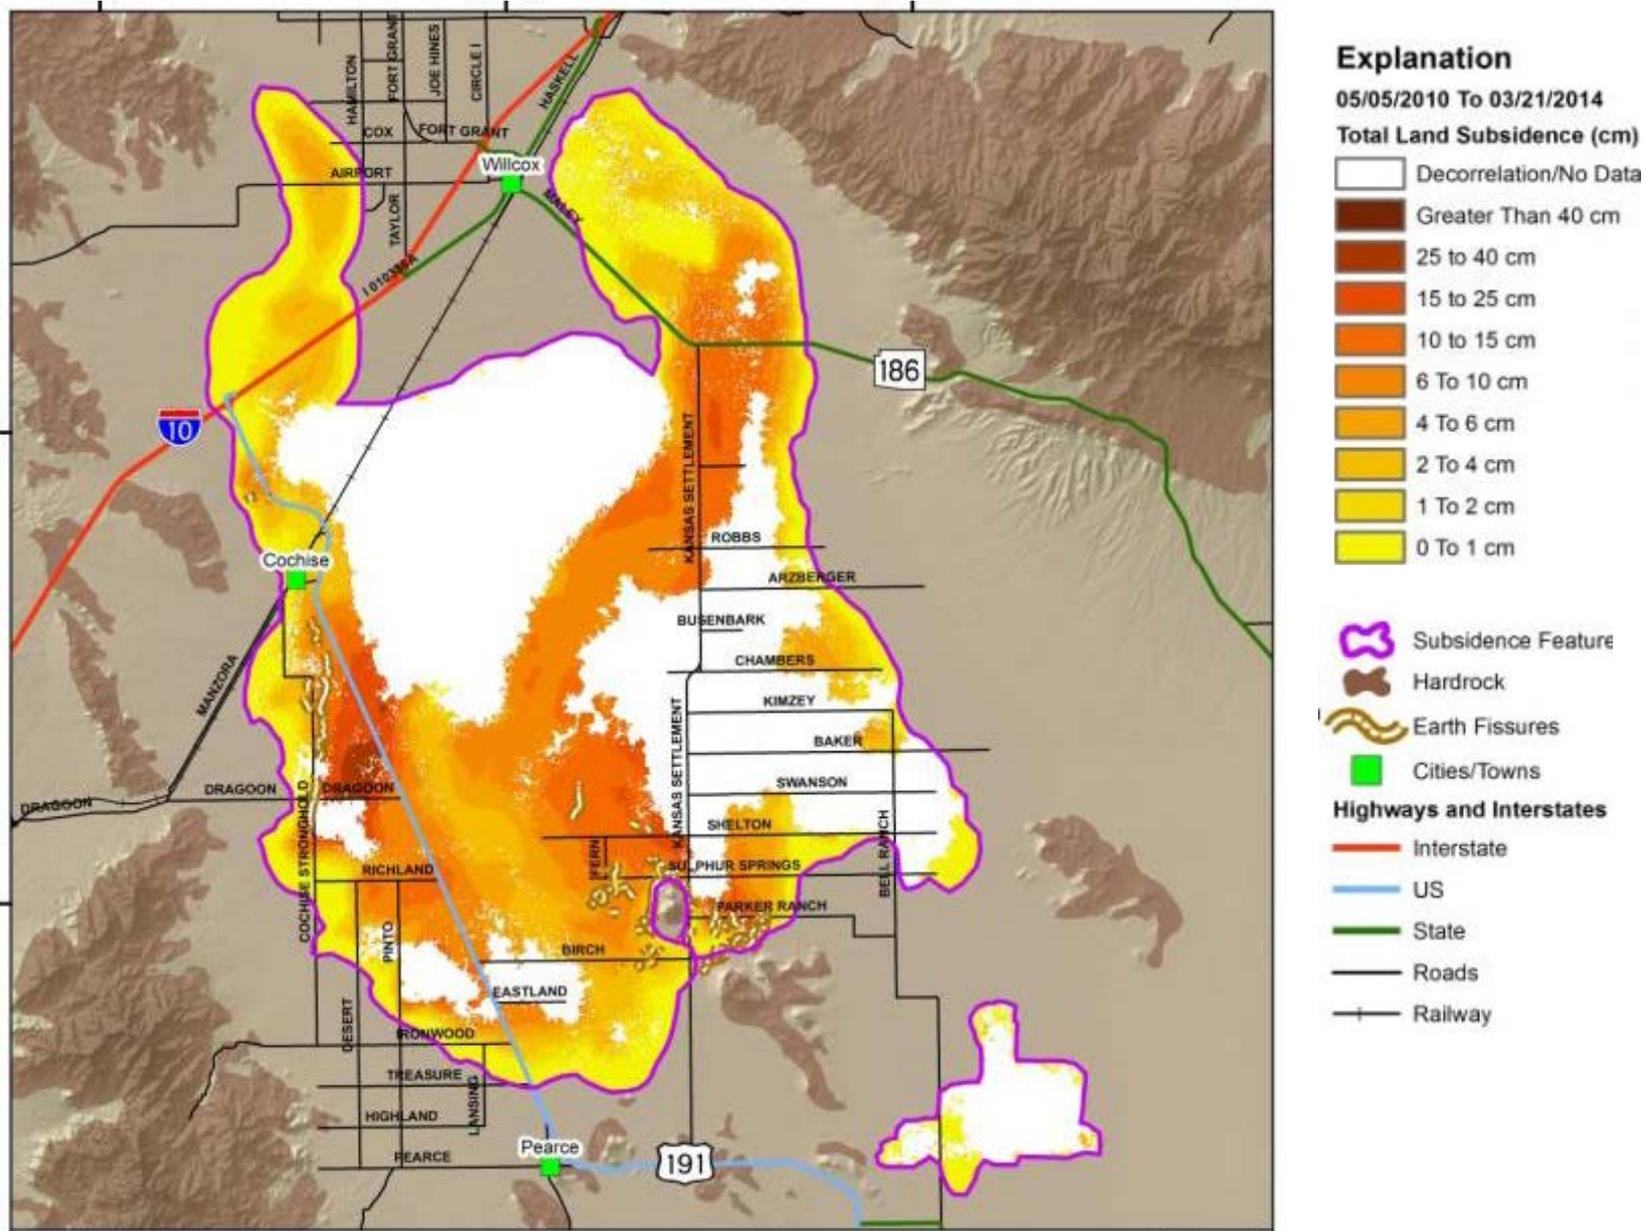
Land Subsidence in the Willcox and Kansas Settlement Areas

May 2010 through March 2014
