Total Land Subsidence in the Bowie and San Simon Areas, Cochise County
 Based on ALOS-1 Satellite Interferometric Synthetic Aperture Radar (InSAR) Data

Time Period of Analysis: 3.0 Years 01/04/2007 To 01/12/2010

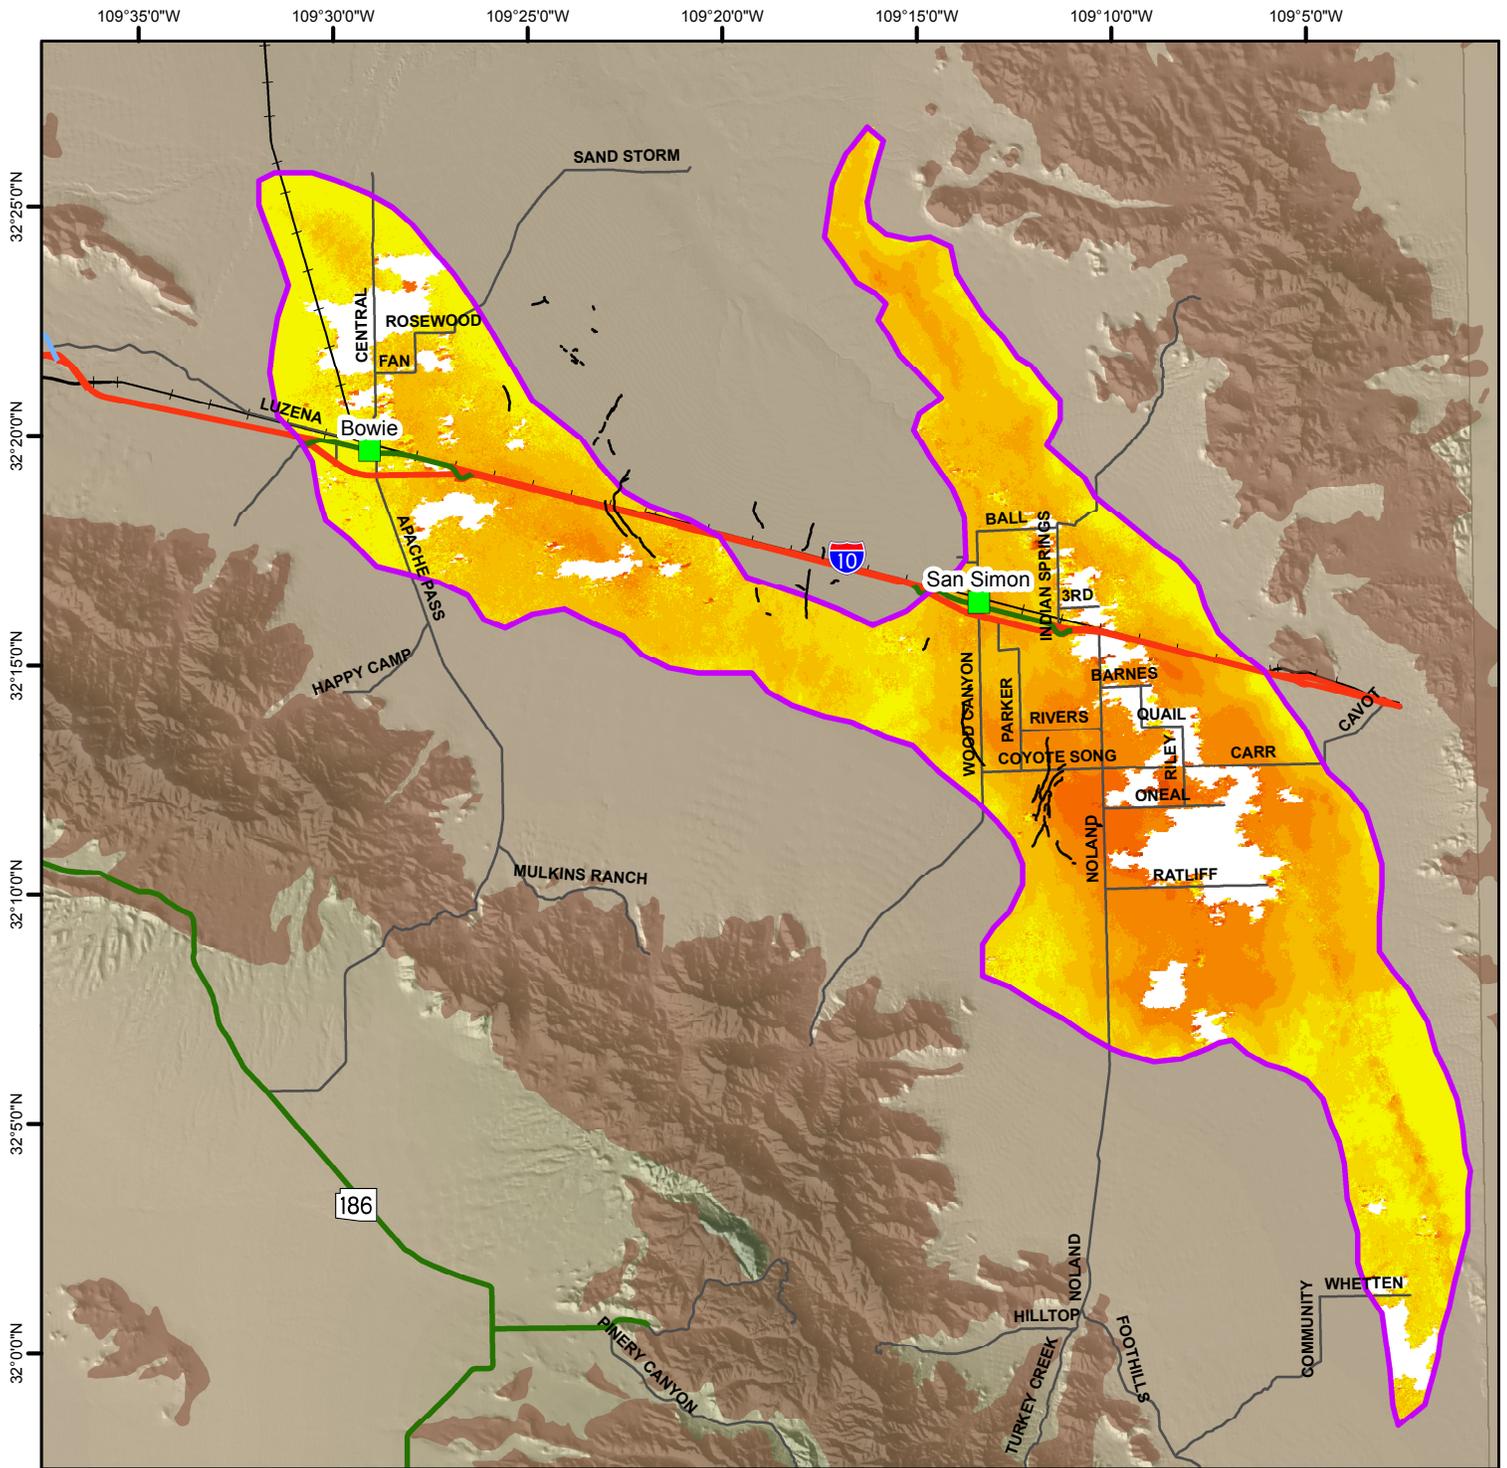
Decorrelation (white areas) are areas where the phase of the received satellite signal changed between satellite passes, causing the data to be unusable. This occurs in areas where the land surface has been disturbed (i.e. bodies of water, snow, agriculture areas, areas of development, etc).
