Total Land Subsidence in the Elfrida Area, Cochise County
 Based on ALOS-1 Satellite Interferometric Synthetic Aperture Radar (InSAR) Data
Time Period of Analysis: 4.2 Years 12/06/2006 To 02/01/2011

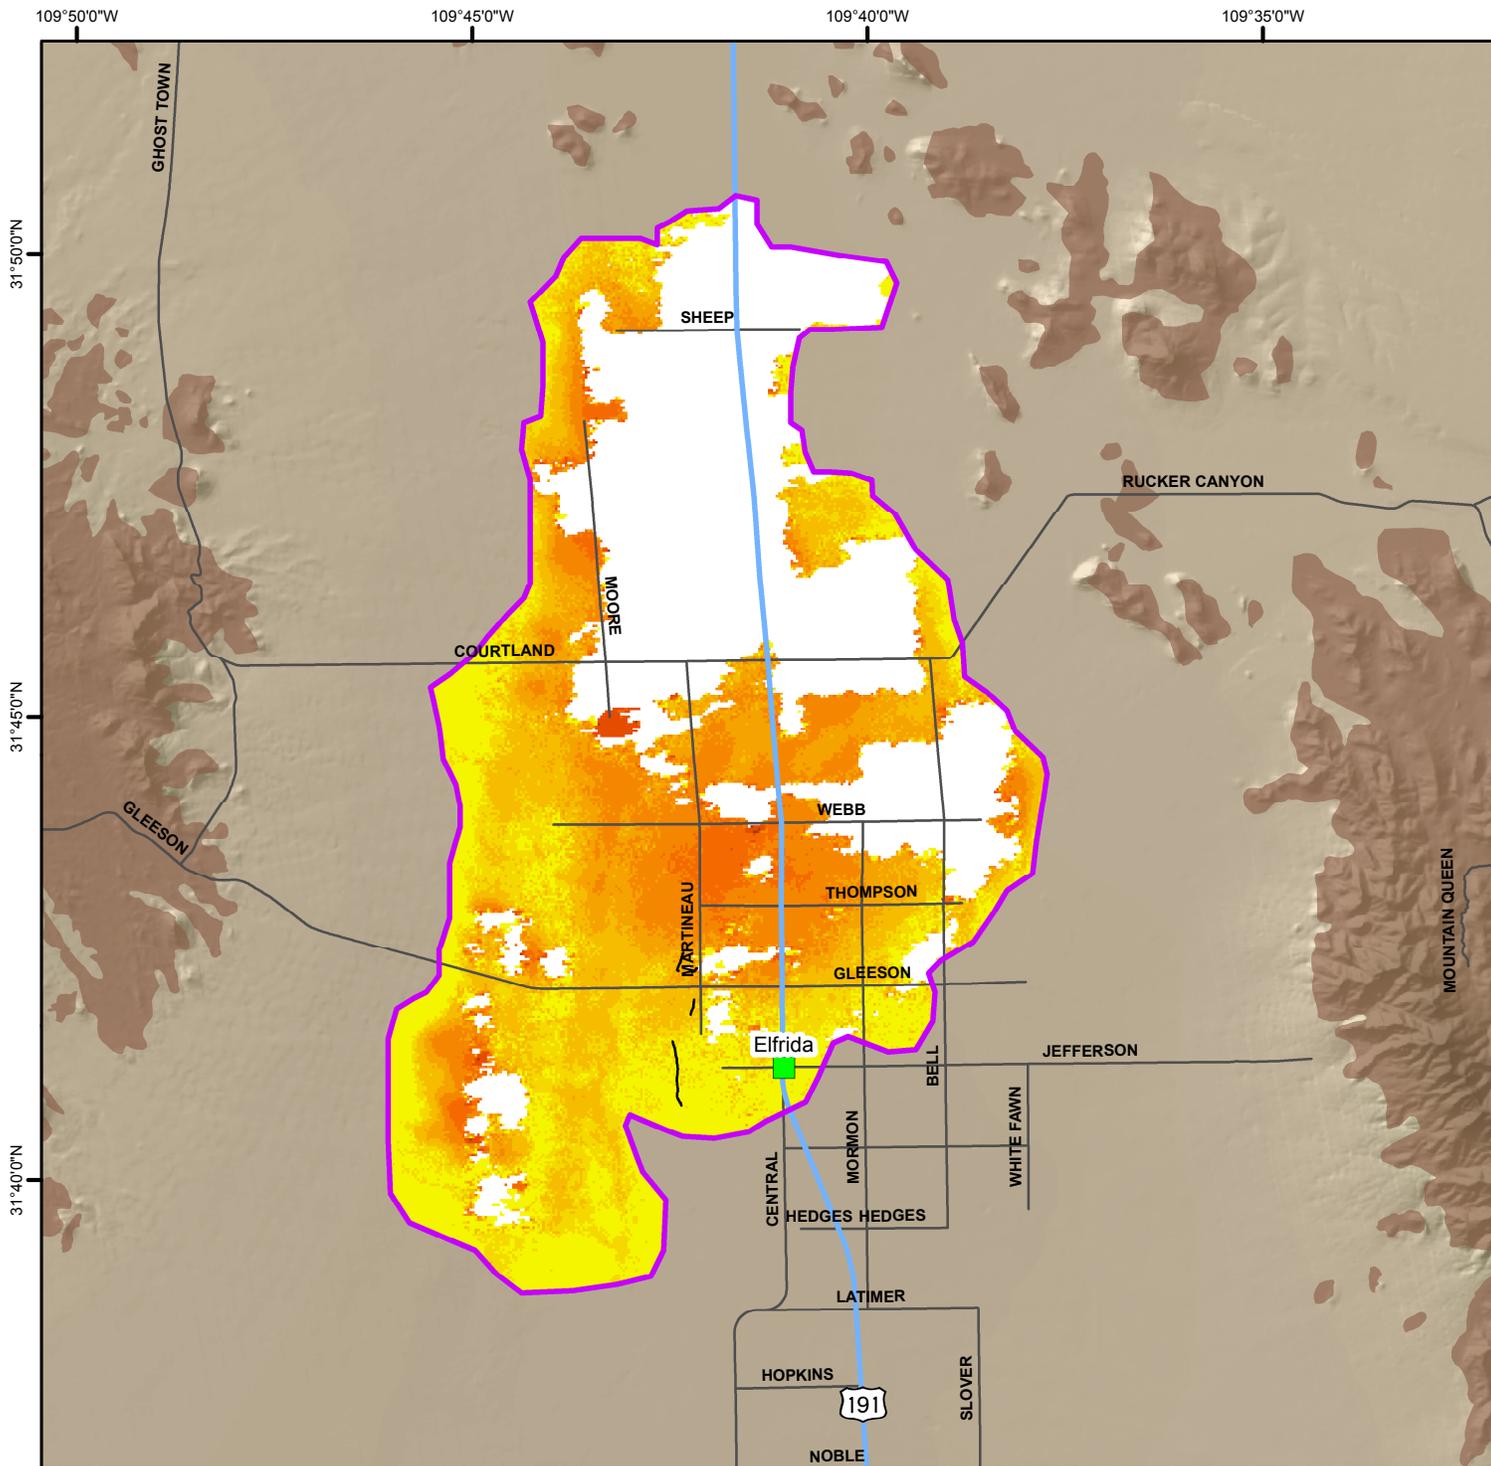
Decorrelation (white areas) are areas where the phase of the received satellite signal changed between satellite passes, causing the data to be unusable. This occurs in areas where the land surface has been disturbed (i.e. bodies of water, snow, agriculture areas, areas of development, etc).

Earth fissures were mapped by the Arizona Geological Survey. For information on earth fissures visit: www.azgs.gov/EFC
