**Total Land Subsidence in the Fort Grant Rd and Willcox Areas, Cochise County
Based on Envisat Satellite Interferometric Synthetic Aperture Radar (InSAR) Data**

Time Period of Analysis: 1.0 Years 01/20/2009 To 01/05/2010

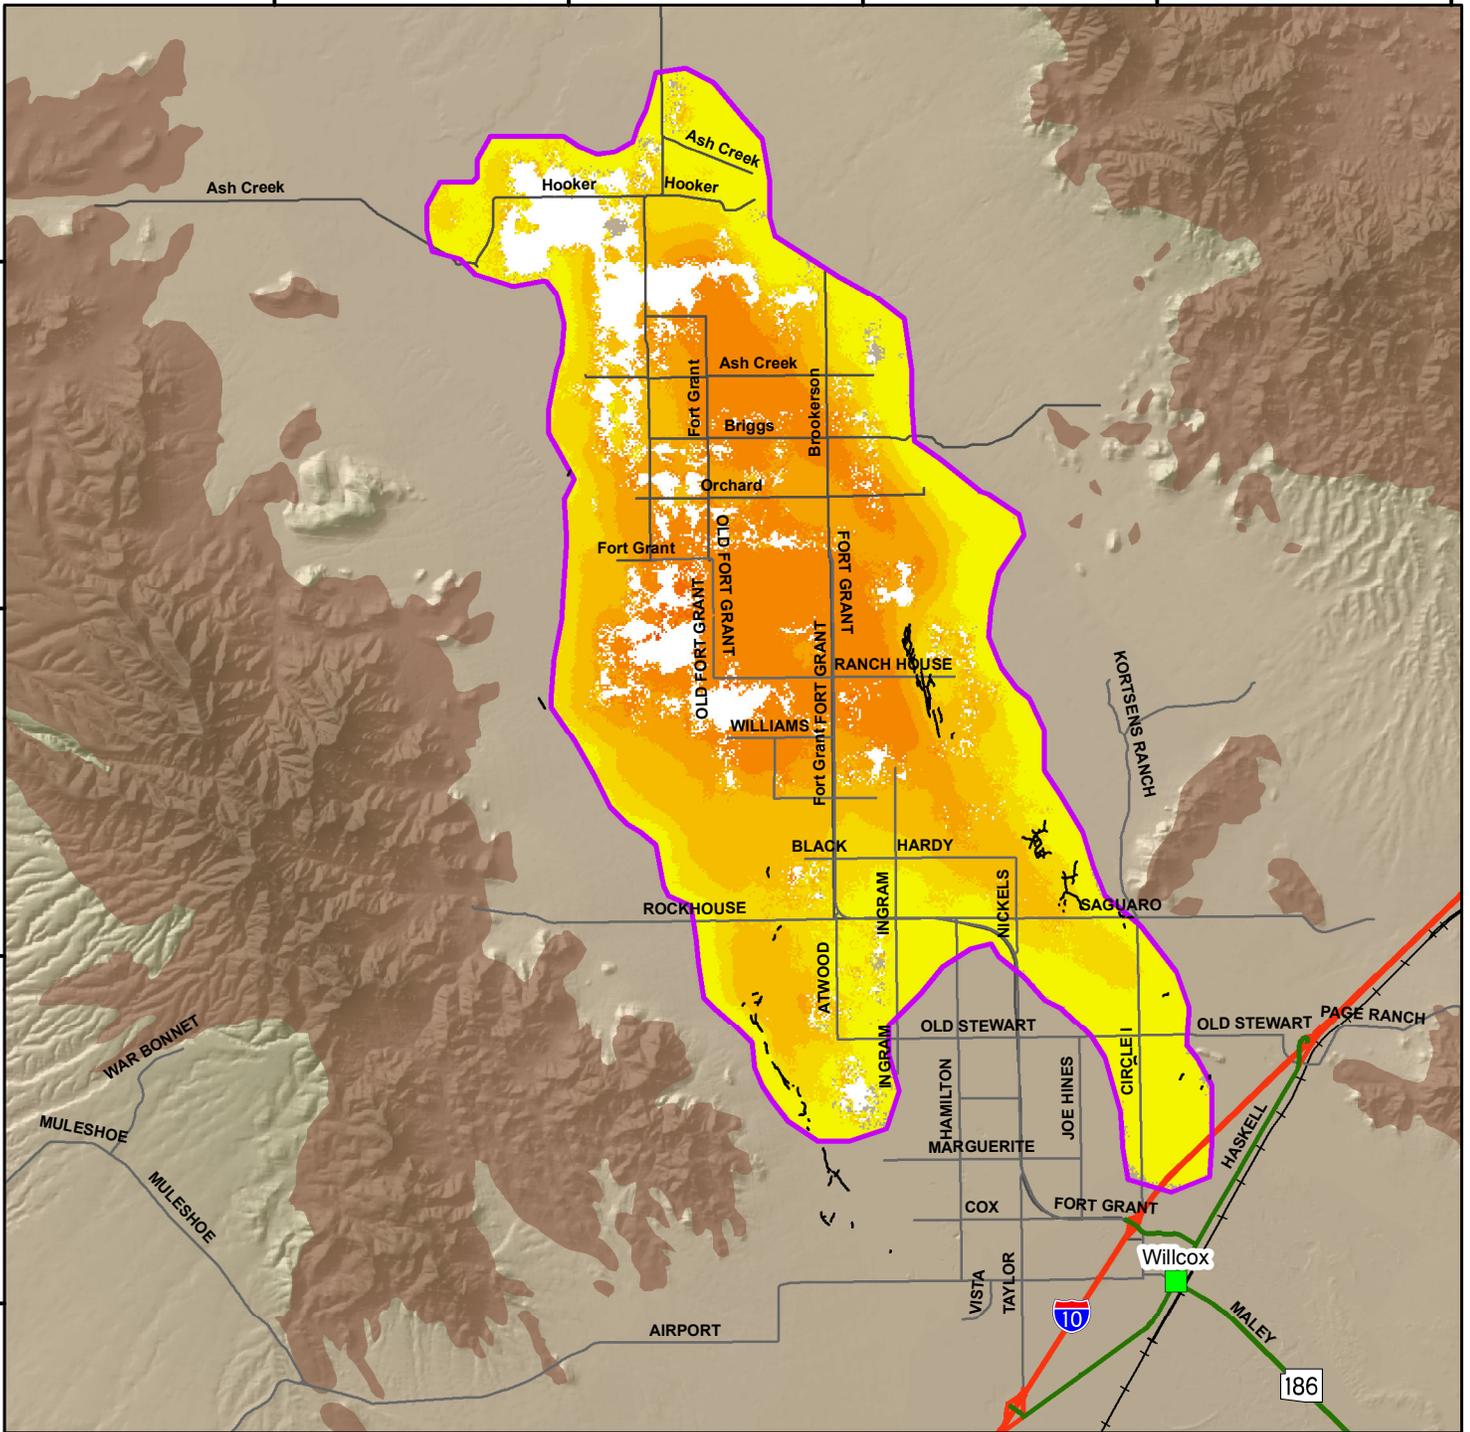
- Decorrelation/No Data
- Greater 40 cm (15.7 in)
- 25 - 40 cm (9.8 - 15.7 in)
- 15 - 25 cm (5.9 - 9.8 in)
- 10 - 15 cm (3.9 - 5.9 in)
- 6 - 10 cm (2.4 - 3.9 in)
- 4 - 6 cm (1.6 - 2.4 in)
- 2 - 4 cm (0.8 - 1.6 in)
- 1 - 2 cm (0.4 - 0.8 in)
- 0 - 1 cm (0 - 0.4 in)

Decorrelation (white areas) are areas where the phase of the received satellite signal changed between satellite passes, causing the data to be unusable. This occurs in areas where the land surface has been disturbed (i.e. bodies of water, snow, agriculture areas, areas of development, etc).
