Total Land Subsidence in the Fort Grant Rd and Willcox Areas, Cochise and Graham Counties
Based on Radarsat-2 Satellite Interferometric Synthetic Aperture Radar (InSAR) Data

Time Period of Analysis: 2.0 Years 03/21/2014 To 04/03/2016

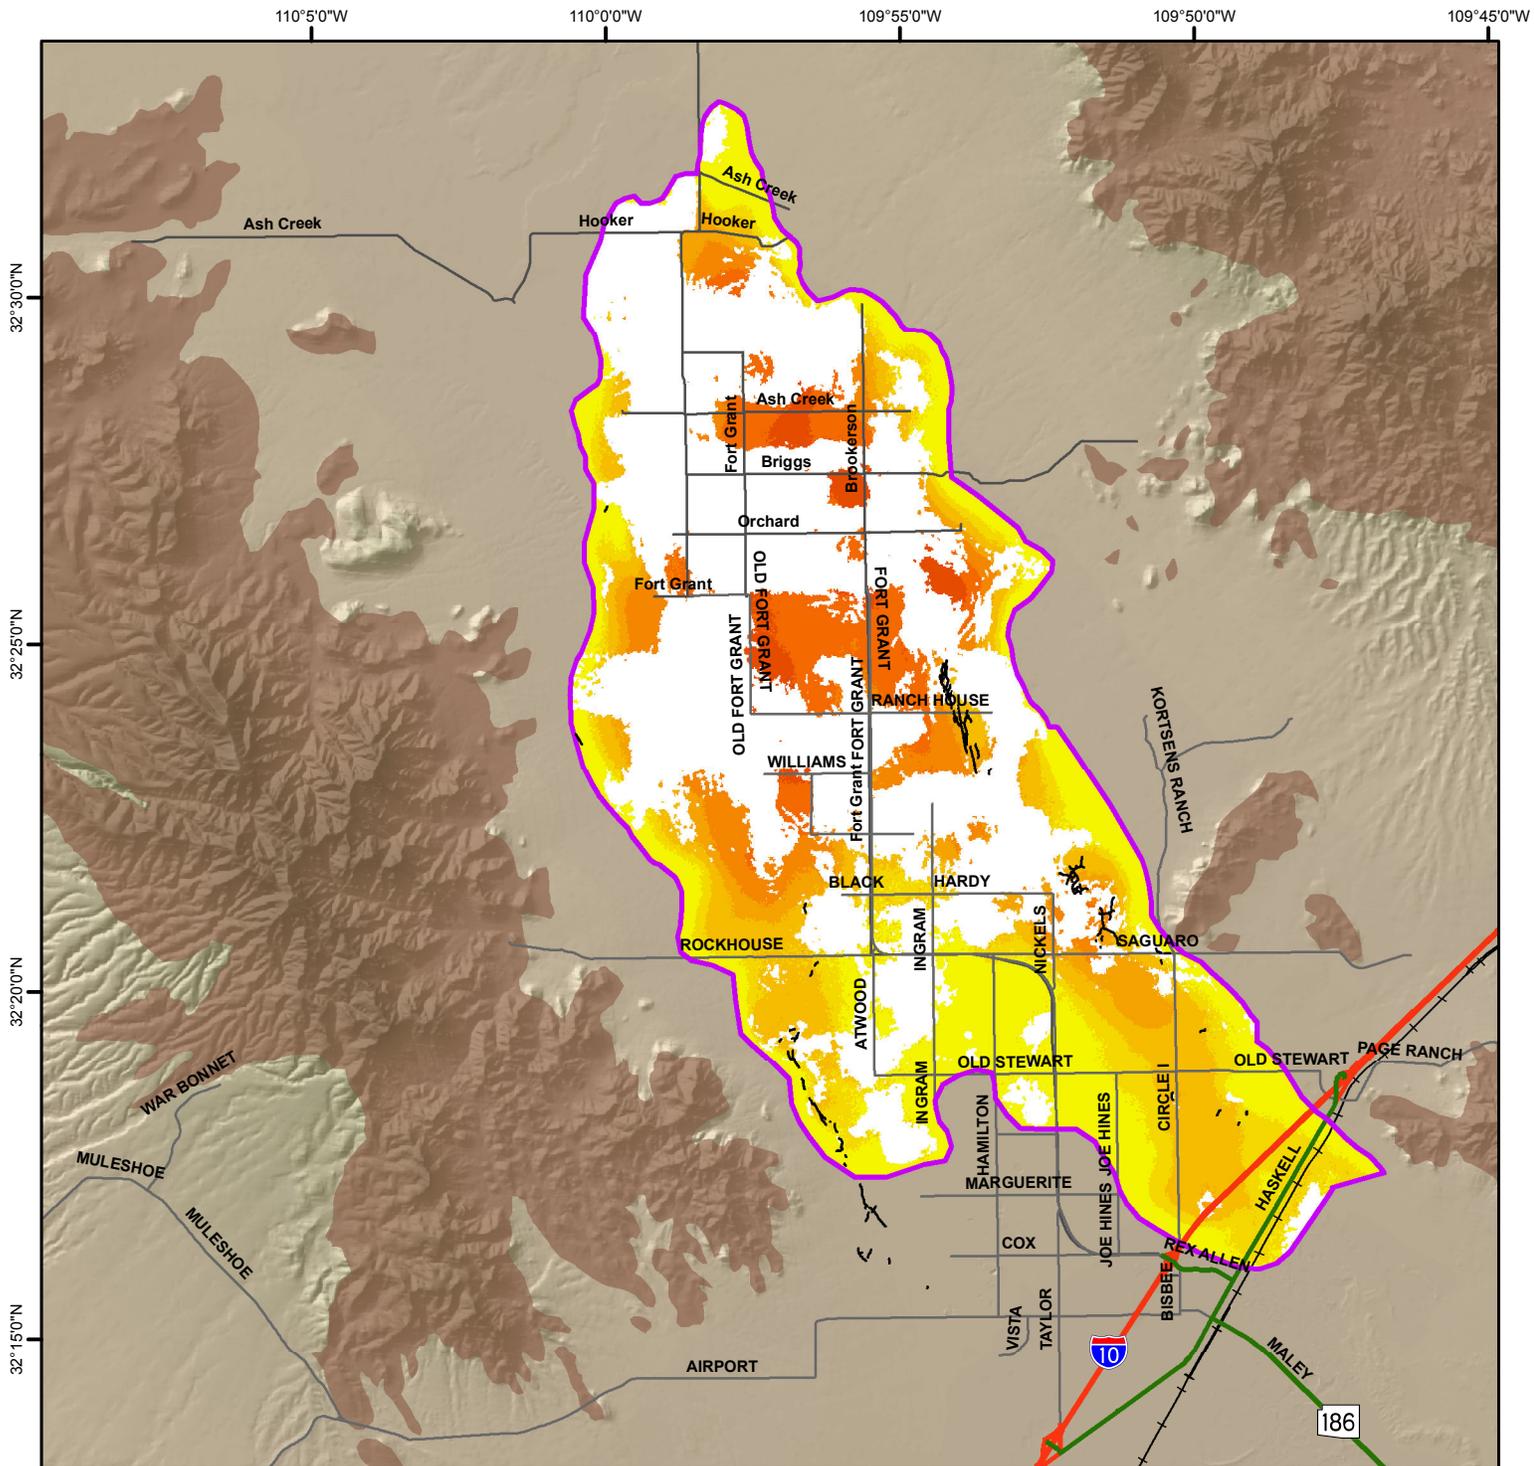
Total Land Subsidence

Decorrelation (white areas) are areas where the phase of the received satellite signal changed between satellite passes, causing the data to be unusable. This occurs in areas where the land surface has been disturbed (i.e. bodies of water, snow, agriculture areas, areas of development, etc).

Earth fissures were mapped by the Arizona Geological Survey. For information on earth fissures visit: www.azgs.gov/EFC
