Total Land Subsidence in the Fort Grant Rd and Willcox Areas, Cochise and Graham Counties
Based on Radarsat-2 Satellite Interferometric Synthetic Aperture Radar (InSAR) Data

Time Period of Analysis: 6.0 Years 05/05/2010 To 04/03/2016

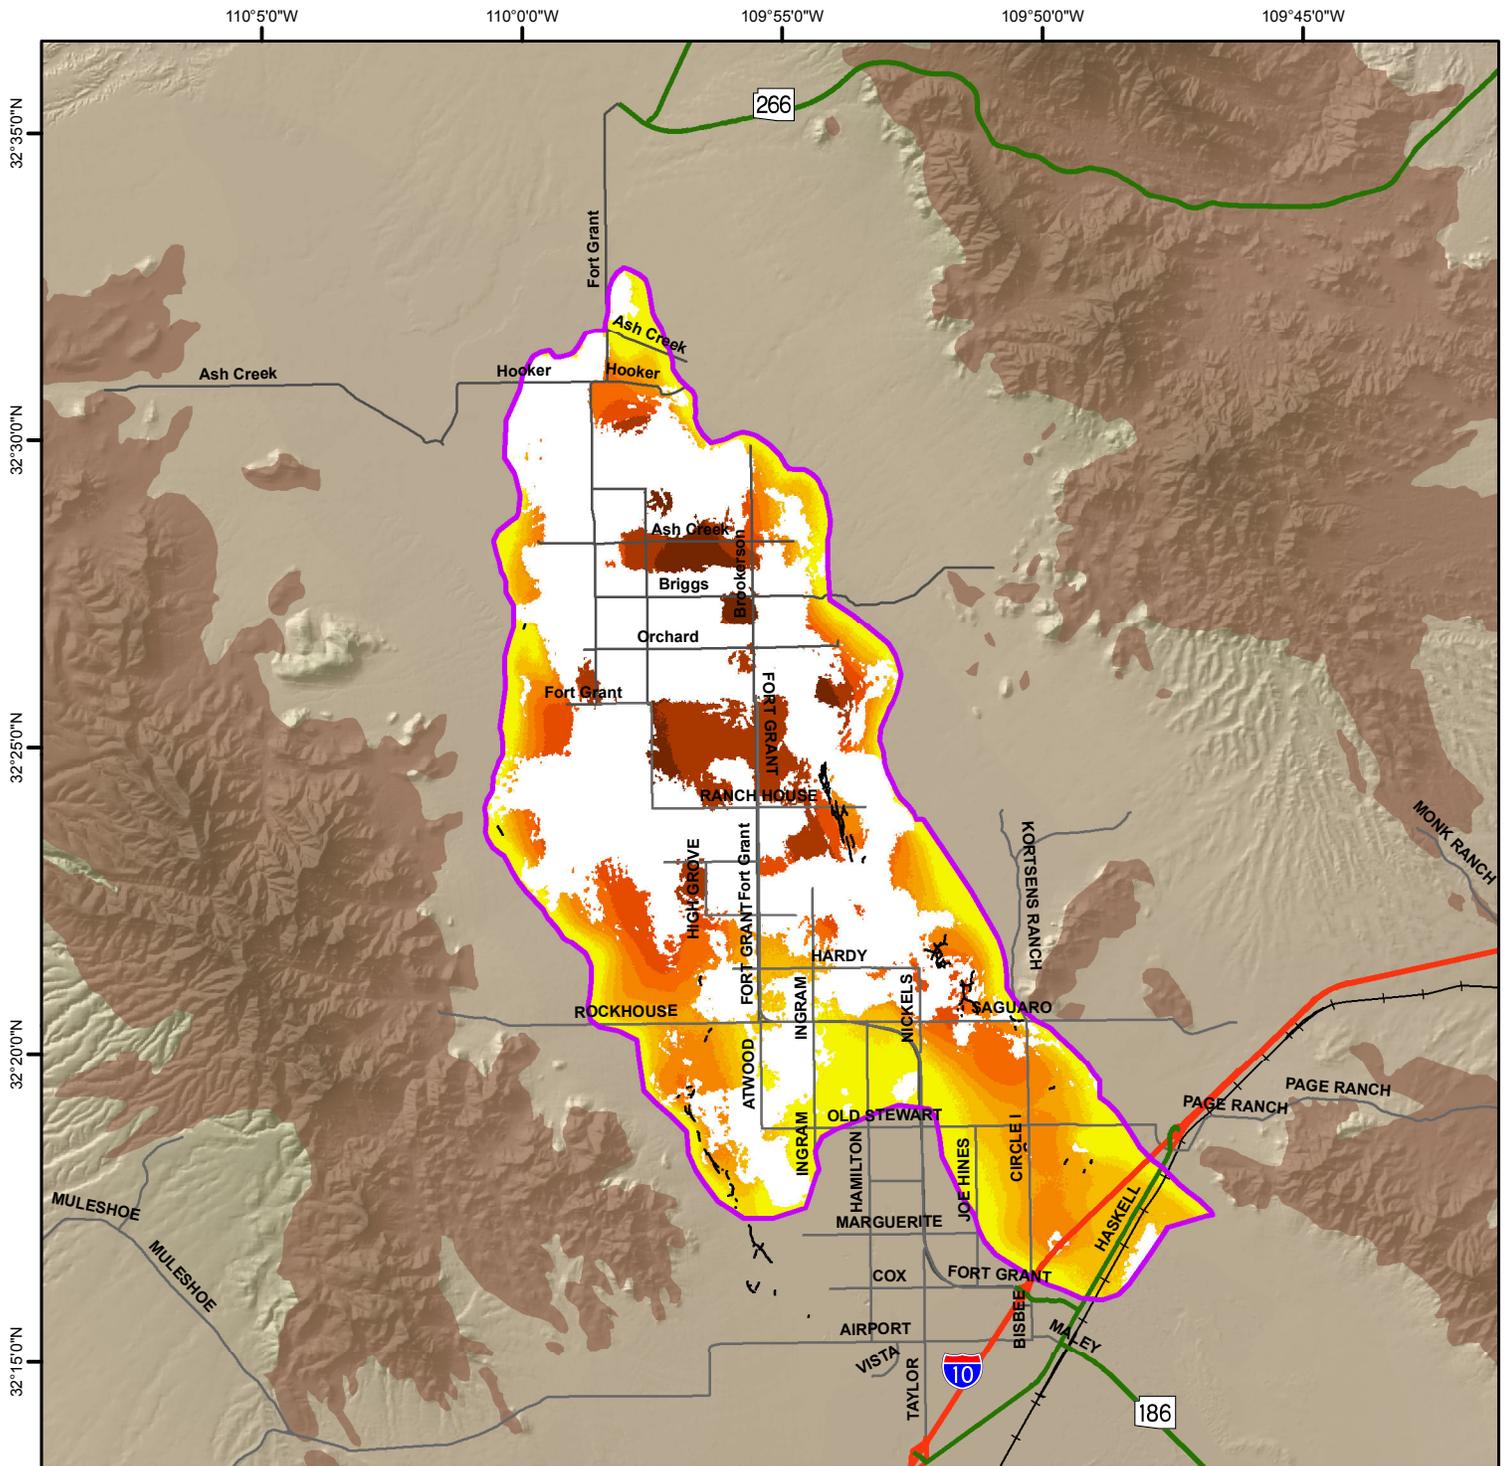
Decorrelation/No Data
Greater 40 cm (15.7 in)
25 - 40 cm (9.8 - 15.7 in)
15 - 25 cm (5.9 - 9.8 in)
10 - 15 cm (3.9 - 5.9 in)
6 - 10 cm (2.4 - 3.9 in)
4 - 6 cm (1.6 - 2.4 in)
2 - 4 cm (0.8 - 1.6 in)
1 - 2 cm (0.4 - 0.8 in)
0 - 1 cm (0 - 0.4 in)

Decorrelation (white areas) are areas where the phase of the received satellite signal changed between satellite passes, causing the data to be unusable. This occurs in areas where the land surface has been disturbed (i.e. bodies of water, snow, agriculture areas, areas of development, etc).

Earth fissures were mapped by the Arizona Geological Survey. For information on earth fissures visit: www.azgs.gov/EFC
