**Total Land Subsidence in the Fort Grant Rd and Willcox Areas, Cochise County  
Based on ERS-1 Satellite Interferometric Synthetic Aperture Radar (InSAR) Data**

**Time Period of Analysis: 1.0 Years 11/12/1992 To 11/06/1993**

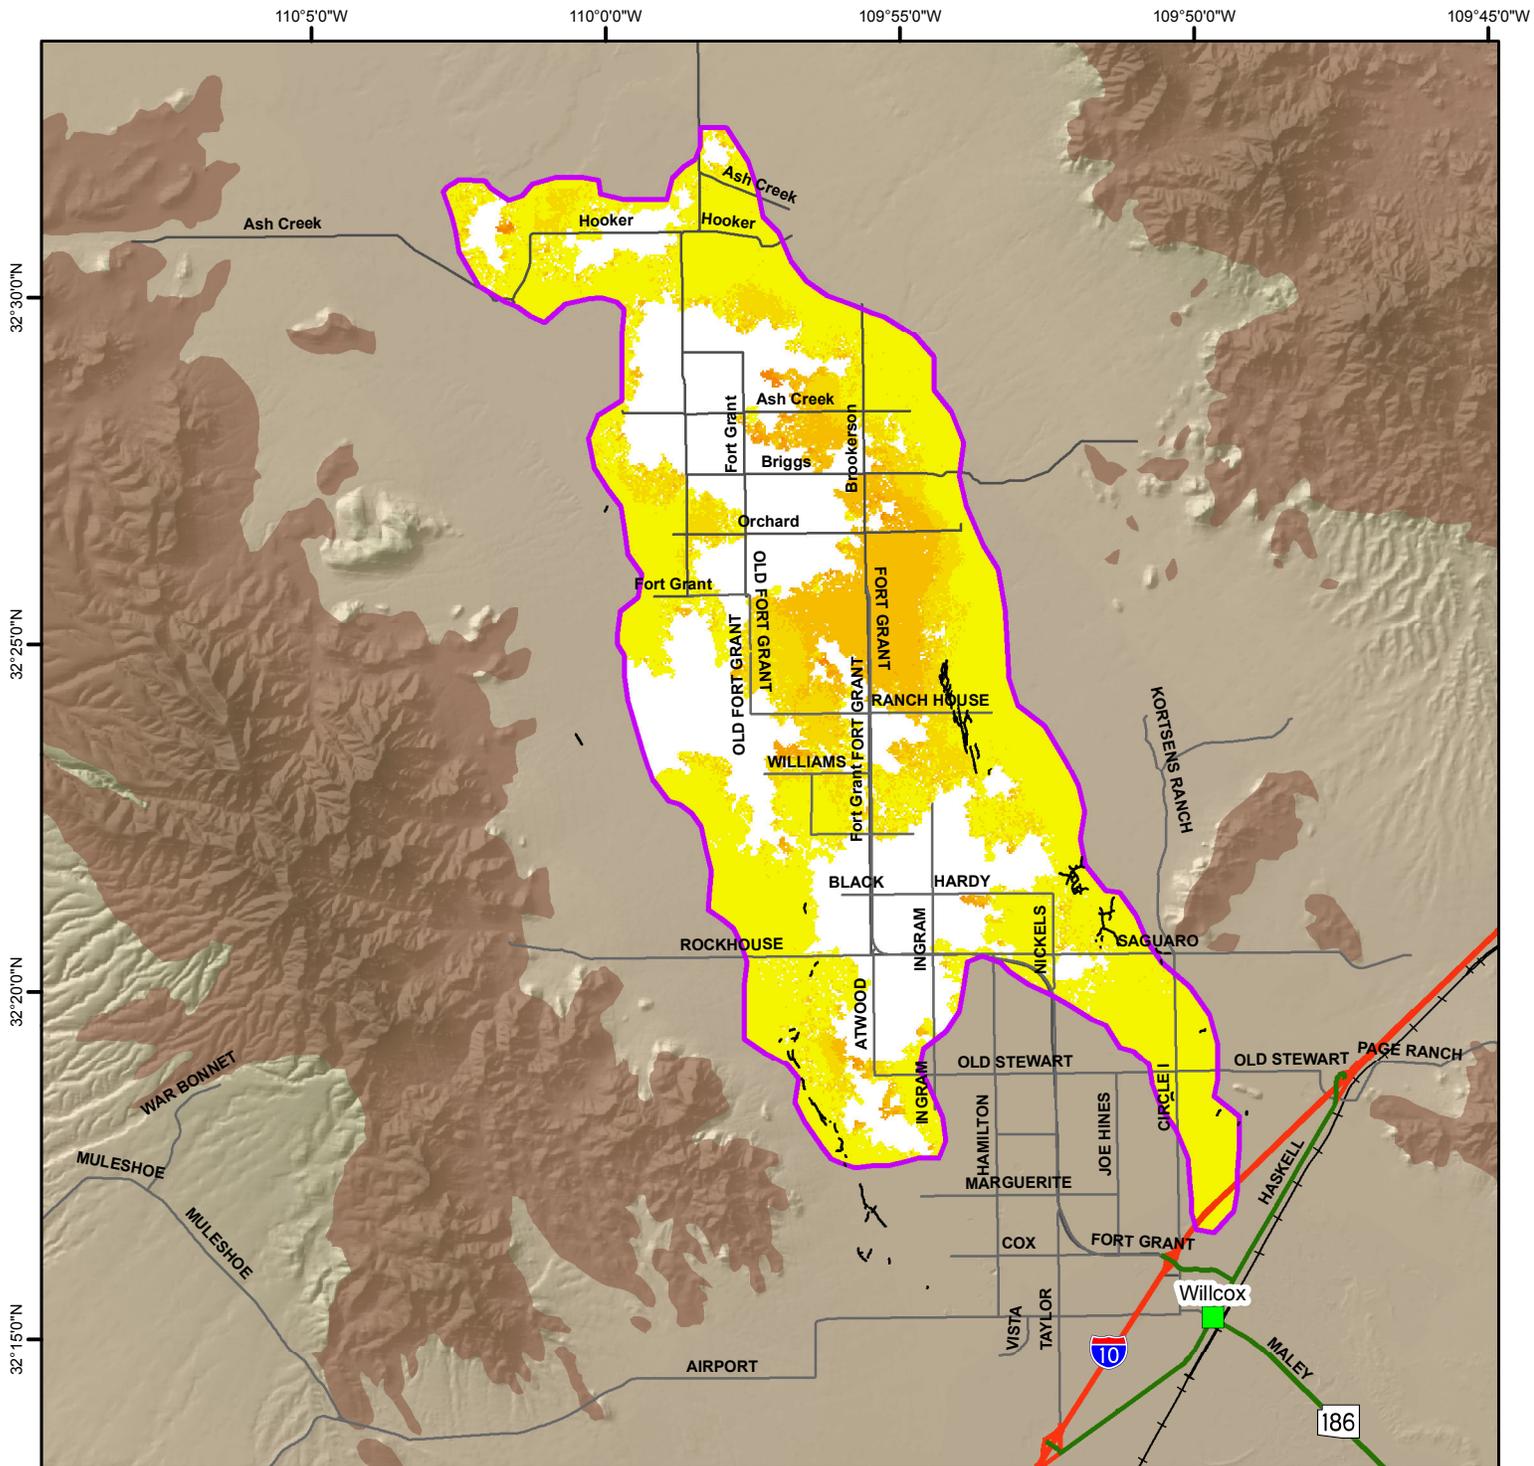
**Total Land Subsidence**

- Decorrelation/No Data
- Greater 40 cm (15.7 in)
- 25 - 40 cm (9.8 - 15.7 in)
- 15 - 25 cm (5.9 - 9.8 in)
- 10 - 15 cm (3.9 - 5.9 in)
- 6 - 10 cm (2.4 - 3.9 in)
- 4 - 6 cm (1.6 - 2.4 in)
- 2 - 4 cm (0.8 - 1.6 in)
- 1 - 2 cm (0.4 - 0.8 in)
- 0 - 1 cm (0 - 0.4 in)

Decorrelation (white areas) are areas where the phase of the received satellite signal changed between satellite passes, causing the data to be unusable. This occurs in areas where the land surface has been disturbed (i.e. bodies of water, snow, agriculture areas, areas of development, etc).

Earth fissures were mapped by the Arizona Geological Survey. For information on earth fissures visit: [www.azgs.gov/EFC](http://www.azgs.gov/EFC)
