Total Land Subsidence in the Fort Grant Rd and Willcox Areas, Cochise County
 Based on ALOS-1 Satellite Interferometric Synthetic Aperture Radar (InSAR) Data

Time Period of Analysis: 4.2 Years 12/06/2006 To 02/01/2011

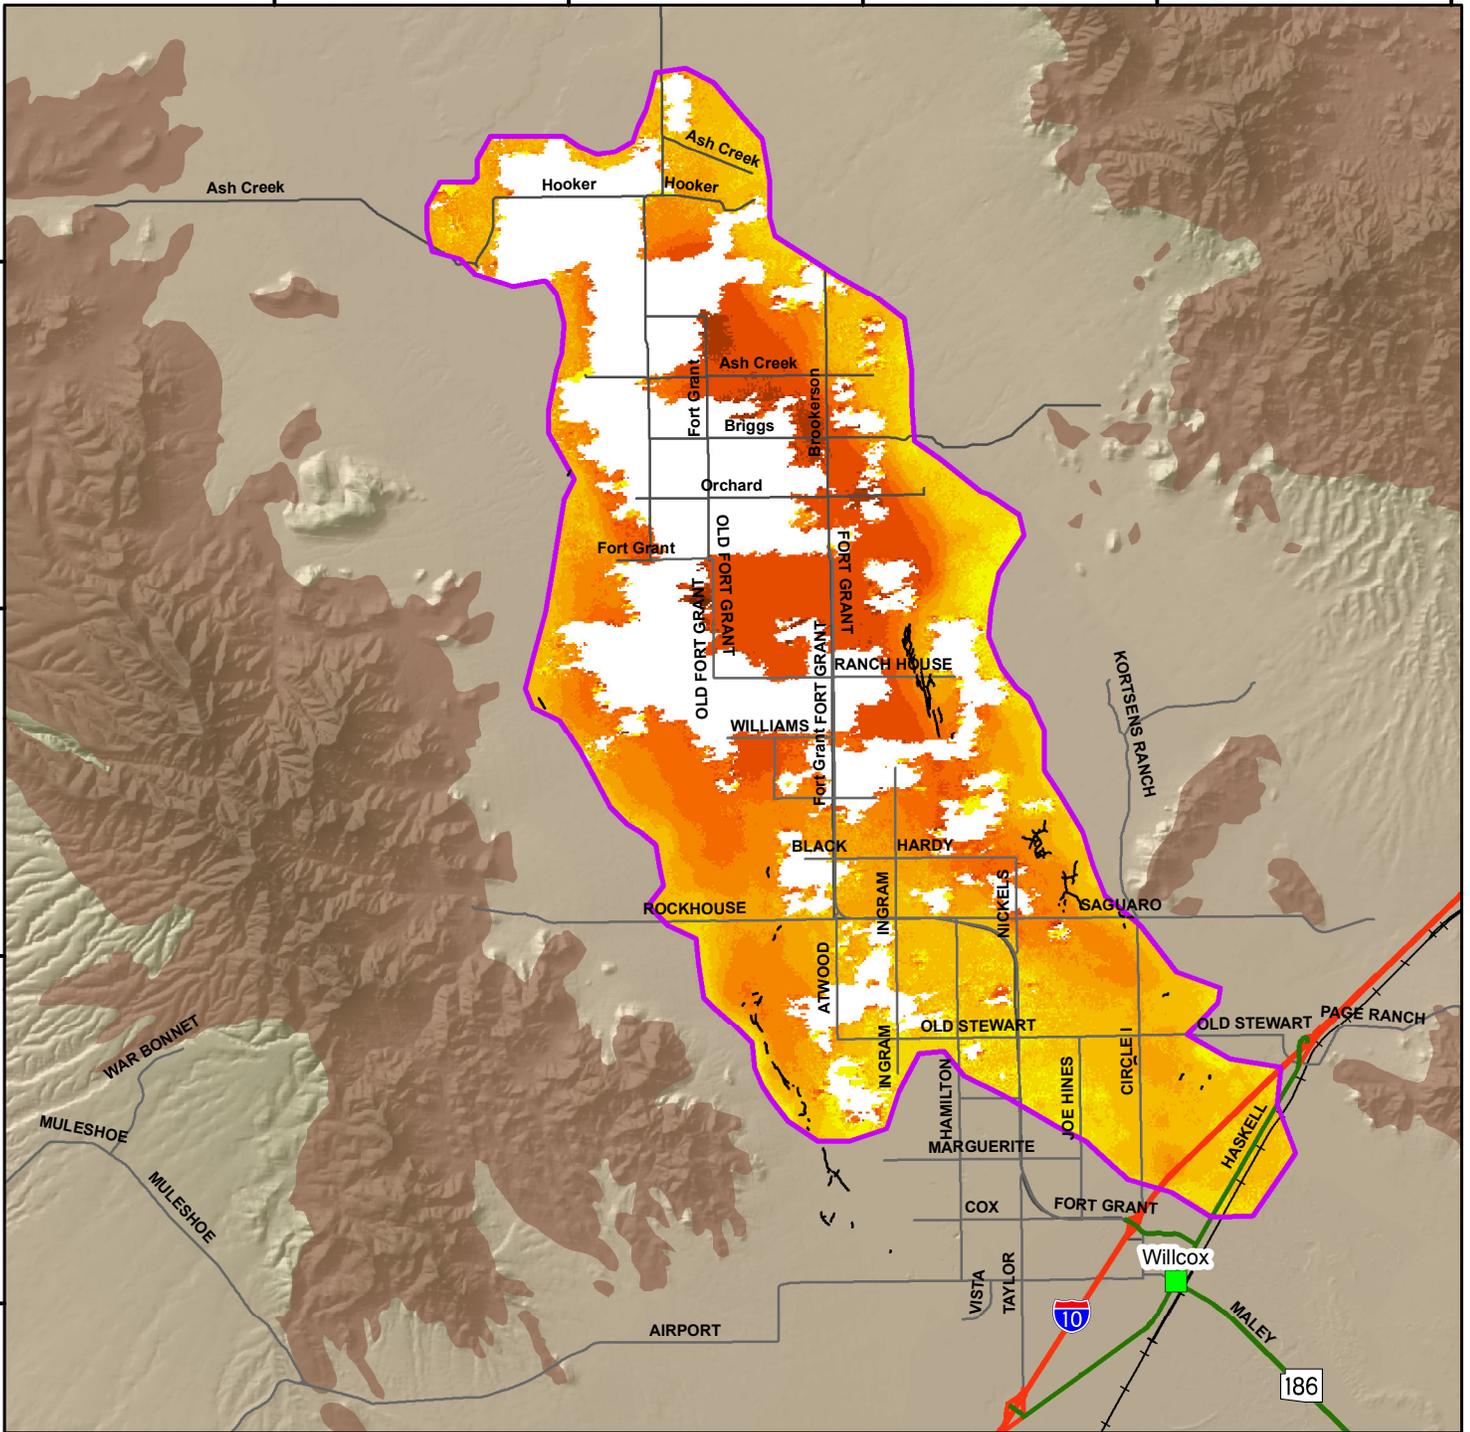
Decorrelation (white areas) are areas where the phase of the received satellite signal changed between satellite passes, causing the data to be unusable. This occurs in areas where the land surface has been disturbed (i.e. bodies of water, snow, agriculture areas, areas of development, etc).
